July 18, 2003
L-03-110

**Subject: Beaver Valley Power Station, Unit No. 1 and No. 2
BV-1 Docket No. 50-334, License No. DPR-66
BV-2 Docket No. 50-412, License No. NPF-73
Supplemental Information in Support of 2001-2002 Steam Generator
Tube Outages Inspection Reports**

Letter L-03-110 - ATTACHMENT A

Information in Response to a Request for Additional Information
for Beaver Valley Power Station, Unit No. 2

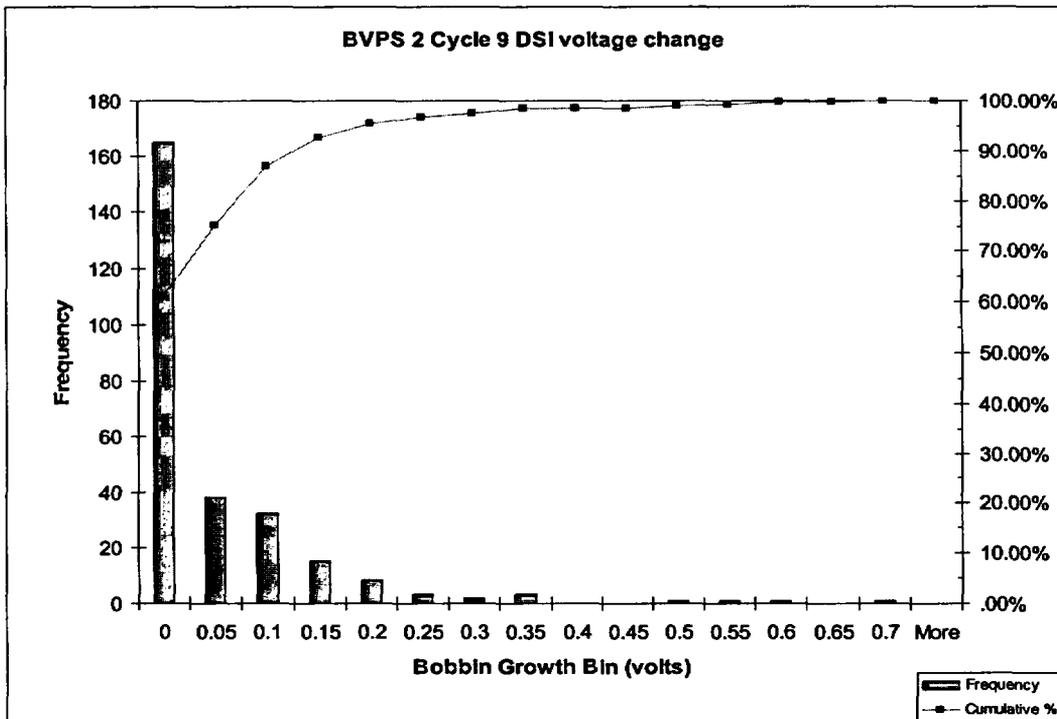
FIGURE 1

Additionally, the overall DSI amplitude growth for BVPS 2 Cycle 9 is negligible. The largest singular bobbin amplitude growth in any SG was 0.70 volts, with an average growth of -0.03 volts. Figure 1 provides a cumulative probability distribution function of DSI growth for Cycle 9. An overwhelming majority of the growth values are within the typical repeatability bounds for the bobbin coil.
