Bottom Mounted Instrument Penetration Condition Resolution

INTRODUCTORY REMARKS

Evidence of Very Small Leakage Found in Routine Inspection

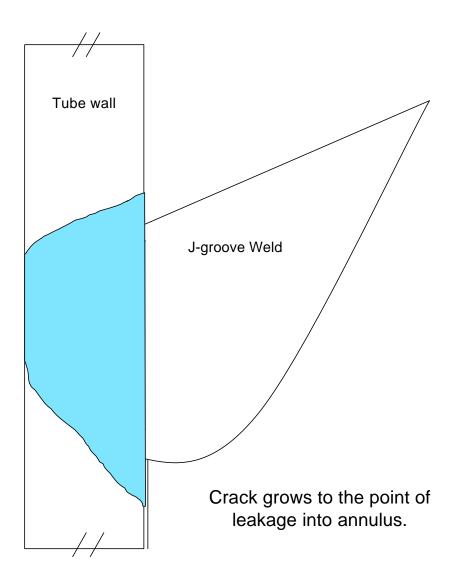
Crack Propagation Scenario

- Cracks not at highest residual stress locations
- Penetrations #1 and #46 are different in terms of residual stress
- Some cracks do not appear to be in contact with primary water

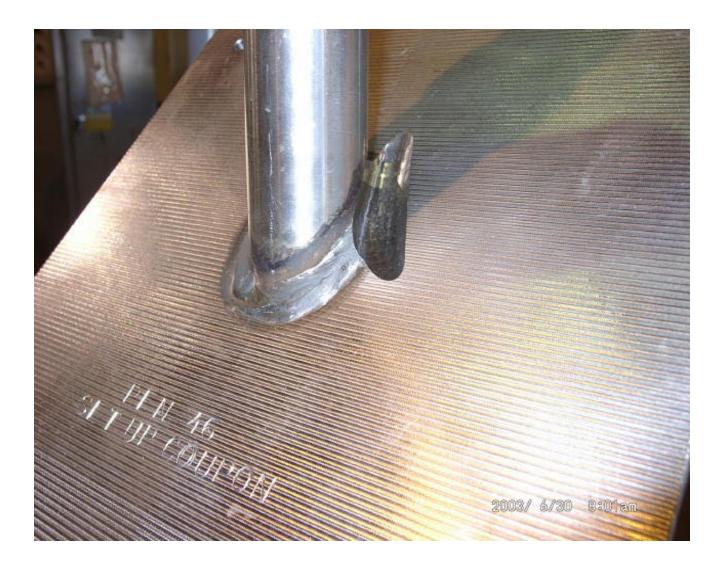
Mock-up Penetration #46 Boat Sample

• Capture portion of crack shown by UT not to connect with the surface
