5. TESTING

5.1 Test Planning

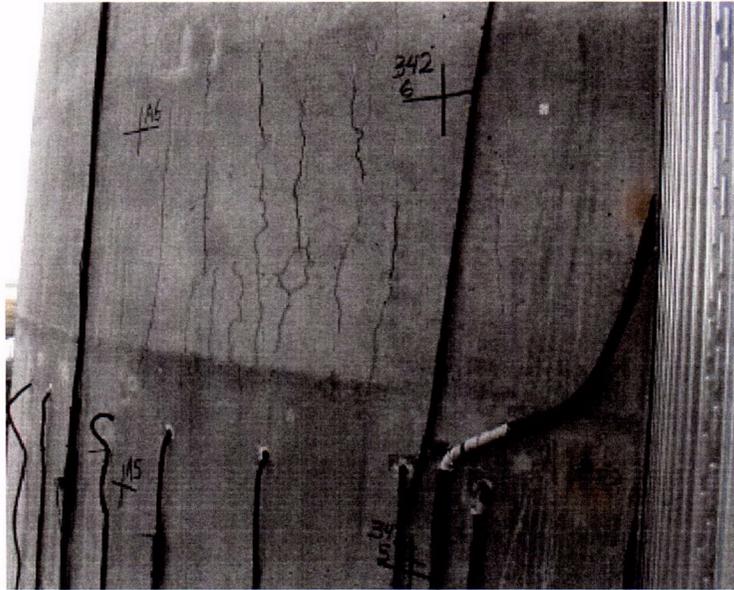
Figure 5.11 Post-SIT Cracks at Azimuth. 350 degrees, Elev. 4680 to 6200 (Grid 45)

While holding at the ILRT pressure, a limited amount of crack mapping was performed. This was accomplished by tracing all new cracks in predetermined areas and taking still photos of these areas. Cracks in the area to the left of the E/H prior to the SIT were traced in black and are shown in Figure 5.10. New cracks, traced in blue during the ILRT, are shown in Figure 5.11. Cracks widths were not measured.

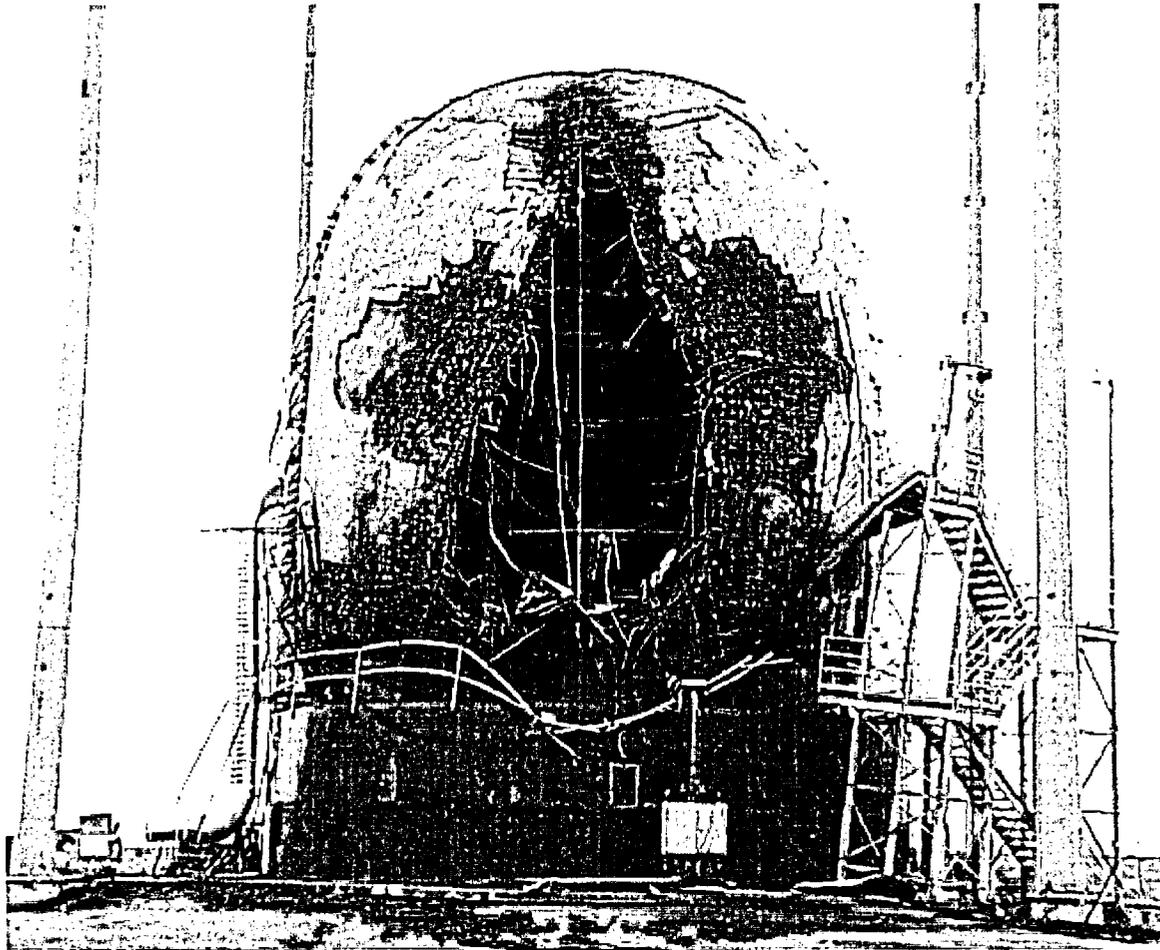
Figure 5.35 PCCV Model after the SFMT

The detailed results of the SFMT are discussed in Section 5.3.3, along with observations from the posttest inspection of the model. In the case of the SFMT, posttest inspection was limited to visual inspection due to the obvious damage and restricted access for safety.
