5.3.2 Limit State Test Results

5.3.2.2 Posttest Inspection

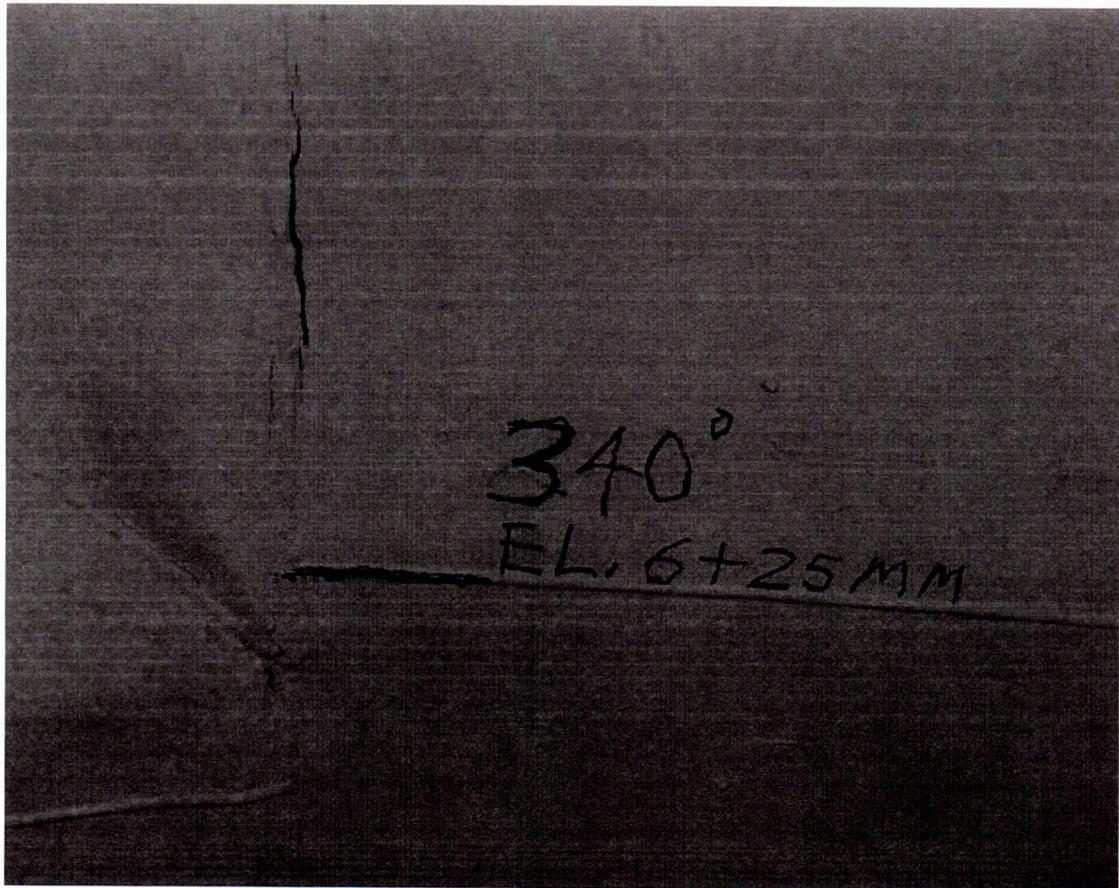
Figure 5.47 Liner Tear (#15) at E/H

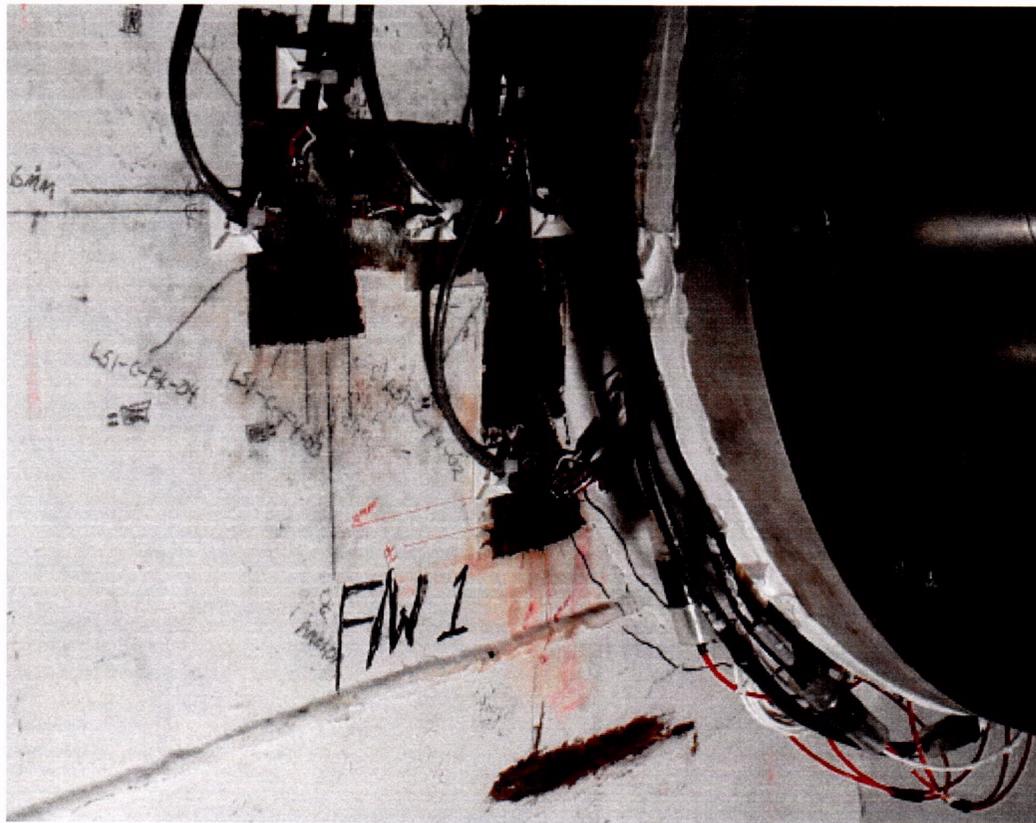
Several large tears occurred at each end of the F/W penetration, beginning at the weld between the thickened insert plate and the liner; however, no tears occurred at the M/S penetration event, though the free-field hoop strains at the M/S are higher since it is closer to the mid-height of the cylinder. There are a number of reasons why this occurred, primarily liner fabrication issues discussed in Section 5.3.2.2. It is interesting to note that even though the strain gages at the F/W penetration were located near the tear (see Figure 5.54), measured strains were relatively low until the very end of the LST, when some strains increased very rapidly. This might indicate that a tear in the vicinity of a strain gage can act as a strain relief mechanism on the surrounding material. The 'jump' in the strain near the end of the test may also be due to material distortion in the vicinity of the tear as the tear propagated. On the other hand, the strains recorded at the M/S penetration begin to climb rapidly at 2.0 to $2.5 P_d$, reaching values as high as 4.5% without resulting in any liner tearing. Detailed inspections of this location did not reveal any evidence of the fabrication problems that were present at the F/W penetration.

Figure 5.54 Liner Tear (#3) and Strain Gages at F/W Penetration

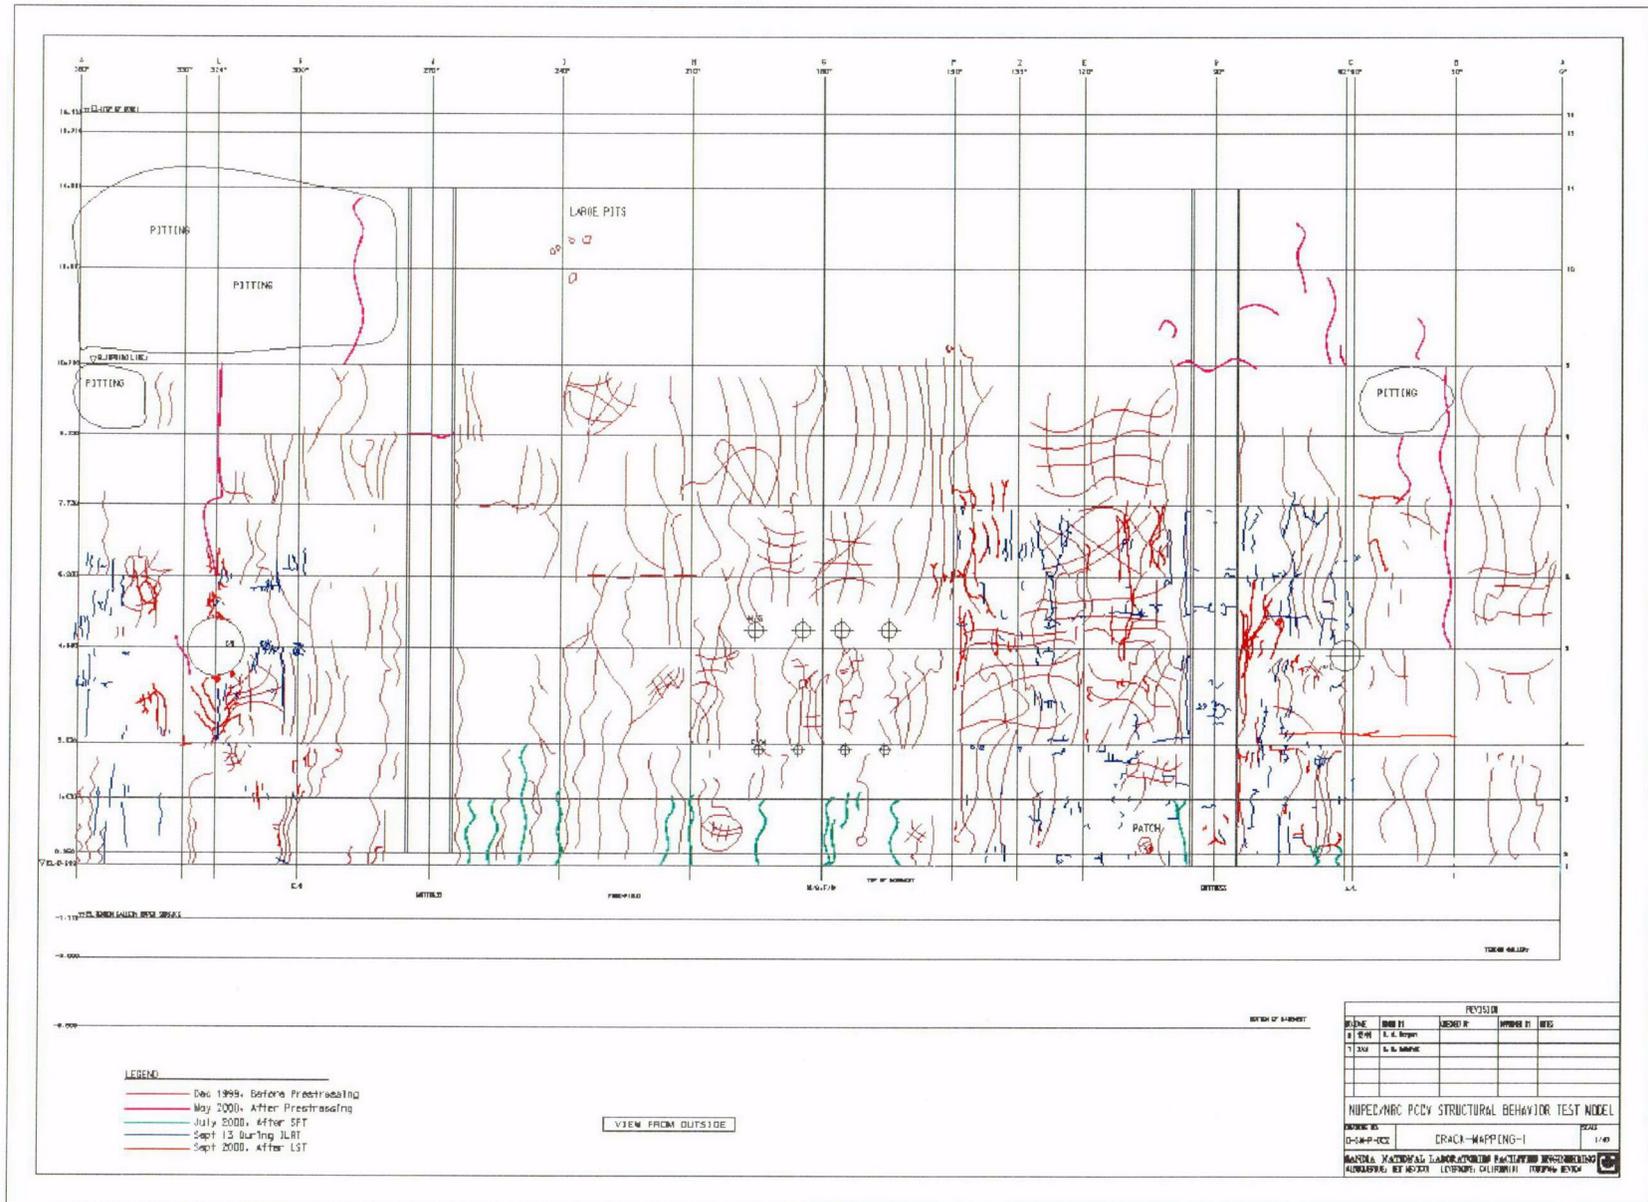
New cracks and extensions of existing cracks within the crack mapping zones resulting from the LST (see Fig. 5.8) were traced in red and the surface was photographed to document the crack locations (e.g. Fig 5.22). The cracks were then transferred to the crack map drawing, shown in Figure 5.76, which shows all the major cracks identified after various loading stages. In general, concrete cracking was not extensive or very severe, with the exception of some areas around the E/H and some of the smaller penetrations. As noted in Chapter 3, there was no effort to measure crack widths. While it can be observed that some of the larger cracks around the E/H are near the liner tear locations, there was no further effort to correlate the crack locations with other events or data.

Figure 5.76 Post-LST Concrete Crack Map

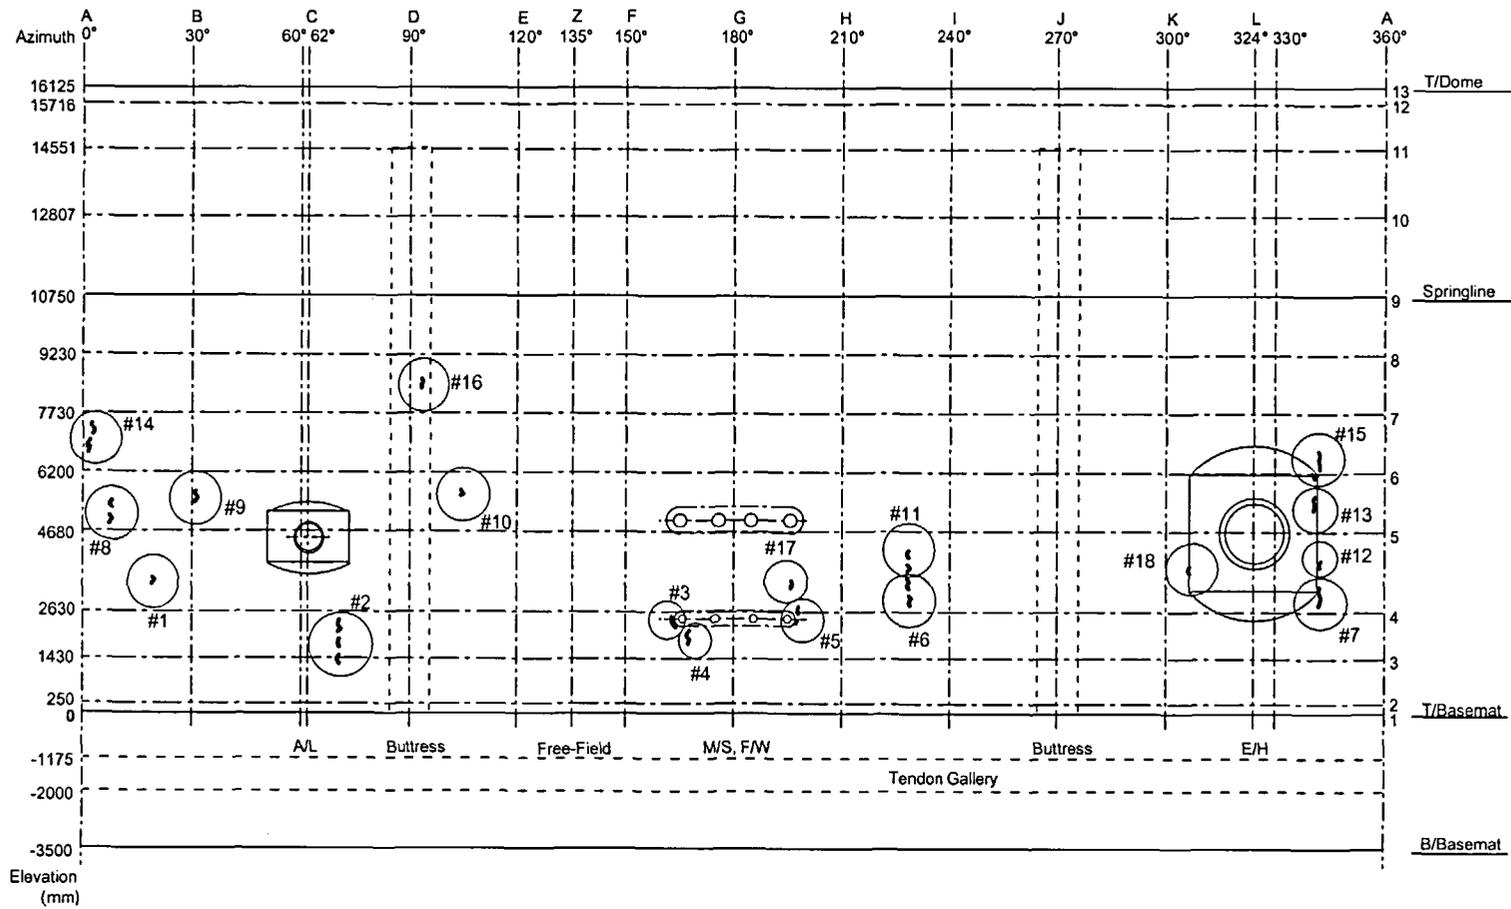
As noted in Section 5.2.3, after entering the model following the LST, the liner surface was examined carefully and 26 discrete tears were found at 18 different locations, the grouping by location being somewhat arbitrary. The location of the tears are mapped in Figure 5.77. The location numbers are subsequently used to identify the tears.

One immediate observation was that each liner tear was at or very near a field weld seam in the liner. No tears were found in the undisturbed parent material or at a shop weld.

Figure 5.77 Post-LST Liner Tears

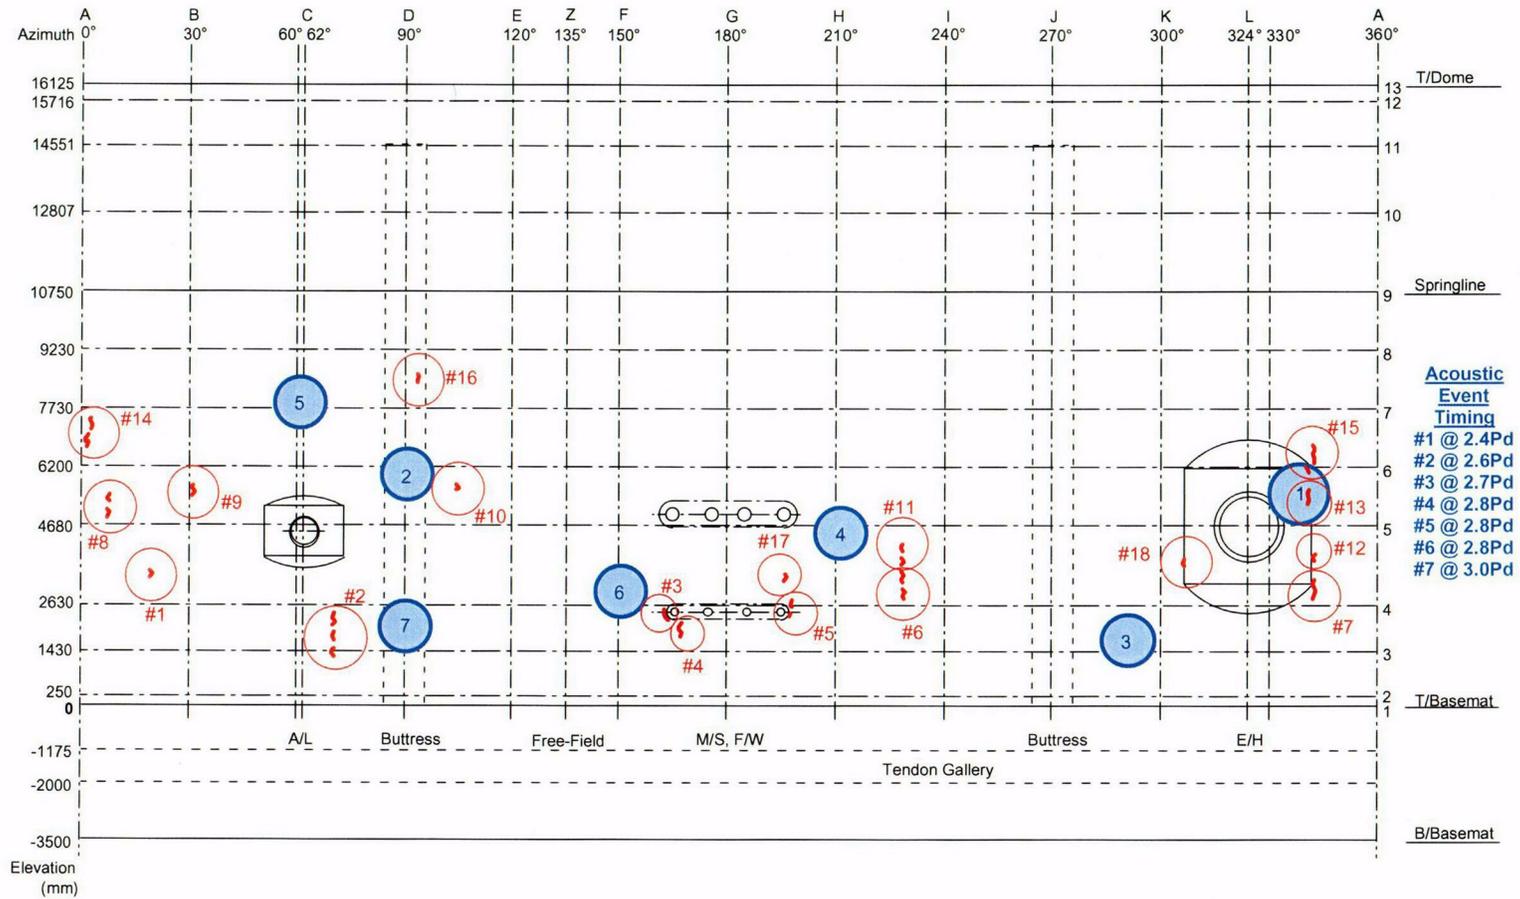
The acoustic events, later associated with the sound of the nitrogen gas escaping through the liner tears, are superimposed on the tear map in Figure 5.78, along with the approximate pressure levels when these events were first detected. The first tearing event appears to be clearly associated with the tears along the edge of the E/H embossment (#7, #12, #13, and #15), although it is arguable which of these occurred first. The other acoustic tearing events cannot be as clearly identified with any specific tear or tears, and, near the end of the test, it may have been difficult to distinguish the separate 'tearing' events from each other since gas continued to escape through each tear after it occurred.

Figure 5.78 Liner Tears and Acoustic Event Locations
