5.3.3 Structural Failure Mode Test Results

5.3.3.2 Posttest Inspection

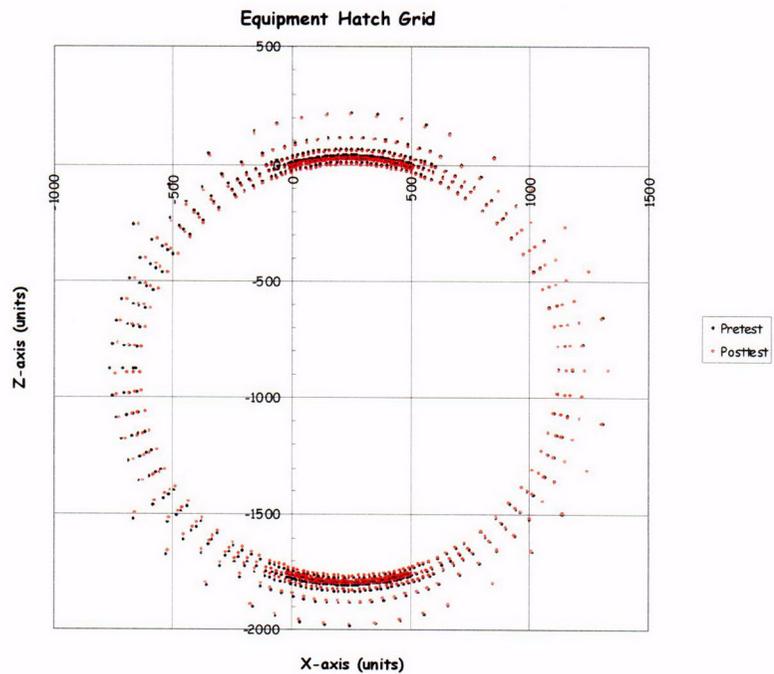
Figure 5.90 E/H Post-LST Displacement

As described in Section 3.2.5.4, a grid was constructed around the E/H to measure the residual strain field after the test. The pretest analysis predicted large strains near the perimeter of the thickened insert plate surrounding the E/H barrel and near the anchors and stiffeners that terminated near the insert. The grid, shown in Figure 5.89, was drawn, and the position of the grid points was obtained using a 3D digital position mapping tool. After the LST, the grid points were mapped again and the pre- and posttest positions were plotted in Figure 5.90.

Unfortunately, as noted previously, the strains in this region were very small and the resulting residual displacements are barely distinguishable from the pretest positions, given the precision of the digital probe. As a result, no useful information was obtained by this effort.

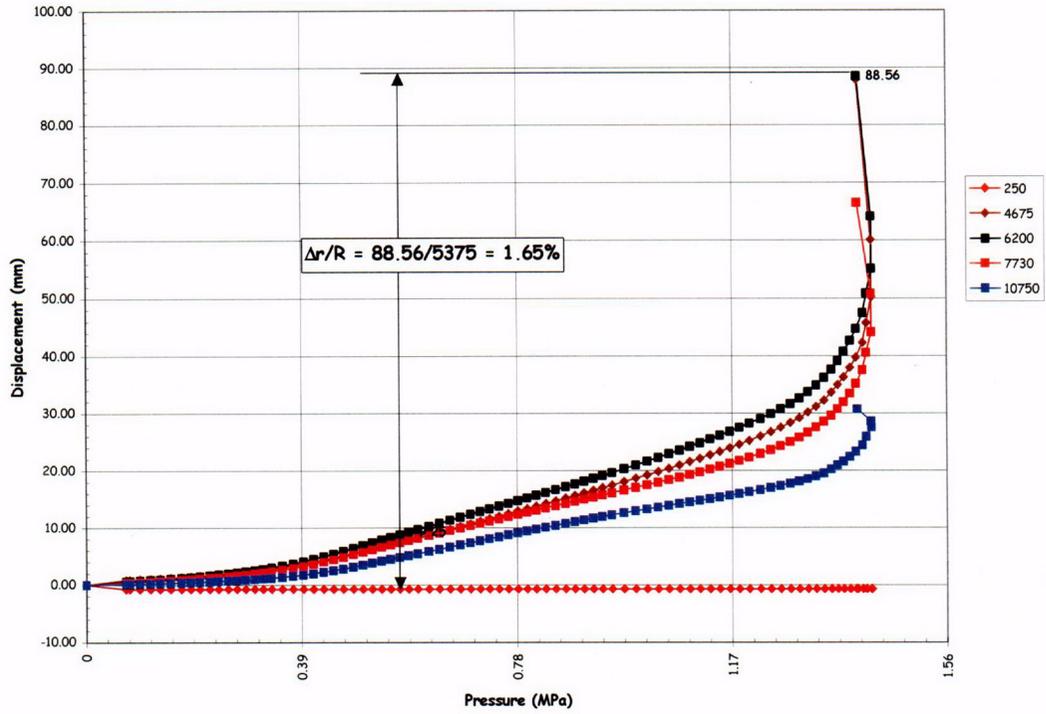
Figure 5.92 SFMT – Radial Displacement at Azimuth 324 degrees (L)

Figure 5.92 displays the displacements at Azimuth 324 degrees, which coincides with the centerline of the E/H. The largest radial displacement recorded during the SFMT, 88.56 mm, again occurred at this azimuth at elev. 6200, above the E/H. Computing the equivalent hoop strain due to pressure at this location from kinematics,

$$\text{@}P_{\text{final}} = 3.58P_d: \frac{\Delta r}{R} = \frac{88.56}{5376} = 1.65\% .$$

At the peak pressure, $3.65P_d$, the displacement was 55.12 mm, yielding an equivalent hoop strain of 1.02%

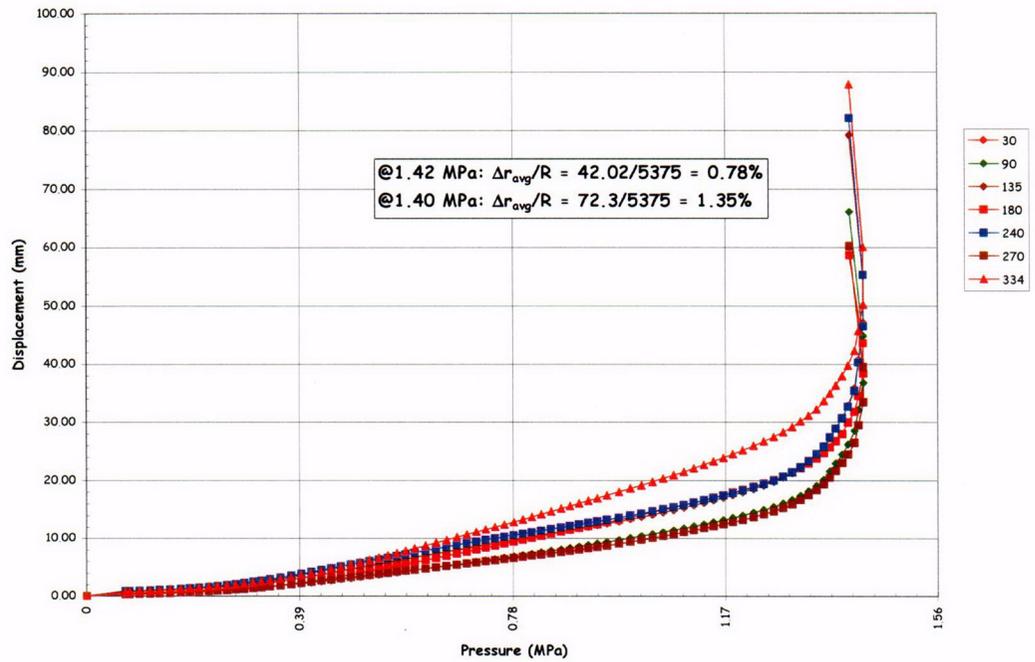
Figure 5.93 SFMT – Radial Displacement at Elev. 4680 (5)

Figure 5.93 compares the displacement response as a function of azimuth at elev. 4680, nominally the mid-height of the cylinder and the centerline of the E/H, A/L, and M/S penetrations. The response is not as uniform as was observed during the LST. Nonetheless, averaging the radial deformation due to pressure yields a nominal average hoop strain of 0.78% at the peak pressure $3.65P_d$. Similarly, the average hoop strain at $3.58P_d$, just prior to rupture, was 1.35%.

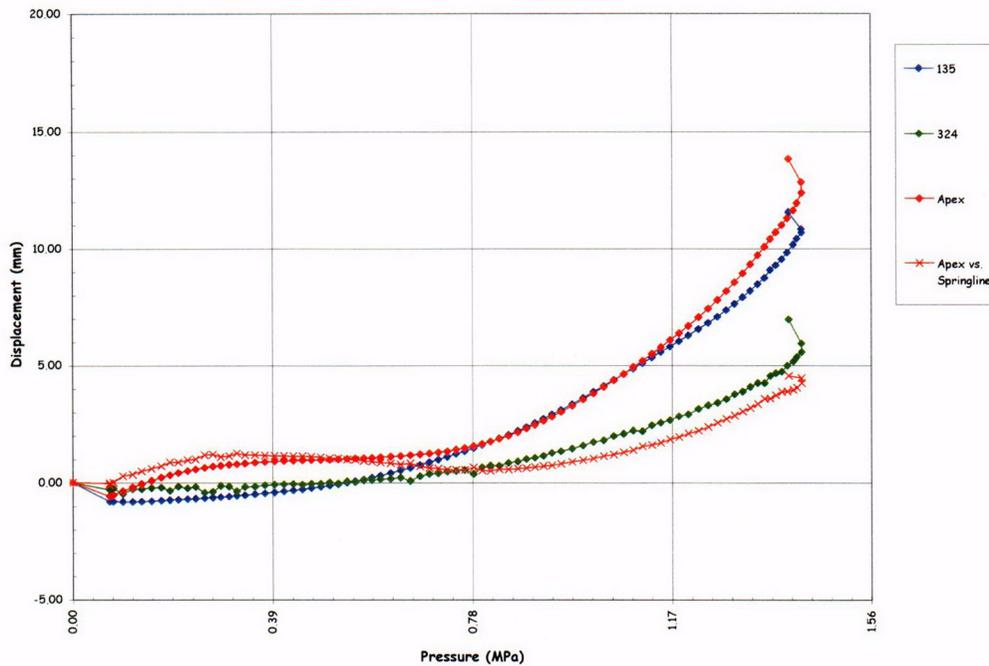
Figure 5.96 SFMT Vertical Displacements at Springline (El. 10750) and Apex

The vertical displacements are shown in Figure 5.96. The maximum vertical displacement at the springline was 10.84 mm at Azimuth 135 degrees, essentially the same as during the LST, and 5.94 mm at Azimuth 324 degrees, less than during the LST. The reason for the small displacement at 324 degrees is not immediately obvious; however, it might be the stiffening effect of the E/H embossment, although this was not observed during the LST. Nevertheless, it is clear that the vessel did not yield in the vertical direction and the vertical strains were still on the order of 0.1%.

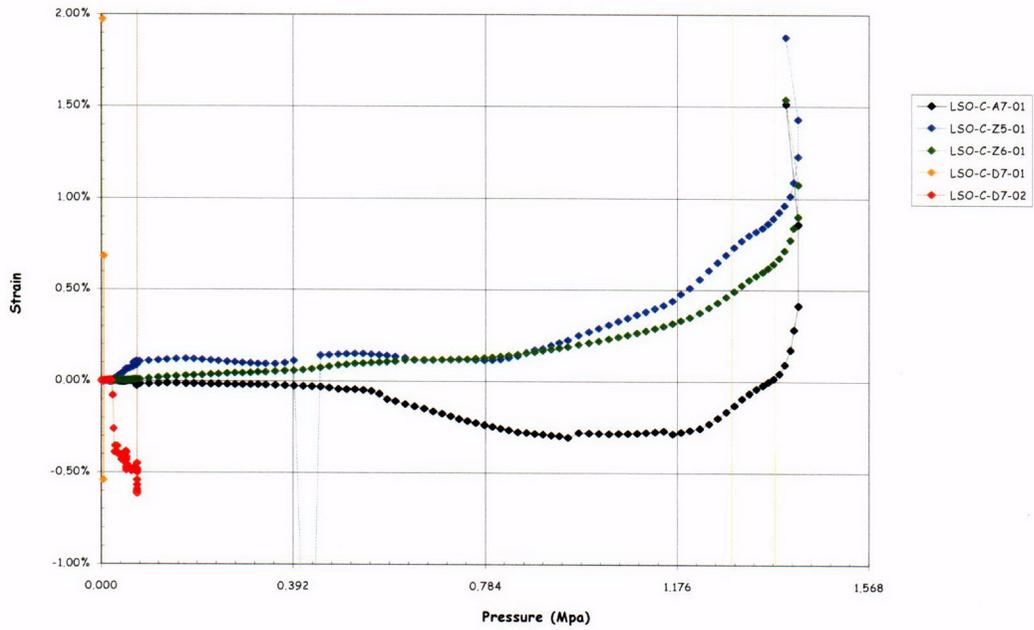
Figure 5.101 SFMT Exterior Liner Strains

The strain histories for the surviving gages are plotted in Figure 5.101. These gages measured the hoop liner strain inside a rathole (see drawing D-SN-P-209, Appendix E) at Azimuth 0 degrees, elev. 7730 (A7) and Azimuth 135 degrees, elev. 4680 and 6200 (Z5 and Z6) at the mid-height of the cylinder. The maximum liner strains at Z5 (1.9%) and Z6 (1.5%) are consistent with the strains calculated from the displacements. At A7, nearest the location where the model ruptured, the hoop strains were consistently lower than those at Z5 and Z6, even going into compression, until the peak pressure was reached, when the strain increased rapidly to a maximum of 1.5% tension. While these were not free-field gages, they nevertheless gave some indication of the hoop strains in the liner.

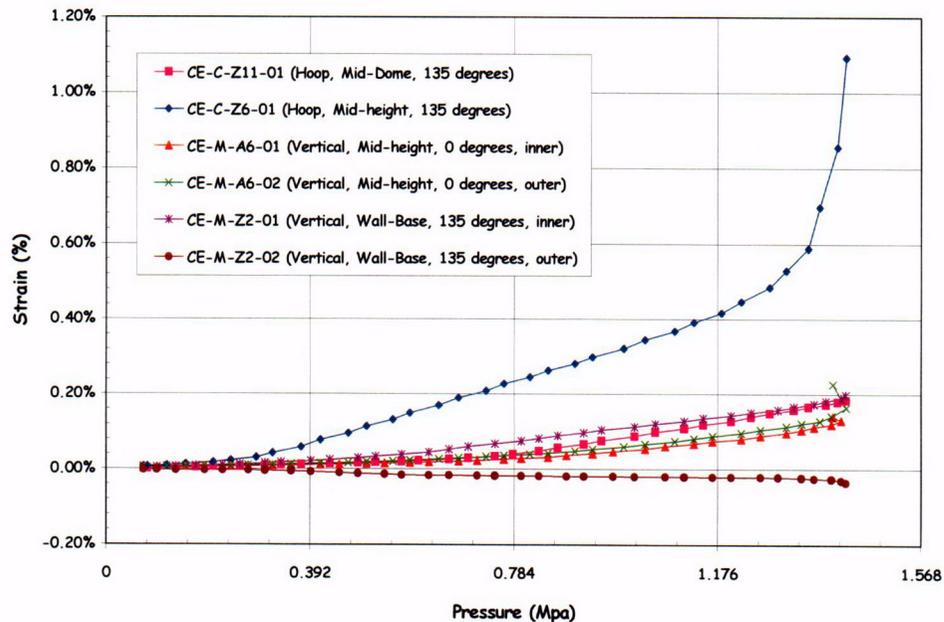
Figure 5.105 SFMT – Concrete (SOFO) Strains

Concrete strains, measured by the surviving SOFO fiber-optic gages, are plotted in Figure 5.105. The maximum hoop strain in the concrete, 1.1% (CE-C-Z6-01) at the mid-height of the cylinder, is a little lower than the displacement-based or rebar strains, but overall the concrete strains are consistent with the other measurements.

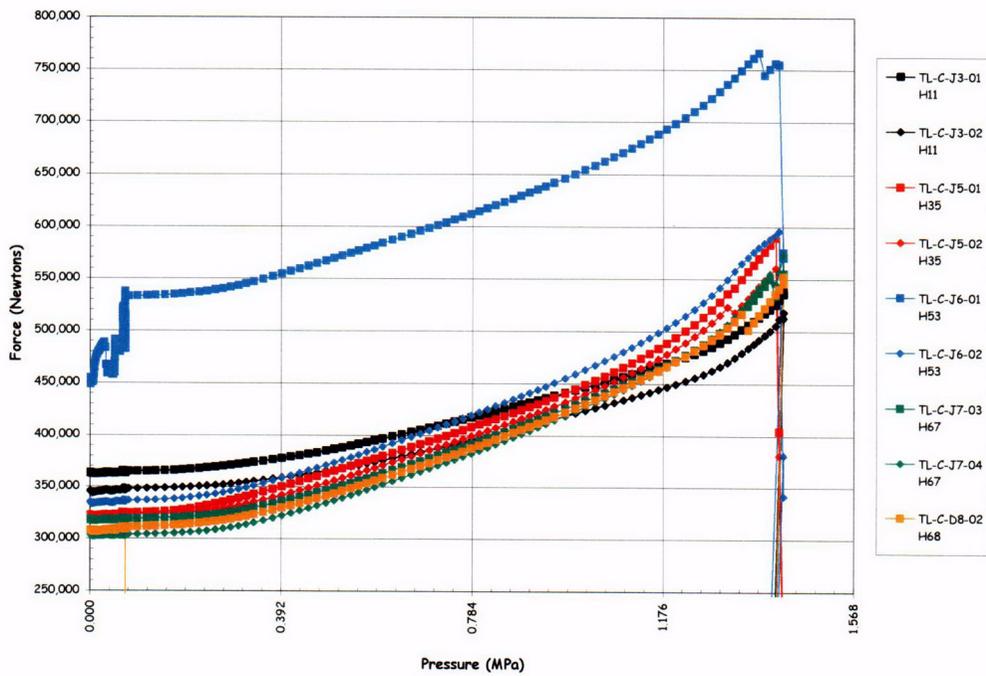
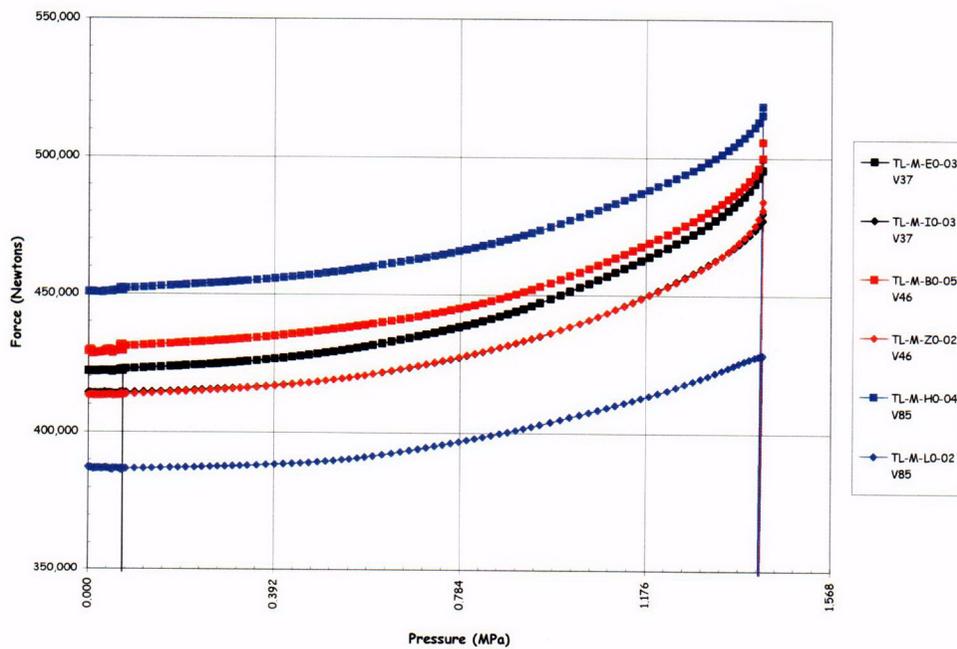
Figures 5.106 and 5.107 show the anchor forces for the instrumented tendons during the SFMT. These anchor forces are representative examples of all the tendon anchors. With the exception of one anchor on H53, the hoop tendon anchor forces increase to nearly 600 kN, which is close to the breaking strength of straight tendons in laboratory tests. It is reasonable to expect that the breaking strength of the curved tendons under field conditions would be lower than the laboratory breaking strength. Load cell TL-C-J6-01 on H53 exhibits an artificially high force near the beginning of the SFMT, most likely from moisture affecting the gage. However, the increased force due to pressure tracks very closely with the other load cells. The vertical tendon anchor forces do not show as large an increase, and the average maximum force only approaches 500 kN, well below the breaking strength. This is consistent with response during the LST and the observation that the vertical tendons did not fail prior to the rupture of the model.

Near the end of the test, sudden decreases in load were observed for several hoop tendon load cells and interpreted as individual strand wires breaking. After reaching the peak pressure, all the load cell readings dropped sharply as the tendons and the model ruptured.

One point deserves mentioning. The tendon anchor forces appear to drop off at or just beyond the peak pressure. This is an artifact of rupture occurring during a data scan. The pressure and strain values were recorded near the beginning of the scan, while the load cells were among the last instruments scanned. If rupture, which occurred in a few seconds, took place during the 30 second data scan, the DAS would associate the pressure before rupture with the load cell reading after rupture, giving the appearance that the tendon anchor forces dropped before the model ruptured.

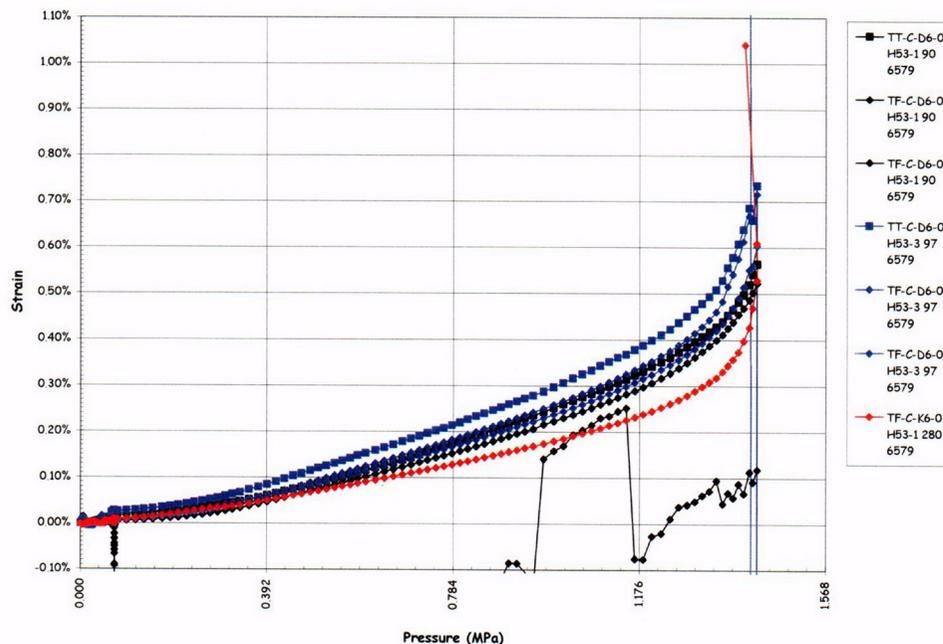
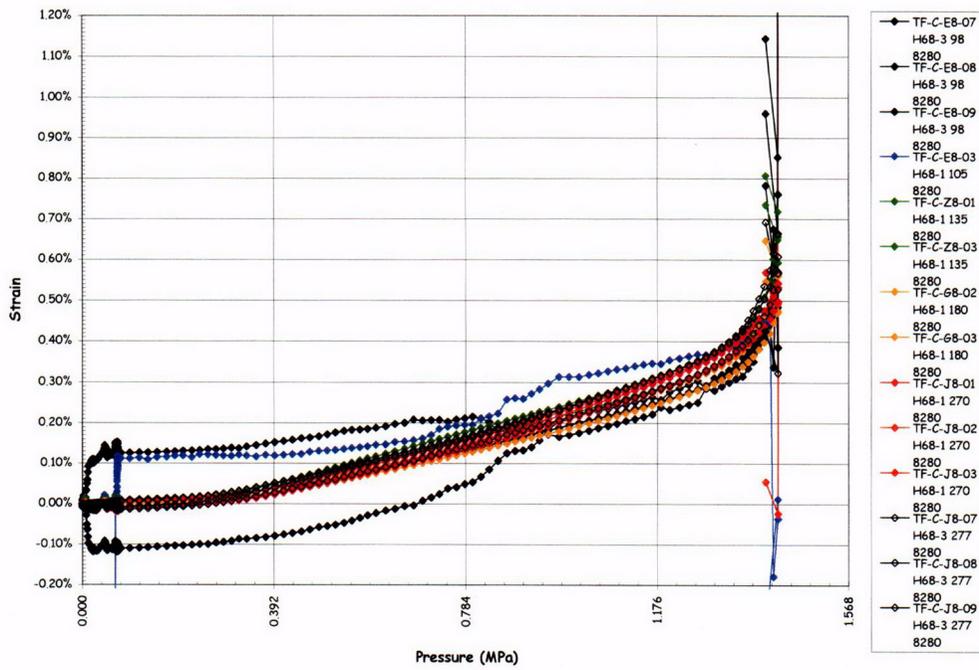
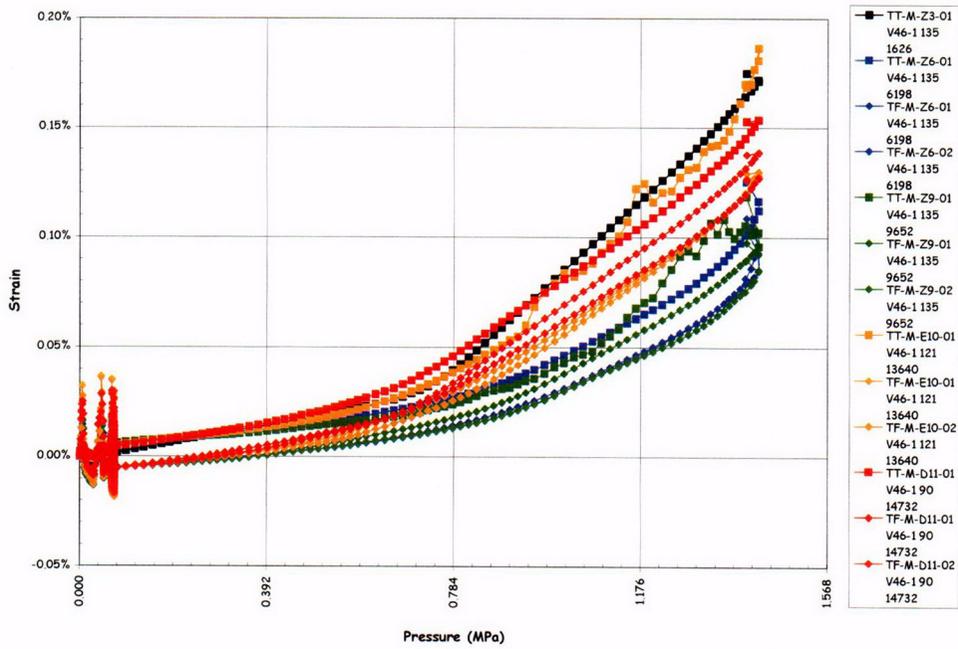
Tendon strains were also recorded using the surviving foil gages mounted on individual strand wires. Figures 5.108 and 5.109 show the strains for hoop tendons H53 and H68, and Figure 5.110 shows the strains for vertical tendon V46. These results are typical of the other instrumented tendons, although the magnitude of the strains vary. Since the strain gages were 're-zeroed' before the SFMT, only the strain due to pressure is plotted. The total tendon strain is the measured strain plus the residual prestressing strain, typically on the order of 0.4% for the hoop tendons and 0.6% for the vertical tendons. The hoop tendon strains at maximum pressure were therefore on the order of 1.0%, 0.4% due to prestressing plus 0.6% due to the maximum pressure of $3.65P_d$. Similarly, the maximum hoop tendon strain measure prior to rupture is on the order of 1.4% to 1.5%. There may be some local strain concentrations that were not captured by the strain gages, but this limiting tendon strain is significantly less than the ultimate strain obtained from laboratory tests of a straight tendon sample, typically on the order of 4% for the tendon and 7% for individual strands. Furthermore, none of the model tendons ruptured at the anchors where strain concentrations might be expected, but all ruptured where the deformation of the model was greatest, approximately azimuth 6 degrees.

Similarly, the strain in the vertical tendons at the maximum pressure are on the order of 0.1 to 0.2%, and the total strain is on the order of 0.7% to 0.8%. Both are well below the strain at which the hoop tendons were believed to have ruptured, reinforcing the belief that the vertical tendons did not fail prior to the rupture of the vessel.

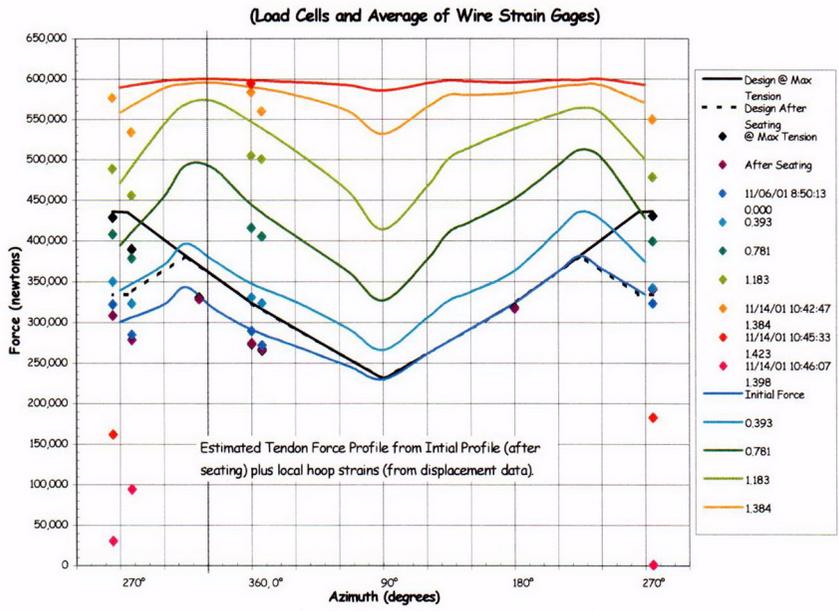
Figure 5.116 SFMT – Tendon H35 Computed and Measured Force Distribution

An attempt was made to determine this by calculating the local, displacement-based strain in the wall and, assuming the tendon behaved as if bonded, adding it to the initial prestressing strains and computing the force profile from these strains. Figure 5.116 compares the force distribution obtained in this manner with the forces based on the tendon strain measurements for tendon H35 near elev. 4680 where the displacements were measured. The results compare favorably and seem to reinforce the idea that the tendons behave as if they were bonded after prestressing. While this is a compelling argument, it must also be admitted that these results are not entirely conclusive and further tests may be required to resolve this issue.

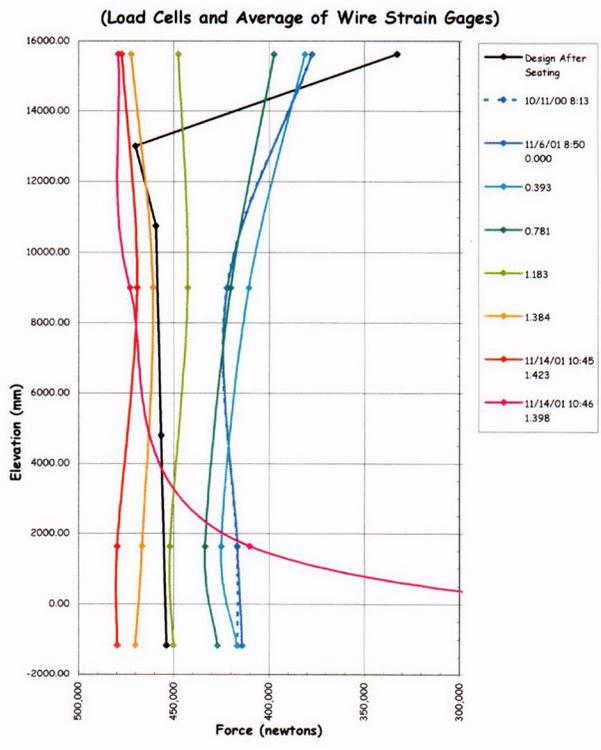
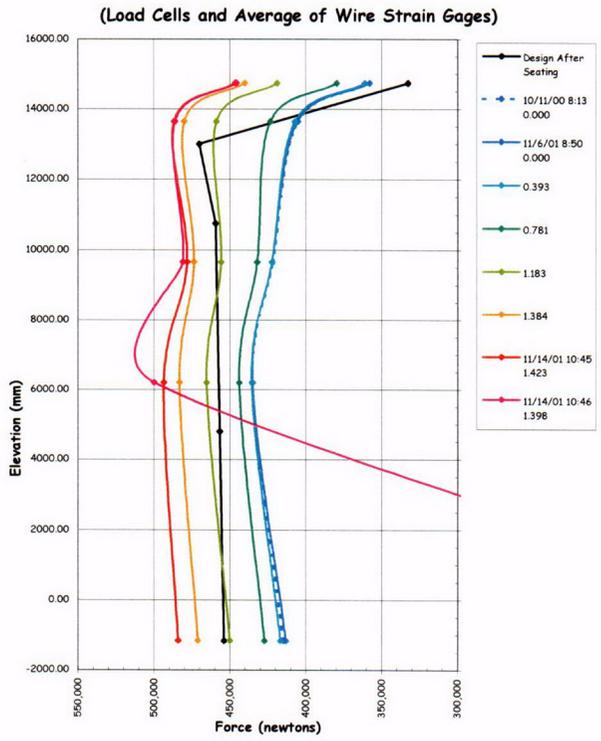
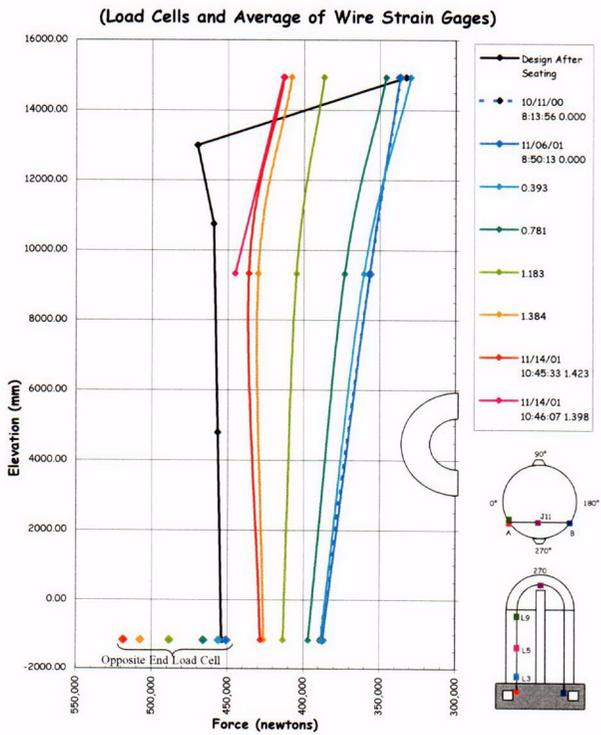
Figures 5.117 to 5.119 show the force profiles for the instrumented vertical tendons. Again, as was observed with the response during the LST, the force profile appears to become more uniform with pressure. Since the vertical tendons do not yield, tendons must slip relative to the sheath or concrete wall, even in the dome where the tendons are curved. This counters the observation made for the hoop tendons that the tendons behave as if they were bonded to the concrete. No explanation for this apparent inconsistency has been proposed, reiterating the need for further investigation of this behavior, including additional testing.

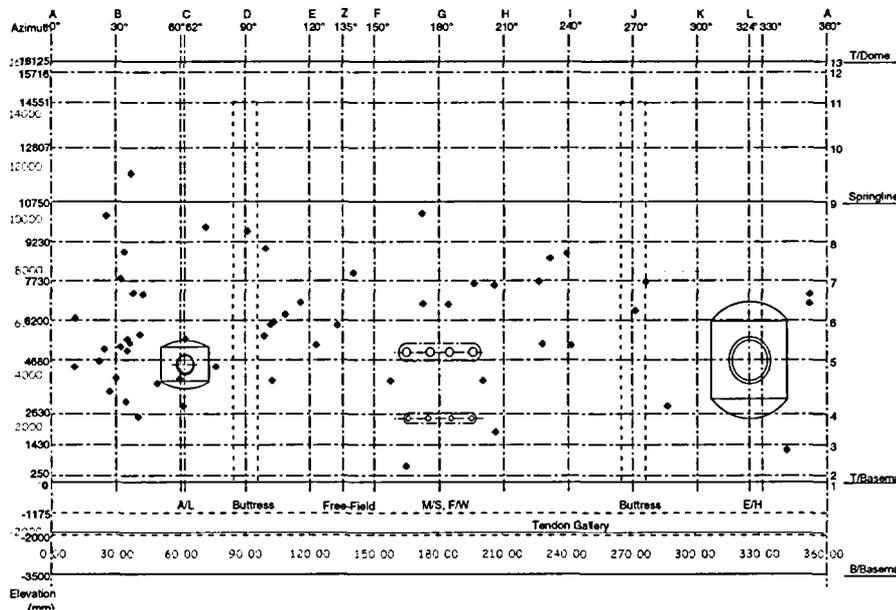
Figure 5.120 SFMT – Wire Break Map

Fifty-seven actual or probable wire break events were identified between 10:39:47 and rupture of the model at 10:46:12. The wire-break event locations are mapped in Figure 5.120.

Other than observing the discontinuities in the tendon load cell and strain time histories that might indicate a wire break, there were no other efforts to correlate the probable wire breaks identified by the acoustic system with the other test data. While it is arguable that the probable wire break events were actual wire breaks, at least a dozen or so were confirmed by the visual records. Figure 5.121 plots the time history of all the acoustic events along with the effective pressure time history. It is readily apparent that the frequency and magnitude of the wire break events increases just prior to rupture.

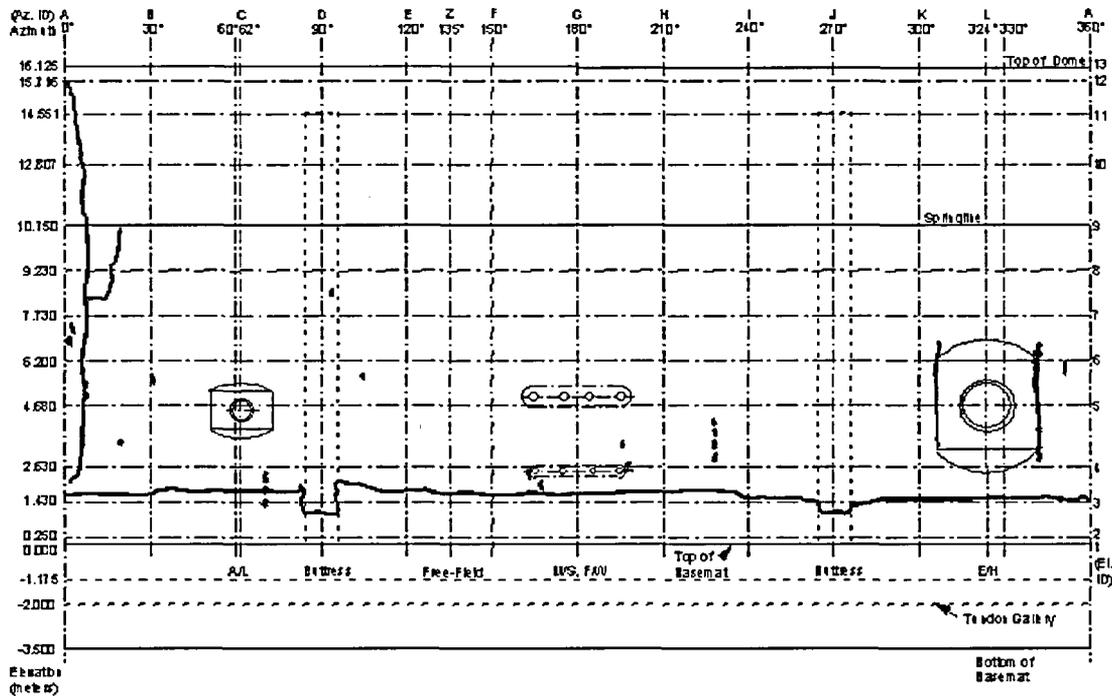
Figure 5.122 SFMT – Rupture Map

The rupture lines are roughly mapped in Figure 5.122. This figure shows the approximate location of major vertical and horizontal rupture lines along with secondary tears at the E/H and adjacent to the main vertical rupture. These secondary tears are most likely associated with previous liner tears and/or cutouts.
