SUBJECT: Relief Request for Previous Repair of Pressurizer Nozzle

Relief Request for Previous Repair of Pressurizer Nozzle

One 1" pipe size pressurizer nozzle (instrument tag number TE-108) on the side of the pressurizer near the bottom. Figure 1 shows the repaired configuration of the TE-108 nozzle.

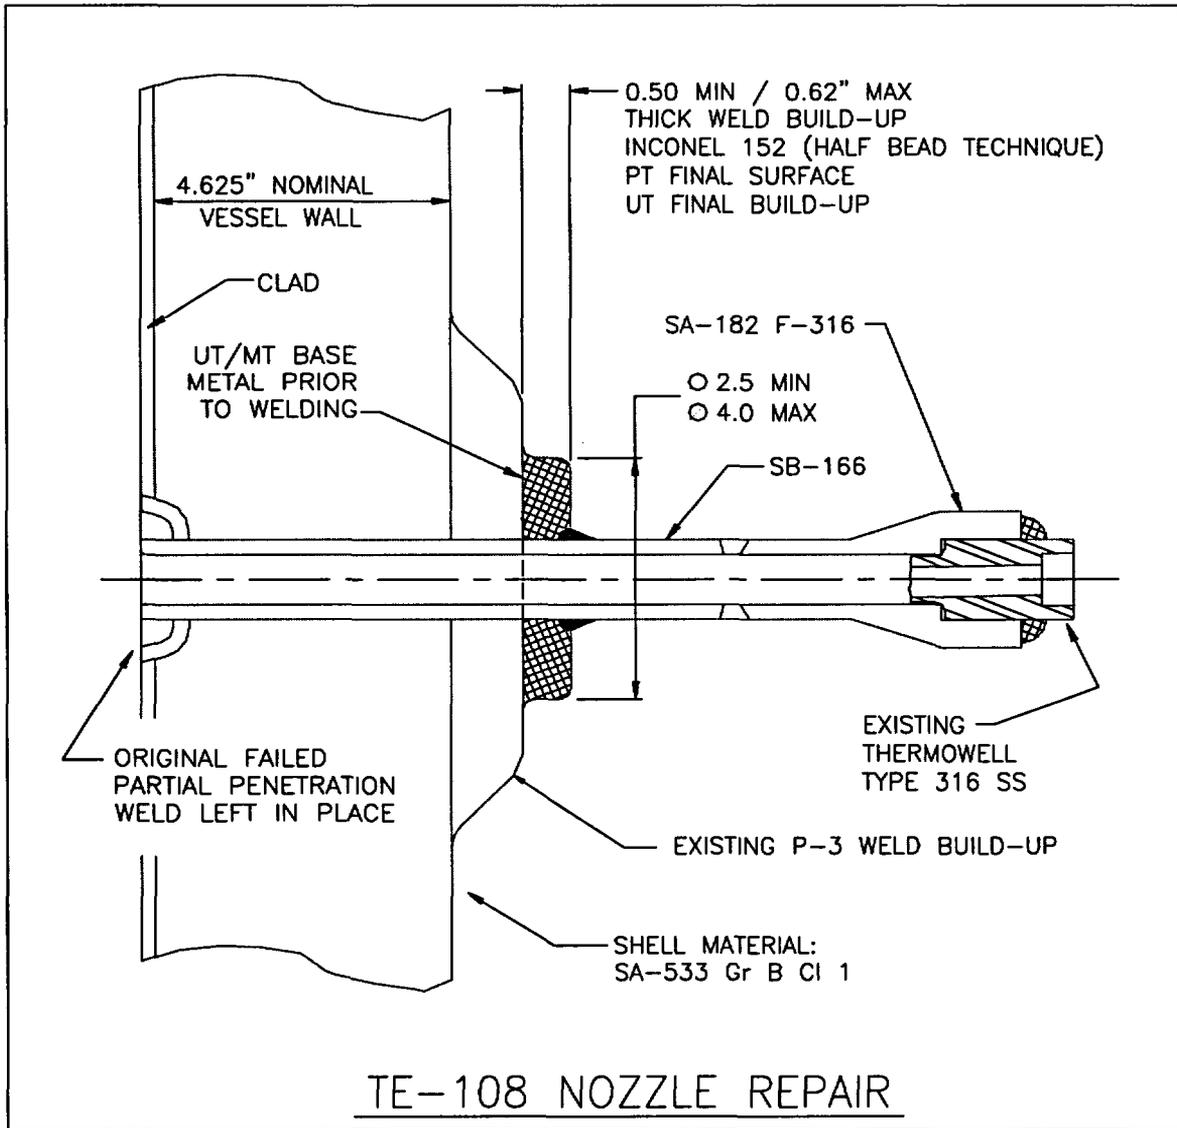
Figure 1: TE-108 – Repaired Nozzle Configuration

In contrast to the requirements of ASME Section XI Code, paragraph IWB-3132.2, a nozzle leak at the TE-108 location on the pressurizer was successfully repaired in October of 2000 without removing the flaw which caused the failure (leakage). Due to the design of the repair which eliminated the pressure boundary function of the element containing the flaw, the following examinations were not performed: 1) NDE to confirm the location of the flaw, 2) Re-

Industry experience has shown that cracks may develop in the Inconel 600 (nozzle) base metal or in the weld metal joining the nozzles to the vessels creating leakage paths for reactor coolant. The cracks are believed to be caused by primary water stress corrosion cracking (PWSCC). The exact leak path, through the weld or through the base metal or through both, frequently cannot be readily determined. To remove all possible leak paths for TE-108 would require access to the interior of the pressurizer and machining or grinding out the attachment weld. Because of the nozzle's location near the bottom of the pressurizer, removal of some or all of the bottom-insertion heater elements would be required for interior access. A repair activity which would remove the flaw would have resulted in a much higher radiation exposure to the personnel involved than the repair performed. Working inside the pressurizer vessel also creates significant personnel safety concerns.

The main portion of the TE-108 nozzle, where it penetrates the vessel wall, is a straight 1" nominal pipe size. It is made of Inconel 600, and has a close tolerance fit into the drilled hole in the vessel wall. The original vessel-to-nozzle attachment weld is a partial penetration J-groove weld inside the vessel to the cladding. The cladding extended into the J-bevel prep area. Welded to the external end of the Inconel nozzle is a type 316 stainless Steel ("safe end") adapter which has a socket-weld end for attachment of a thermo-well for the temperature element.

The repair for the nozzle leakage consisted of first overlaying an Inconel 152 pad 0.50" to 0.62" thick to the outside surface of the vessel wall using the temper bead method. A weld prep was

made in the pad for a partial penetration groove for attaching the nozzle to the pad and was welded. This partial penetration weld, external to the vessel, became the pressure boundary. The original internal J-weld for the nozzle was left in place.
