**WATTS BAR NUCLEAR PLANT (WBN) UNIT 1 – PETITION PURSUANT TO
10 CFR 2.206 – REACTOR COOLANT SYSTEM STAINLESS STEEL CLADDING**

WATTS BAR NUCLEAR PLANT (WBN) UNIT 1 UNION OF CONCERNED SCIENTISTS 10 CFR 2.206 PETITION REACTOR COOLANT SYSTEM (RCS) STAINLESS STEEL CLADDING

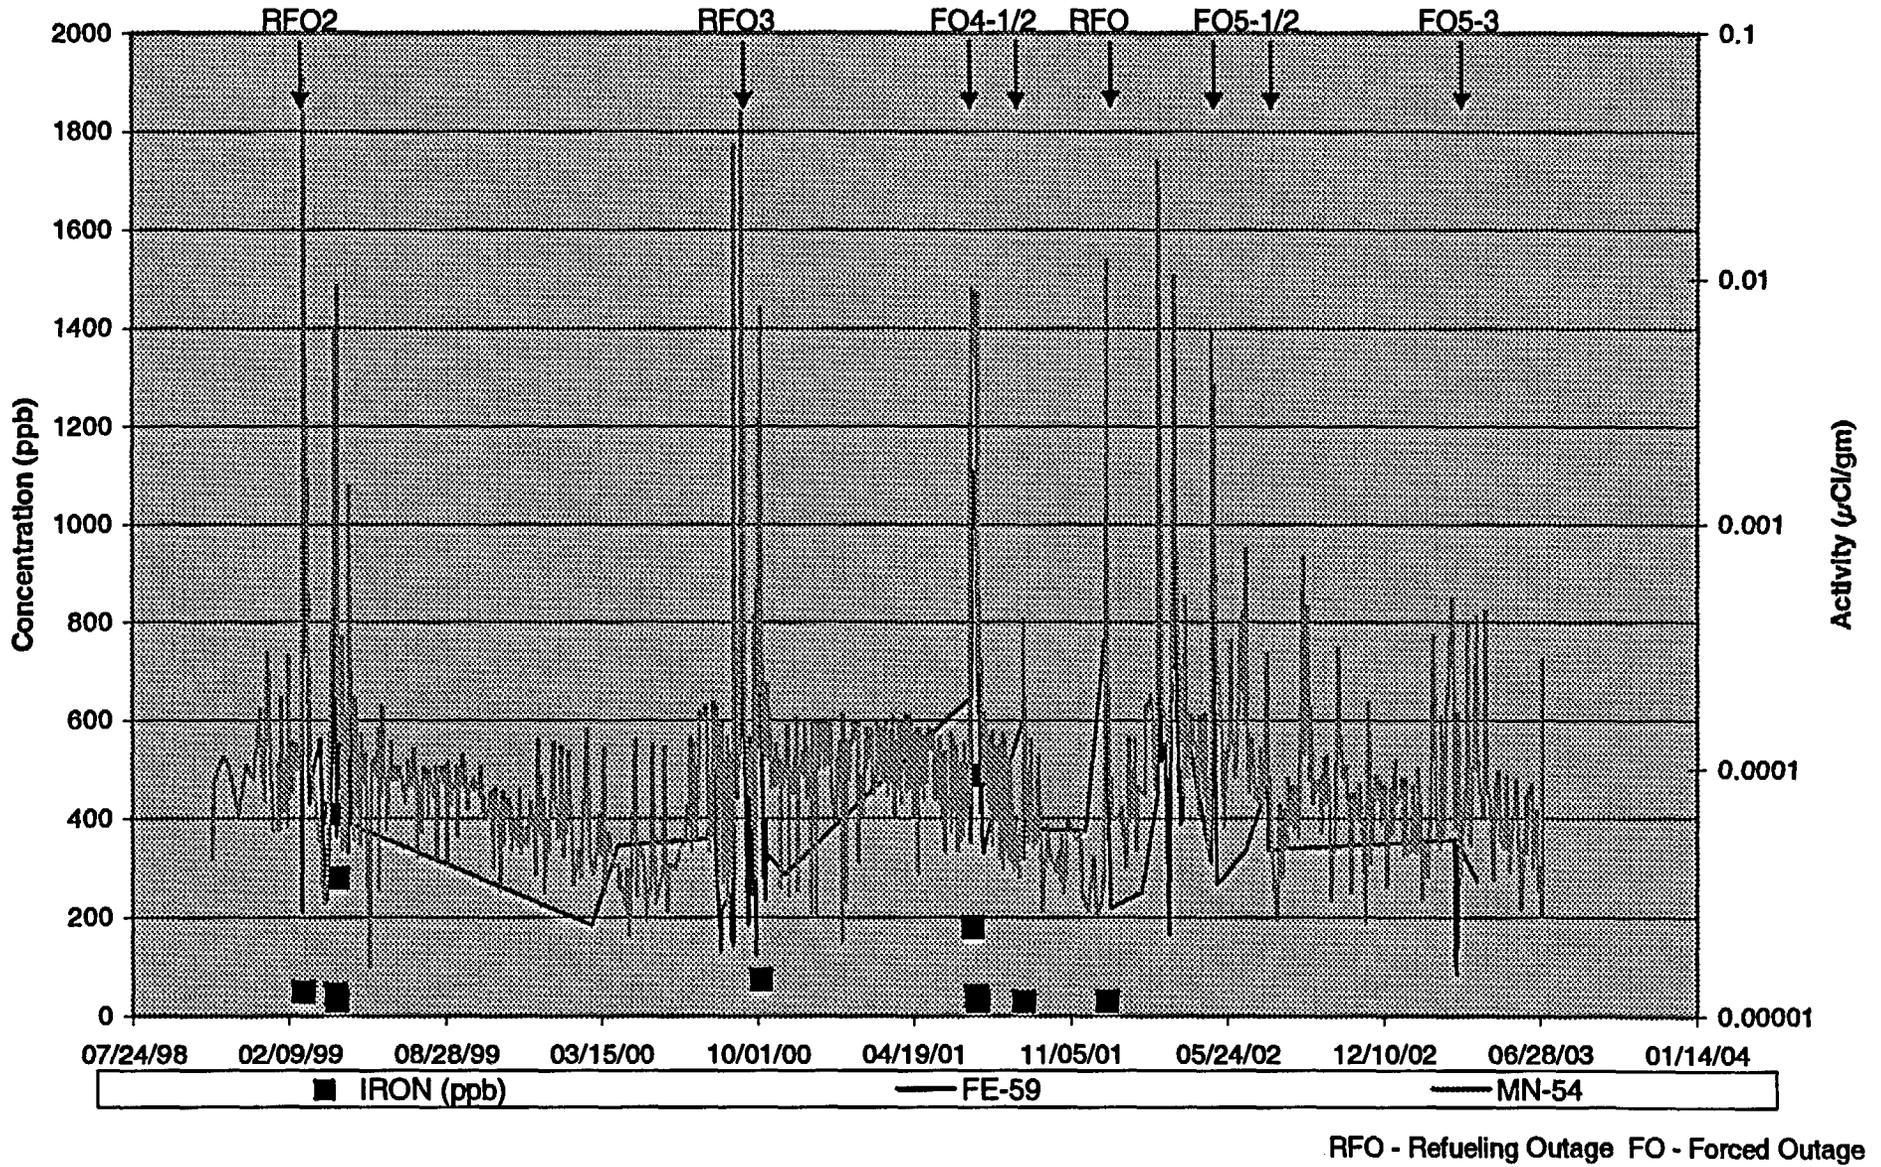
RCS Iron

While TVA does not typically analyze the reactor coolant system for iron concentration, it does measure certain isotopes which are corrosion products produced in the reactor core via neutron activation of iron. Manganese (Mn) 54, with a 312 day half life, is produced via a (n,p) activation of Iron (Fe) 54 which exists as 5.85 percent of all natural occurring iron. Fe-59, with a 44.5 day half life, is produced via a (n, γ) interaction of Fe-58 which is present in 0.28 percent of natural occurring iron. Since both of these isotopes have relatively long half lives, these activities can be trended to provide an indication of the reactor coolant system iron trend. The graph provided in Enclosure 3 indicates the trend using the above isotopes. Based on this data, the dissolved iron in the RCS is considered to be negligible.

It should be noted that the plant outages are indicated on the graph provided in Enclosure 3. The increase in iron in the reactor coolant during an outage results from chemistry changes in the RCS during the change from plant operation to refueling conditions. Prior to moving fuel, the boron concentration is increased to approximately 2500 ppm boron. This increase in boron to shutdown concentrations and plant cooldown causes a decrease in the coolant pH, which in turn causes an increase in soluble iron corrosion products in the coolant.
