NP-33-03-007-00

LER 2003-007
Davis-Besse Nuclear Power Station, Unit No. 1
Date of Occurrence – June 6, 2003

4. TITLE
AC System Analysis Shows Potential Loss of Offsite Power Following Design Basis Accident

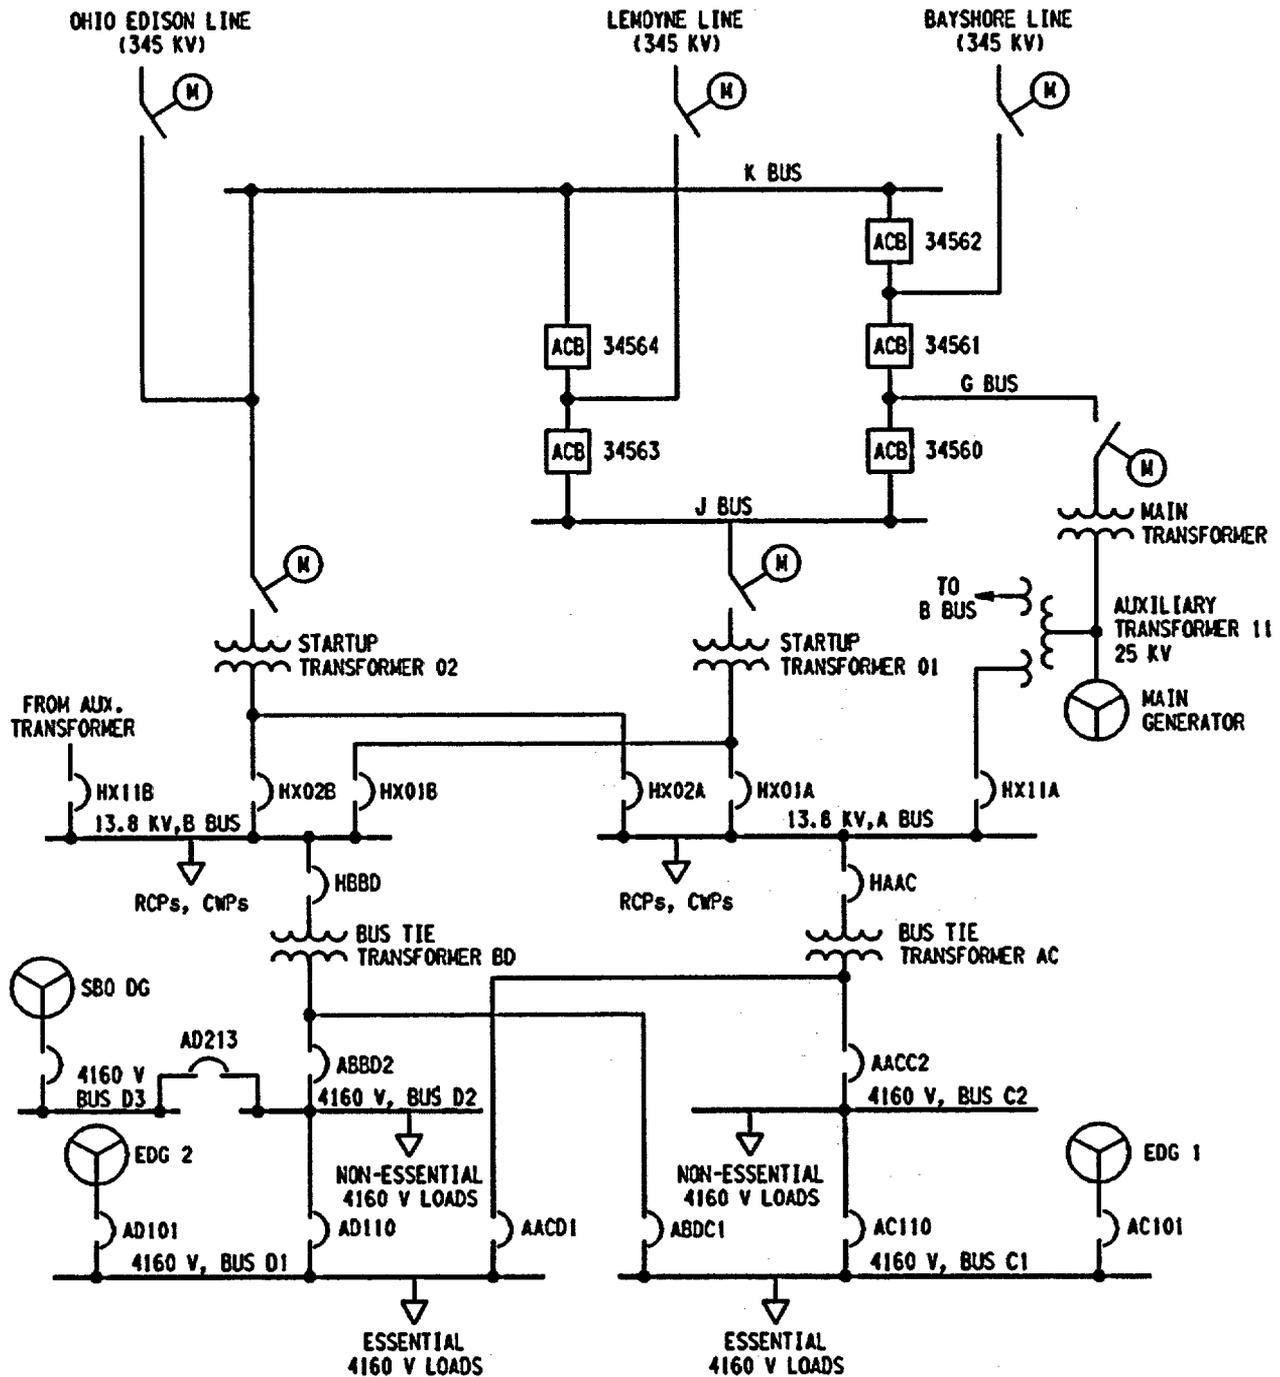
FIGURE 1-DAVIS-BESSE ELECTRICAL DISTRIBUTION SYSTEM

The DBNPS onsite electrical systems include the 13.8 kV [EB], the 4160 V [EA, EB], and the 480 V [EC, ED] AC distribution systems, two 4160 V emergency diesel generator units [EK-DG] and one non-essential 4160 V diesel generator which serves as the alternate AC source for station blackout concerns (All voltages listed are nominal voltage). Refer to Figure 1 for a diagram of the DBNPS 4160 V and above electrical system. With the turbine-generator [EL-TG] operating, the normal source of station power is from the unit auxiliary transformer [EA-XFMR] to the 13.8 kV buses [EA-BU]. There are two 345 kV to 13.8 kV startup transformers that provide reserve and startup power from the offsite distribution network. Isolation of the turbine-generator from the 345 kV grid system [FK] results in de-energization of the unit auxiliary transformer and fast transfer of the 13.8 kV buses A and B to their respective startup transformer. The specific startup transformer used to power each 13.8 kV bus is pre-determined by the position of a reserve source selector switch. These switches can align either startup transformer to each 13.8 kV bus, but are typically selected so that each 13.8 kV bus is aligned to a different startup transformer. Each startup transformer was originally designed to have sufficient capacity to be operated as a complete reserve source for both 13.8 kV buses if either startup transformer is out of service. This design feature allows for flexible alignment of the offsite to onsite power supply while maintaining power available to non-essential plant equipment if the auxiliary transformer becomes unavailable.

Power to the 4160 V distribution system is from two bus tie transformers that step down the voltage from 13.8 kV to 4160 V. Each bus tie transformer normally supplies one essential and one non-essential 4160 V bus and is available as a reserve source for the redundant set of essential and non-essential 4160 V buses. The capacities of the bus tie transformers and the associated circuit breakers are designed to permit station operation with one bus tie transformer out of service. Transfer schemes are provided to switch each set of 4160 V buses from its normal bus tie transformer to its reserve. The transfer between the two sources is done automatically by protective relay
