Subject: Davis-Besse Nuclear Power Station  
Transmittal of Final Report on Examination of the Reactor Vessel Head  
Degradation, and Safety Significance Assessment Update

**EXAMINATION OF THE REACTOR VESSEL (RV) HEAD DEGRADATION  
AT DAVIS-BESSE**

**BWX TECHNOLOGIES, INC.  
BWXT SERVICES, INC.  
REPORT 1140-025-02-24**

**IMPACT OF LABORATORY EXAMINATION RESULTS  
ON THE  
SAFETY SIGNIFICANCE ASSESSMENT  
OF THE  
DEGRADED REACTOR VESSEL HEAD**

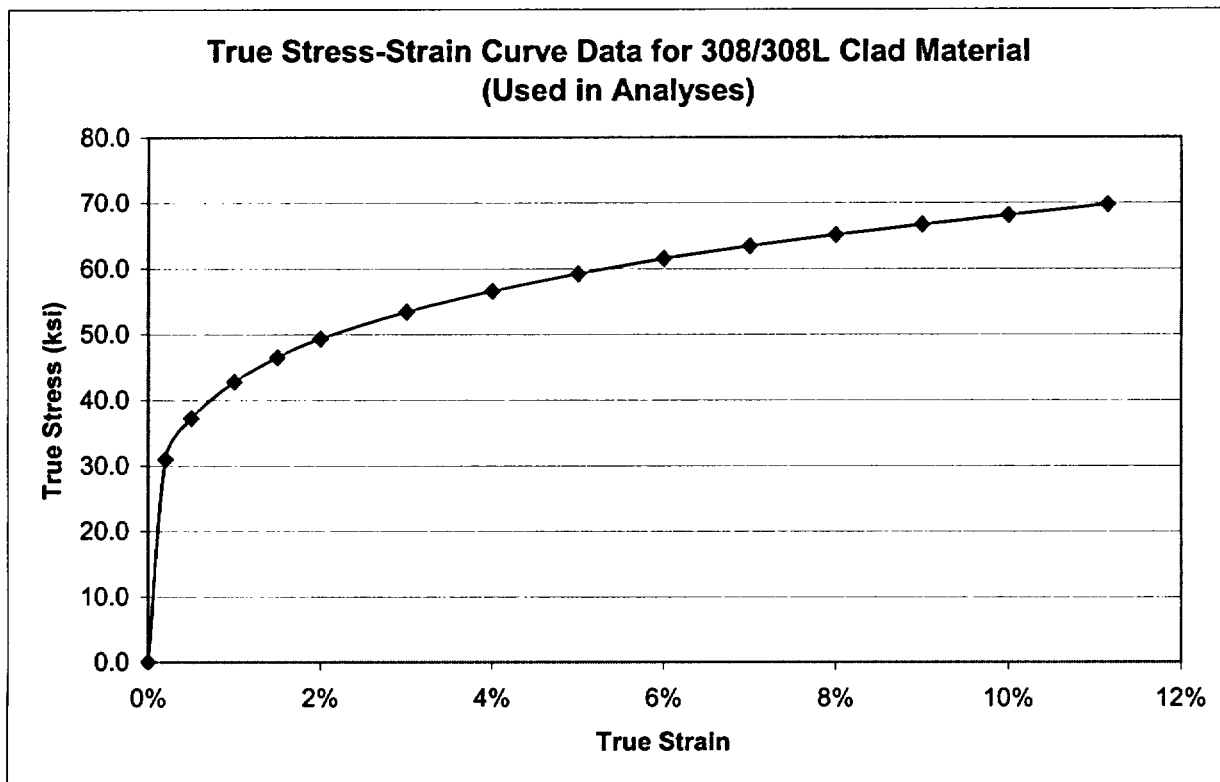
Figure 1. True Stress-Strain Curve for Stainless Steel Type 308/308L Clad Materials Used in Analyses

- Two bounding clad thicknesses (0.297 and 0.125 inch) were considered in this evaluation. The evaluation assumed a defect-free cladding.
- A very conservative stress-strain curve was used in the evaluation. A plot of the stress-strain curve is shown in Figure 1.

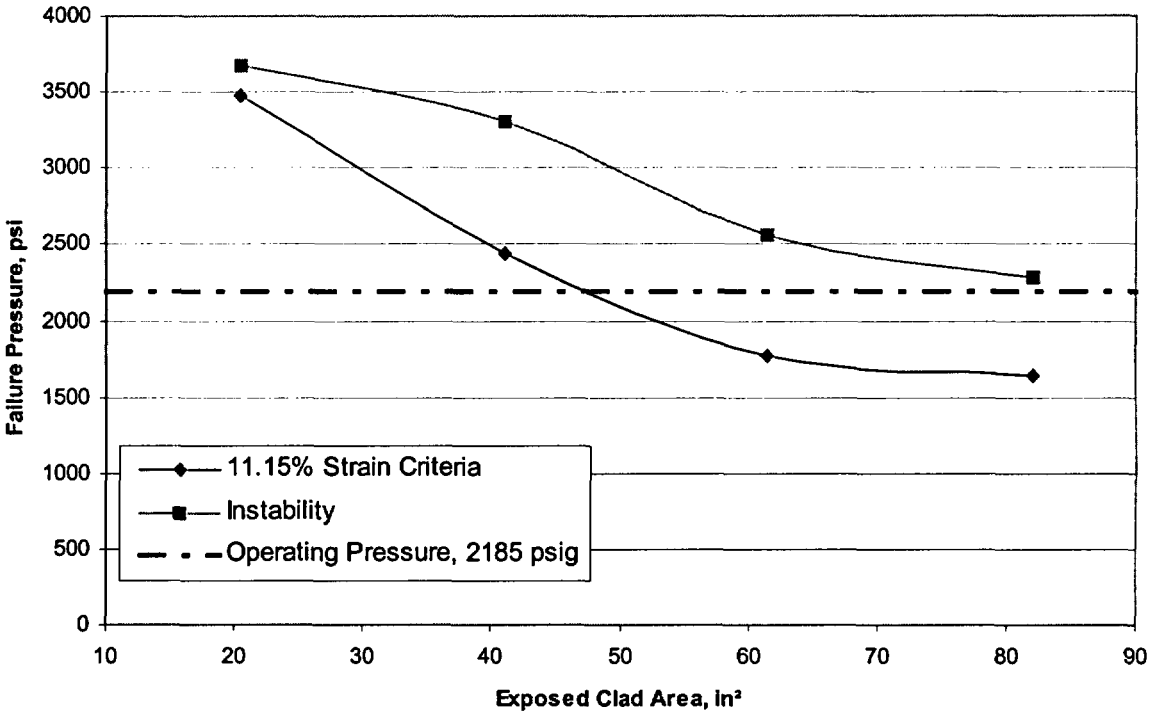
Figure 2. Failure Pressure Versus Cavity Exposed Area (Clad Thickness = 0.125 inches)

- The results of the evaluation are summarized in Figures 2 and 3 for the two clad thickness cases considered. As can be seen from these Figures, significant margins exist for the exposed cladding area of 20.5 square inches even for the cladding thickness of 0.125 inches regardless of the failure criterion used. As shown in Figures 2 and 3, two failure criteria were used in the analyses; one based on plastic instability and the other based on the maximum strain limited to 11.15%.

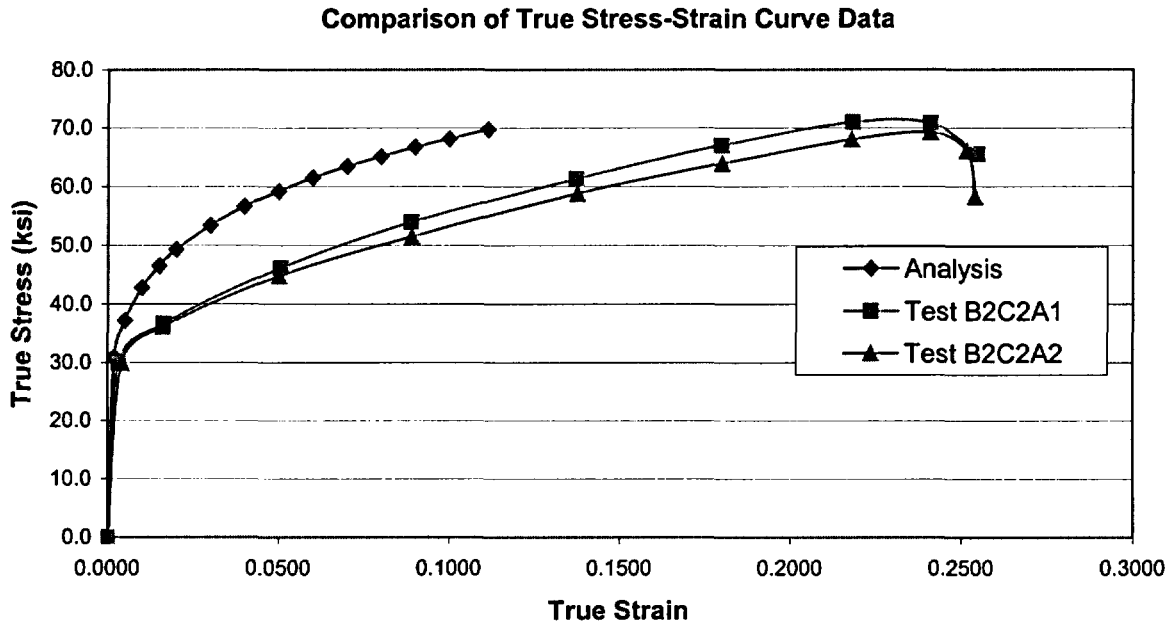
Figure 4. Comparison of Actual Stress-Strain Curve to That Used in the Analyses

- The actual exposed area of the cladding is approximately 16.5 sq. inches.
- The actual stress-strain curve of the cladding material is much tougher (measured by the area under the stress-strain curve) and more ductile (measured by the failure strain) than that used in the analysis. A comparison of the two curves is shown in Figure 4. It should be noted that the engineering stress-strain curves from Reference 4 have been converted to true stress-strain curves for the comparison in Figure 4.

- Because of the ductile nature of the actual cladding material as demonstrated by its high toughness and ductility, the cladding is expected to fail by net section plastic collapse. As such, the crack tip stress intensity factor is not of essence and only the remaining ligament of the cladding is critical to the determination of the failure pressure.
