Update on Steam Dryer Activities

Presentation to USNRC J.F. Klapproth D.C. Pappone July 25, 2003

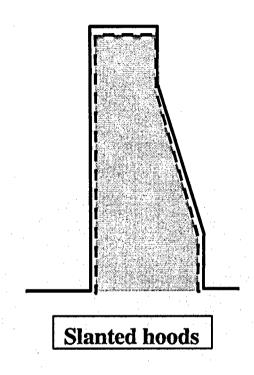
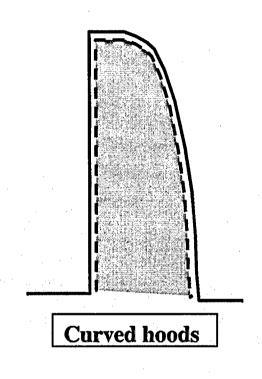
Sasic Hood Types

- •BWR/3 Style Dryer
- •Earliest Design
- Localized Top Hood Stress
- •Early BWR/4 Style Dryer
- Improved
 - •Better Steam Flow
 - •Reduced Stress Concentration

- •BWR/4 and Later
- Optimized for Steam Flow

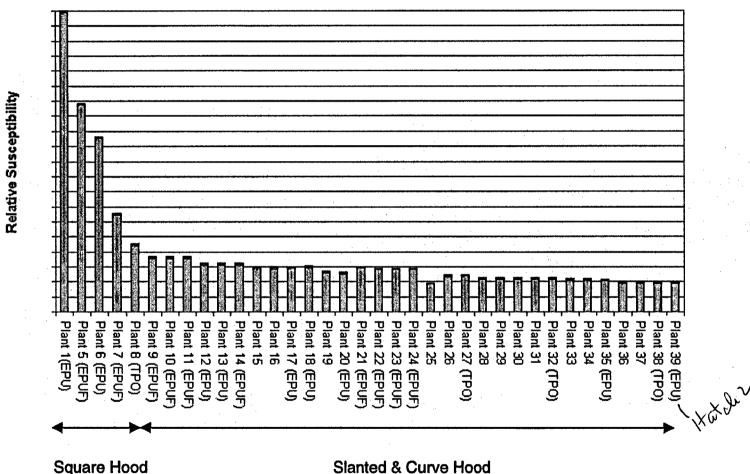
Steam Dryer Outer Hood Relative Susceptibility

BWR/3-Style Steam Dryer is susceptible to dryer failure
