U. S. NUCLEAR REGULATORY COMMISSION

Report No.: 999-90002/2003-003

Facility: Smith Iron & Metal Company, Inc.

Inspection Dates: August 4 and 7, 2003, and subsequent
telephone conversations

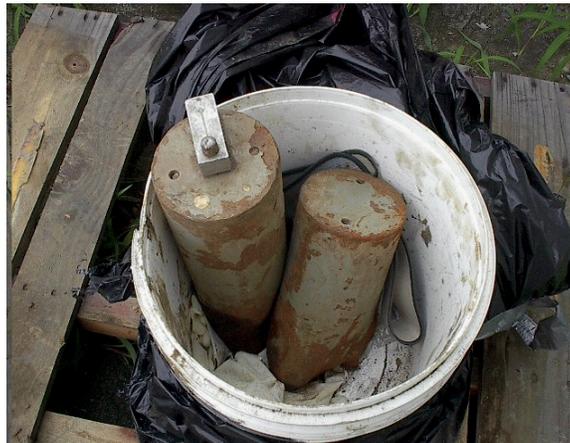
Above: Picture showing the two pieces of the device as found at Smith Iron & Metal. Note the silver shutter mechanism on the top of the left piece.

The VABRH representative conducted removable contamination and area radiation surveys of the device without removing it from the bucket, determining that it contained a cesium-137 (Cs-137) source. The VABRH representative reported exposure rates of

120 milliroentgen per hour (mR/hr) on contact and less than 2.6 mR/hr at three feet from the bucket. SI&M posted the bucket with a radiation sign and temporarily placed it in a secured location on site. A local company assisted SI&M in these efforts by hiring a health physics consultant to characterize the damage to the device and any resulting contamination.

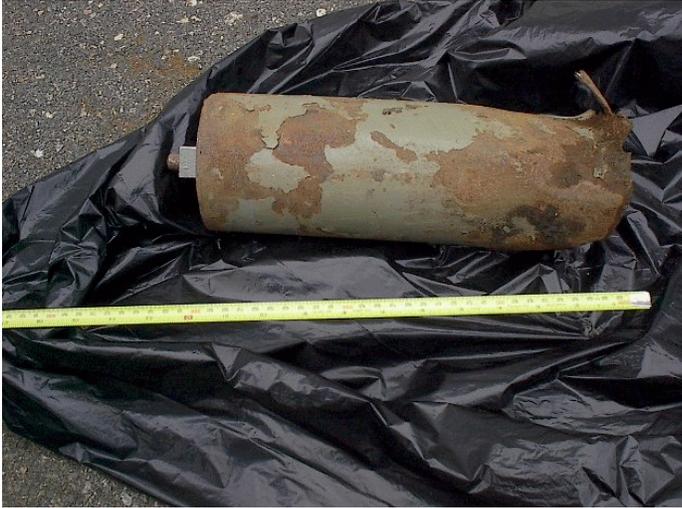
Left: Picture showing one half of the cylindrical device. The shutter mechanism is discernable on the left end of the device. The right end of the device shows where it was cut and deformed by the shear. In all, this section measured approximately 12 inches long.

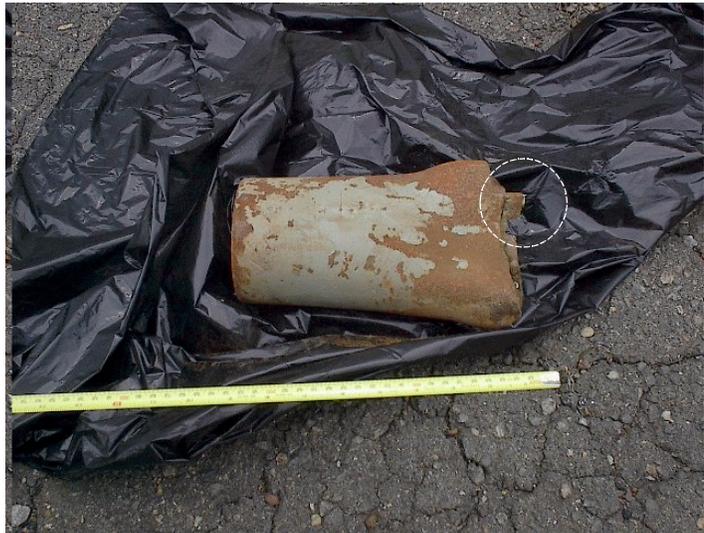
Right: This is the second section of the device. A portion of the exposed source rod is visible (centered within the dashed circle) at the location where the shear cut the device in two. This section of the device measured approximately 8 inches long. Neither section of the device was marked with identifying labels or markings.

of the device. The highest reading swipe was later quantified in the VABRH lab to be 381 picocuries of Cs-137. Area radiation surveys were also performed by the inspectors, and the highest readings on both pieces were detected near the cut ends of the device. The highest readings observed by the inspectors at these ends were approximately 650 mR/hr and 3.5 mR/hr at contact and three feet, respectively. After surveying, the pieces were returned to the bucket and placed in a locked and secured building at the SI&M facility.
