U. S. NUCLEAR REGULATORY COMMISSION

Report No.: 999-90002/2003-003

Facility: Smith Iron & Metal Company, Inc.

Inspection Dates: August 4 and 7, 2003, and subsequent
telephone conversations

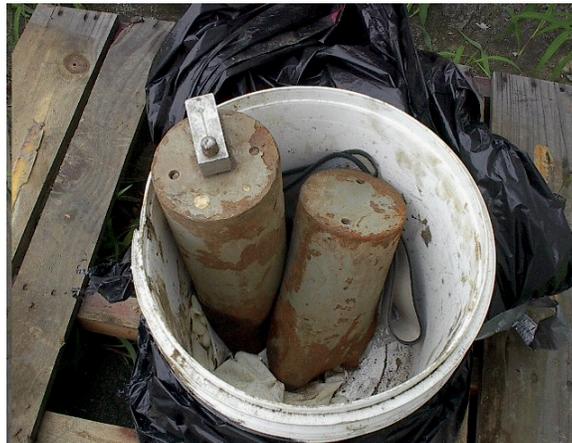
Above: Picture showing the two pieces of the device as found at Smith Iron & Metal. Note the silver shutter mechanism on the top of the left piece.

The VABRH representative conducted removable contamination and area radiation surveys of the device without removing it from the bucket, determining that it contained a cesium-137 (Cs-137) source. The VABRH representative reported exposure rates of

120 milliroentgen per hour (mR/hr) on contact and less than 2.6 mR/hr at three feet from the bucket. SI&M posted the bucket with a radiation sign and temporarily placed it in a secured location on site. A local company assisted SI&M in these efforts by hiring a health physics consultant to characterize the damage to the device and any resulting contamination.

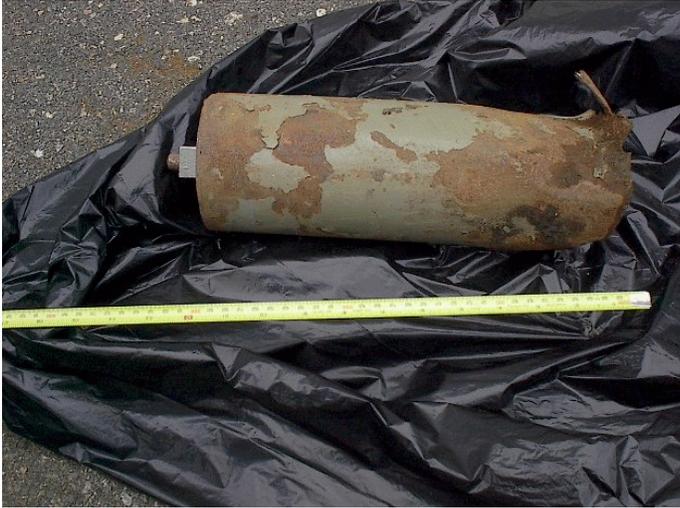
Left: Picture showing one half of the cylindrical device. The shutter mechanism is discernable on the left end of the device. The right end of the device shows where it was cut and deformed by the shear. In all, this section measured approximately 12 inches long.

of the device. The highest reading swipe was later quantified in the VABRH lab to be 381 picocuries of Cs-137. Area radiation surveys were also performed by the inspectors, and the highest readings on both pieces were detected near the cut ends of the device. The highest readings observed by the inspectors at these ends were approximately 650 mR/hr and 3.5 mR/hr at contact and three feet, respectively. After surveying, the pieces were returned to the bucket and placed in a locked and secured building at the SI&M facility.
