SUBJECT: SUMMARY OF AUGUST 25, 2003, MEETING FOR COMANCHE PEAK STEAM
ELECTRIC STATION

This refers to the meeting conducted in Arlington, Texas, on August 25, 2003. This purpose of this meeting was to discuss the Comanche Peak plant response to a grid disturbance on May 15, 2003.

Comanche Peak

Response to Grid Disturbance

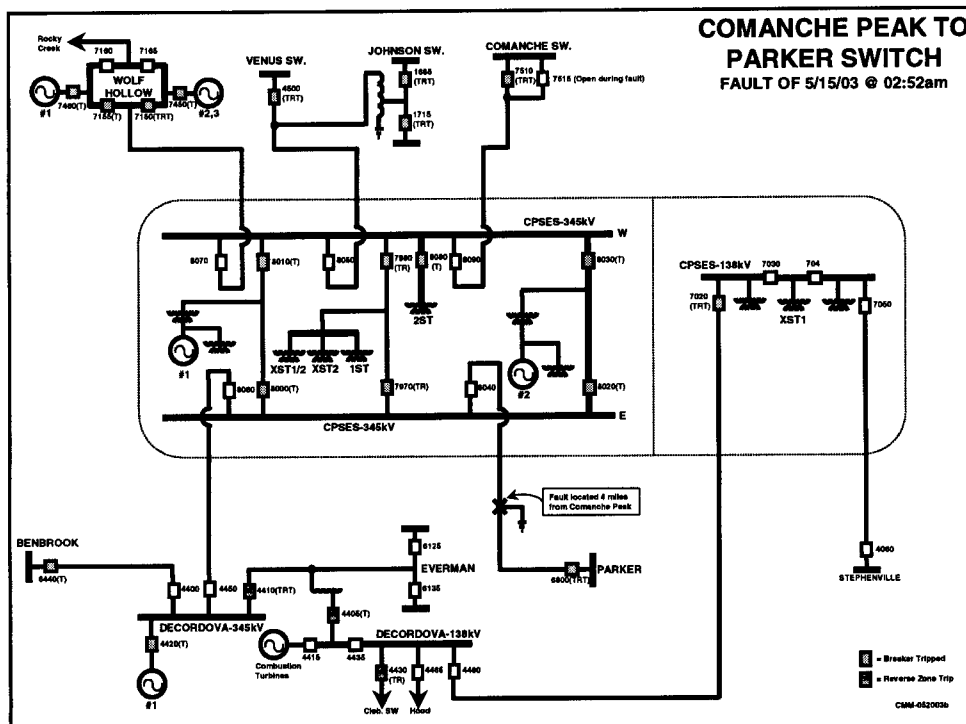
- The fault occurred 4 miles from CPSES switchyard
- Insulators and static wires were damaged by the fault
- Remote breakers cleared the fault

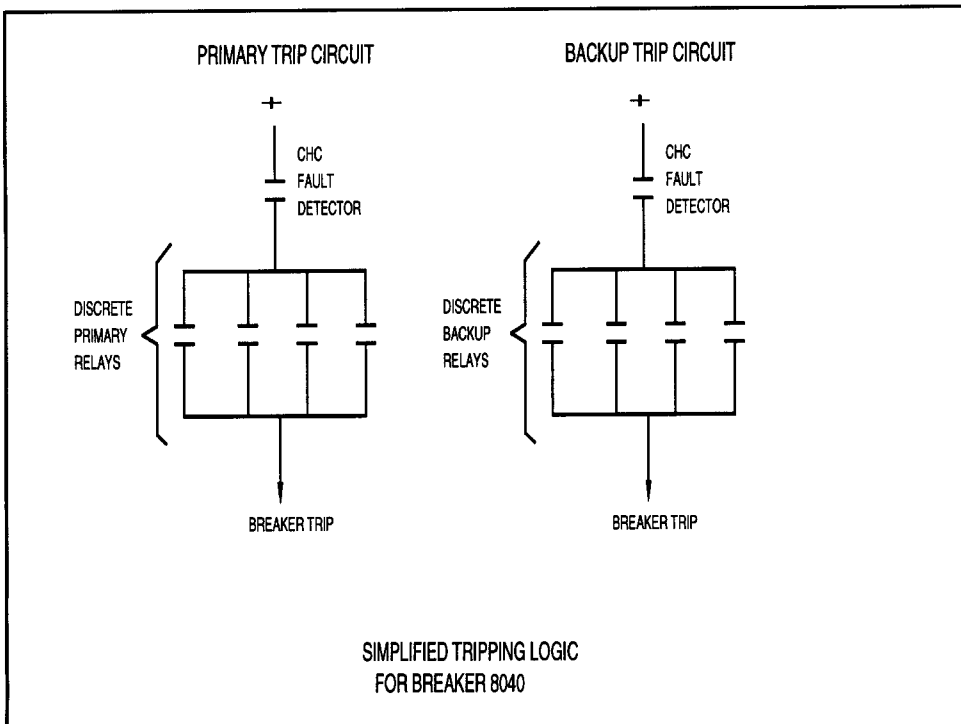
Event root cause is the fault detector relays failed to operate on CPSES breaker 8040.

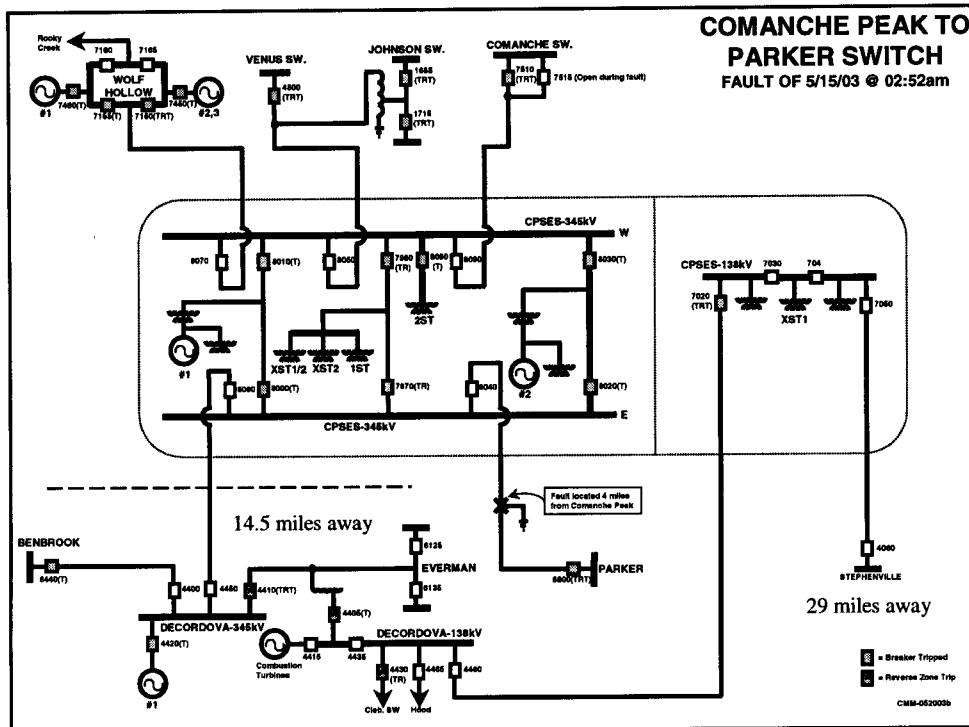
DeCordova 345 kV Breaker 4450 Failure to Trip

- Lack of coordination at DeCordova for failure of primary and backup relay failures at CPSES
- Intentionally designed not to over trip
