SUBJECT: SUMMARY OF AUGUST 25, 2003, MEETING FOR COMANCHE PEAK STEAM
ELECTRIC STATION

Comanche Peak

Response to Grid Disturbance

Oncor Event Analysis

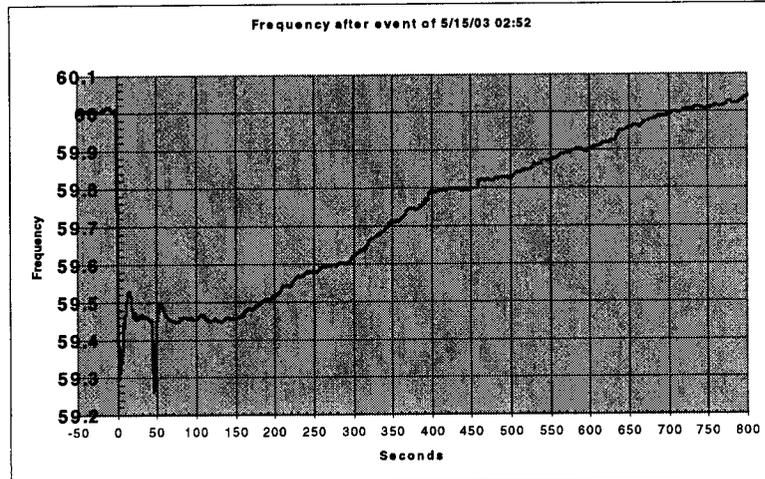
- Total capacity loss was 7215 MW
- Total actual generation lost was ~3621 MW
- Total load shed on High Set underfrequency relays was 471 MW
- Total firm load shed on underfrequency relaying was ~ 1549 MW (5.6%) in the ERCOT grid – distributed throughout most of Texas

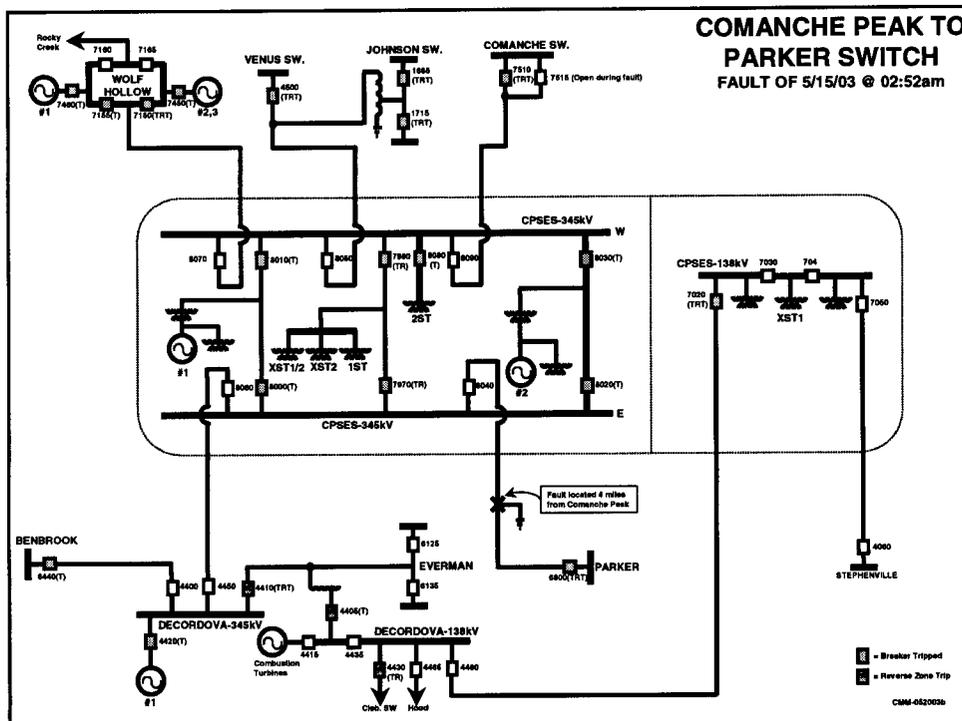
Initiating Event

- The fault occurred 4 miles from CPSES switchyard
- Insulators and static wires were damaged by the fault
- Remote breakers cleared the fault

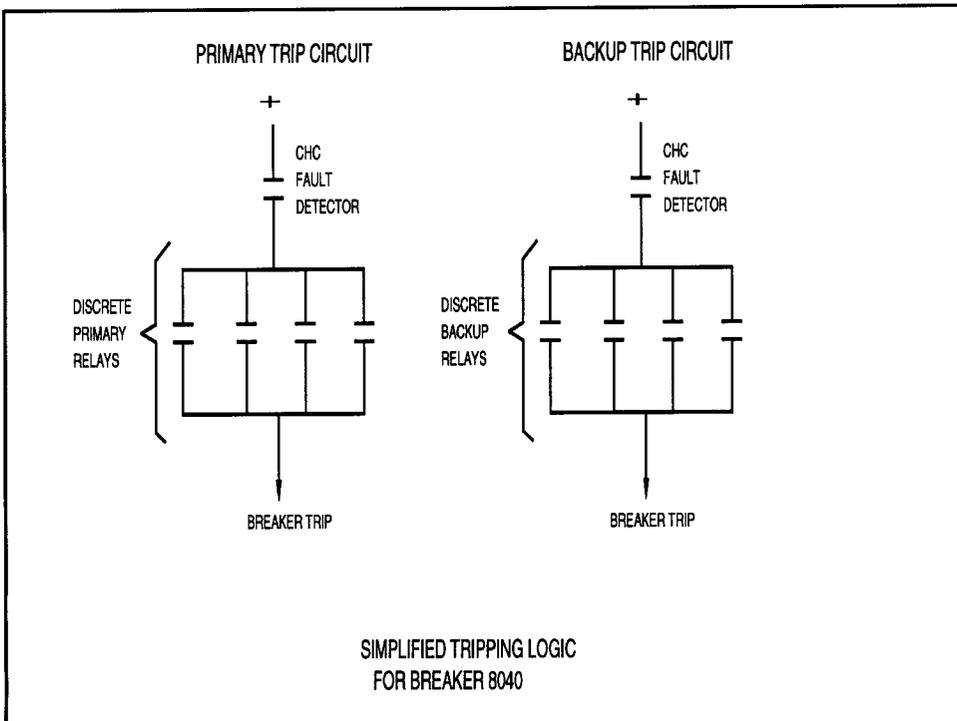
Causes for Undesirable Operations

Event root cause is the fault detector relays failed to operate on CPSES breaker 8040.

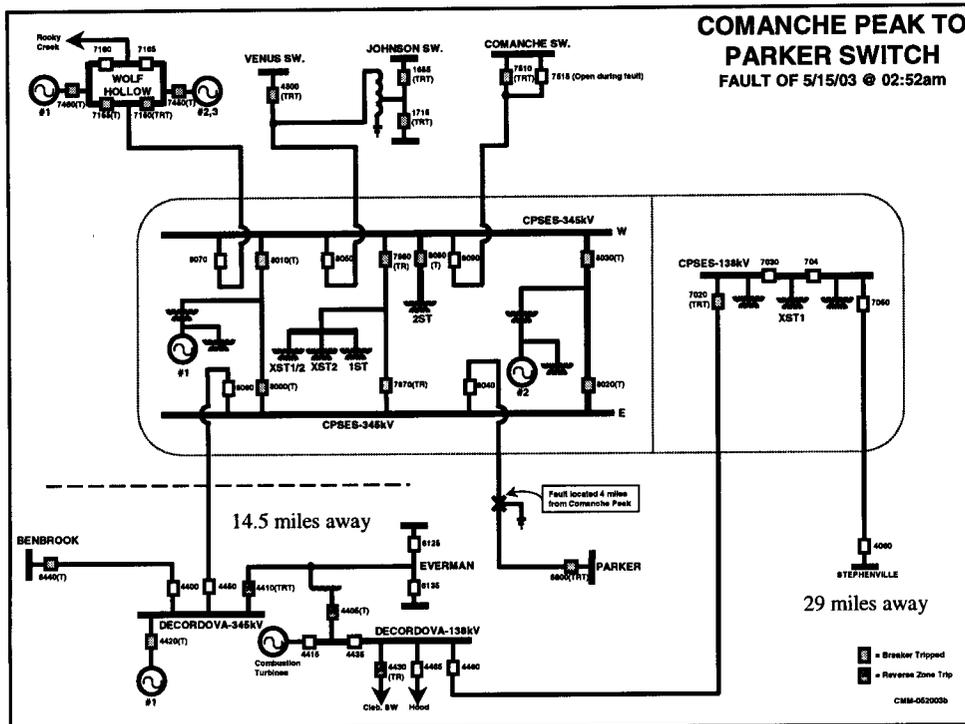
DeCordova 345 kV Breaker 4450 Failure to Trip

- Lack of coordination at DeCordova for failure of primary and backup relay failures at CPSES
- Intentionally designed not to over trip
