**TENNESSEE VALLEY AUTHORITY - BROWNS FERRY NUCLEAR PLANT (BFN) -  
UNITS 2 and 3 - DOCKETS 50-260 AND -296 - FACILITY OPERATING  
LICENSES DPR - 52 AND DPR - 68 - LICENSEE EVENT REPORT (LER)  
50-260/2003-004-00**

The enclosed report provides details of an electrical cable separations design error which potentially affected the plants' Appendix R safe-shutdown capability.

<b>1. FACILITY NAME</b> Browns Ferry Nuclear Plant Units 2 and 3						<b>2. DOCKET NUMBER</b> 05000260			<b>3. PAGE</b> 1 OF 6				
<b>4. TITLE</b> Cable Separations Design Error Related to Appendix R requirements													
<b>5. EVENT DATE</b>			<b>6. LER NUMBER</b>			<b>7. REPORT DATE</b>			<b>8. OTHER FACILITIES INVOLVED</b>				
MO	DAY	YEAR	YEAR	SEQUENTIAL NUMBER	REV NO	MO	DAY	YEAR	FACILITY NAME	DOCKET NUMBER			
07	07	2003	2003 - 004 - 00			09	05	2003	BFN Unit 3	05000296			
									FACILITY NAME	DOCKET NUMBER			
									None	N/A			
<b>9. OPERATING MODE</b>		1		<b>11. THIS REPORT IS SUBMITTED PURSUANT TO THE REQUIREMENTS OF 10 CFR § (Check all that apply)</b>									
<b>10. POWER LEVEL</b>		100		20.2201(b)		20.2203(a)(3)(ii)		X		50.73(a)(2)(ii)(B)		50.73(a)(2)(ix)(A)

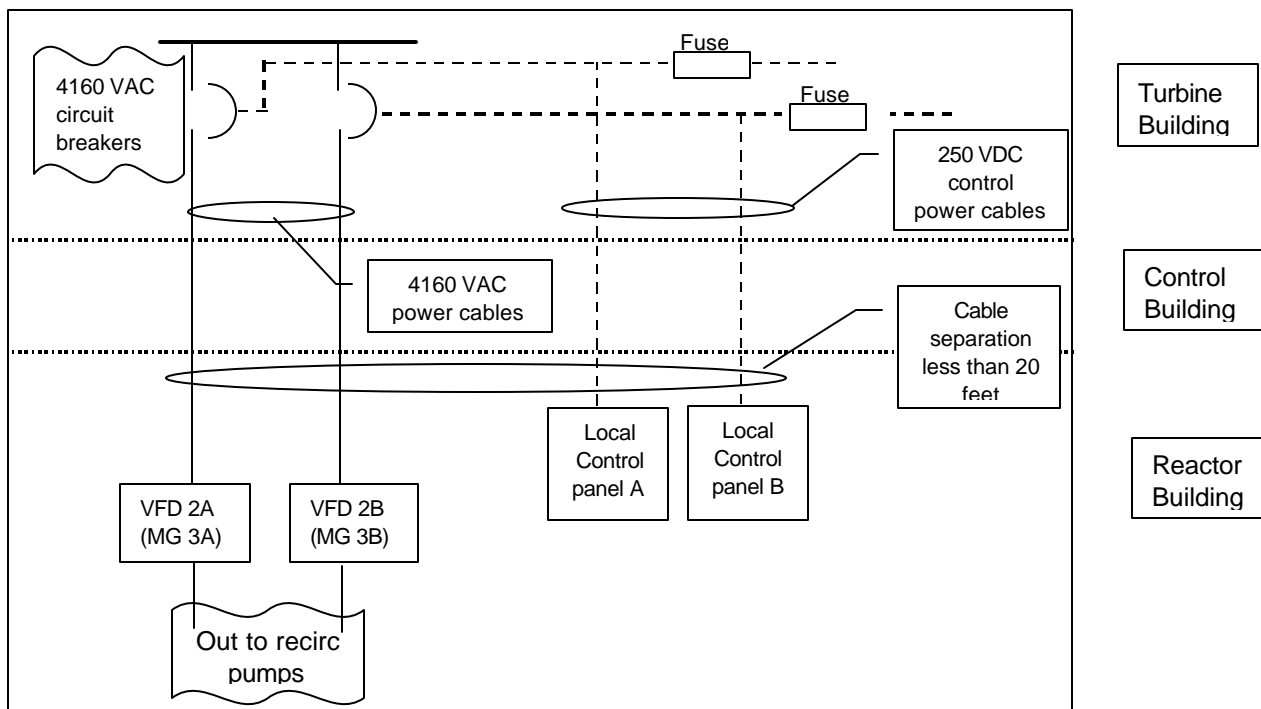
As physically configured, control power cables which affect power circuit breaker control are routed within 20 feet of the power cables being fed by these same breakers. The plant loads affected are the Unit 2 variable frequency drives (VFDs) and the Unit 3 recirculation motor-generator (MG) sets which provide power to drive the reactor recirculation pumps. As a result of this cable routing, fires in certain zones of the BFN plant could result in electrical faults on power cables which could not be de-energized by automatic breaker operation. Such faults could result in cable insulation fires being initiated in fire areas other than the area where the original fire occurred, thus creating an associated circuit of concern.

The event apparent cause was a lack of attention to detail when the subject calculations were performed prior to the restarts of Unit 2 (1991) and Unit 3 (1995). The common vulnerabilities to damage from a single fire of the control and power circuits for the recirculation pump drives (VFDs on Unit 2 and MG sets on Unit 3) was not properly evaluated when the Appendix R calculations were originally performed.

It was identified that the control power cables associated with the recirculation pump breakers and the power cables from these breakers to the recirculation pump drives (VFDs on Unit 2 and MG sets on Unit 3) are routed such that a single fire event could potentially damage both types of cabling. Should the control power cables be damaged in such an event, it would then be impossible to remotely operate the recirculation pump drive breakers. Given the current cable routing, it is also possible that the same fire could subsequently damage the recirculation pump drive power cables. With the control power already hypothetically failed by the fire, the recirculation pump drive breakers would not automatically trip to isolate such a fault on the power cables. Under such circumstances, high fault currents could flow uninterrupted along the cable's entire length. As a result, the cable insulation could ignite in other fire areas along the cable run. A fire in a reactor building fire zone could therefore spread to another reactor building fire zone or to a control building fire zone via this propagation mechanism. See the sketch below:

1. Design changes will be developed to remove the common vulnerability problem.
2. These design changes will be physically implemented on BFN Units 1, 2, and 3
