State of New Mexico
ENVIRONMENT DEPARTMENT

August 15, 2003

RE: New Mexico Environment Department inspection visit with Mr. Anton Allensworth-Cannaday, Milan, New Mexico

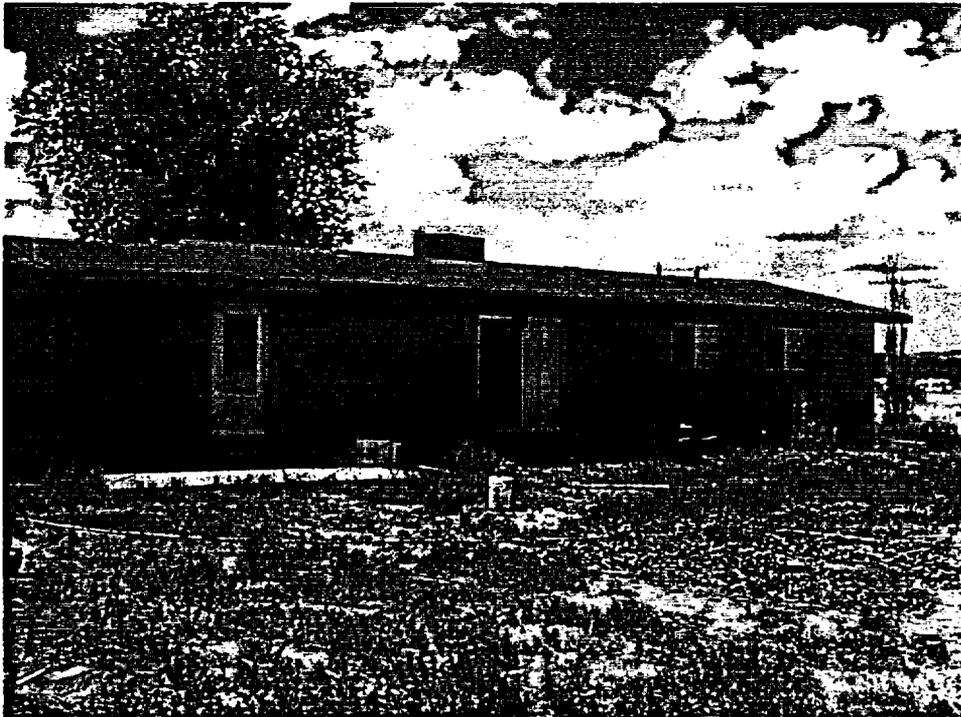
Figure 2: General view of back side (i. e., northern side) of Mr. Allensworth-Cannaday's house

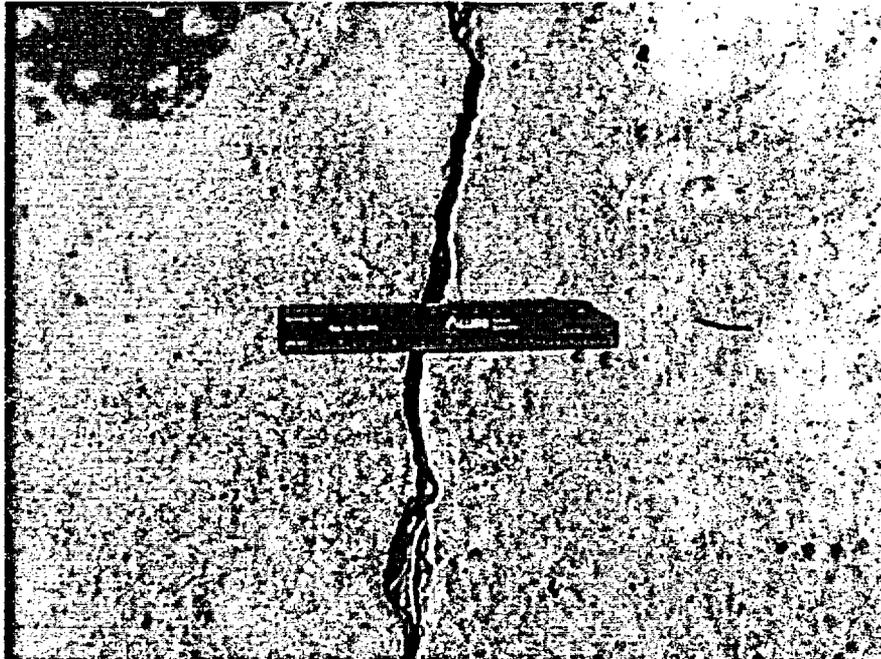
Mr. Allensworth-Cannaday showed NMED personnel a crack in the concrete apron on the back (i. e., north side) of the house (Figure 5). This crack is oriented approximately north/south, in approximate alignment with well ACW and is approximately ¼ inch in width. The crack is visible into the wall stucco up to the house's eave. This crack is located approximately 5 feet to the east of the inferred seam between the original house structure and the addition to the house. Some dislocation of the roof line was noted, but may be related to the seam of the house addition.

No evidence of the crack was noted on the interior of the house; however Mr. Allensworth-Cannaday stated that he had repaired interior cracks on several occasions.

Mr. Allensworth-Cannaday stated that all of these dislocations suddenly appeared shortly after HMC had discontinued injection into well ACW.

1. The area around well ACW, which is in relatively close proximity to the house, was elevated, damp and highly-vegetated at the time it was used for injection. These observations might indicate leakage to the surface of injected water. Such leakage, if it occurred, may have caused swelling of near-subsurface clays and/or soil liquefaction, contributing to foundation dislocation. The crack on the back side of the house aligns fairly closely to this well, and involves both the house itself as well as a concrete apron that appears to be unconnected to the structure.
2. The observed structural dislocations occurred subsequent to cessation of HMC's injection activities.

Figure 5: Crack in concrete apron on back (i. e., north) side of Mr. Allensworth-Cannaday's house

NMED has spoken to Mr. Al Cox (HMC) to request that he contact, and subsequently arrange to visit, Mr. Allensworth-Cannaday about his property concerns, and also to inform him about the status and process of HMC's ongoing remedial effort. NMED believes that the following assertions by the owner may be mitigating factors that could indicate the need for HMC to provide Mr. Allensworth-Cannaday with an independent structural engineering inspection of house to determine the cause of the observed structural dislocations:
