**UNITED STATES
NUCLEAR REGULATORY COMMISSION
REGION IV
611 RYAN PLAZA DRIVE, SUITE 400
ARLINGTON, TEXAS 76011-4005**

September 8, 2003

**SUBJECT: SOUTH TEXAS PROJECT ELECTRIC GENERATING STATION - NRC SPECIAL
INSPECTION TEAM REPORT 05000498/2003008 AND 05000499/2003008 AND
EXERCISE OF ENFORCEMENT DISCRETION**

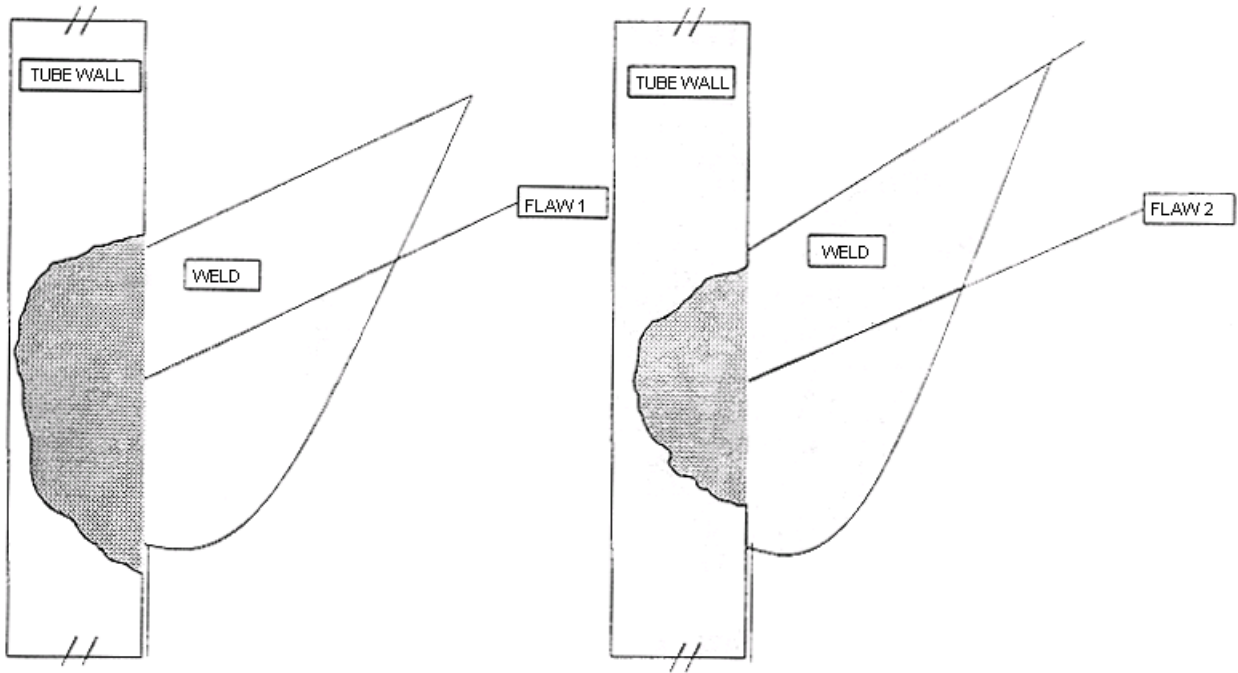
Figure 3

On April 12, 2003, during Refueling Outage 1RE11 at STP, Unit 1, the licensee performed a planned bare metal inspection of the RPV bottom head as part of its Boric Acid Corrosion Control (BACC) program. The inspection identified white deposits that had extruded from the annular gap around BMI Penetrations 1 and 46. The licensee quantified the amount of observed deposits as approximately 150 milligrams around Penetration 1 and 3 milligrams around Penetration 46. No wastage was identified on the exposed RPV surface. Results of chemical and isotopic analyses of the deposits confirmed that they originated from the RCS and that they were, on average, about 4 years old. Further, the licensee concluded that RCS pressure boundary leakage was the most likely source of the deposits. An estimate of the total quantity of leakage from the RCS was that it was less than 50 gallons over the estimated 4 year period.

The licensee conducted NDE inspections of the BMI nozzles, J-groove welds, and portions of the reactor vessel shell during May and June of 2003. The inspections confirmed that the repair scope was limited to Penetrations 1 and 46. On June 5, 2003, the licensee presented its inspection results and repair plans to the NRC at a public meeting and, on June 11, 2003, submitted Licensee Event Report (LER) 05000498/2003-003-00. The licensee performed repairs using the half-nozzle repair technique in June. Following completion of the repairs, cleaning of all 58 guide tubes was performed to correct a previously identified condition involving difficulty in the insertion and removal of thimble tubes. Material samples were taken from the nozzle and weld material of Penetrations 1 and 46 for destructive evaluation in July 2003.

Penetration #46

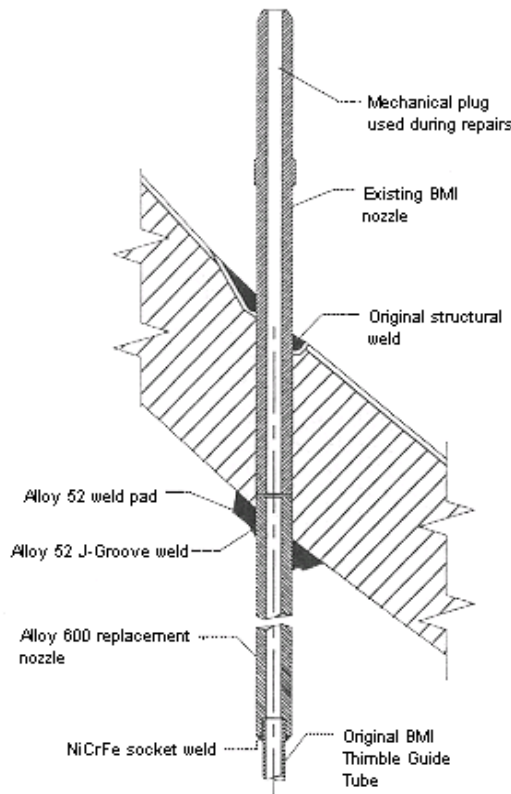
Figure 4

Half-Nozzle Repair
