Edwin I. Hatch Nuclear Plant
Measurement Uncertainty Recapture Power Uprate (MURPU)
Post MURPU Steam Dryer Performance Monitoring and Inspections

BWR steam dryer integrity

**SIL No. 644
Supplement 1
September 8, 2003**

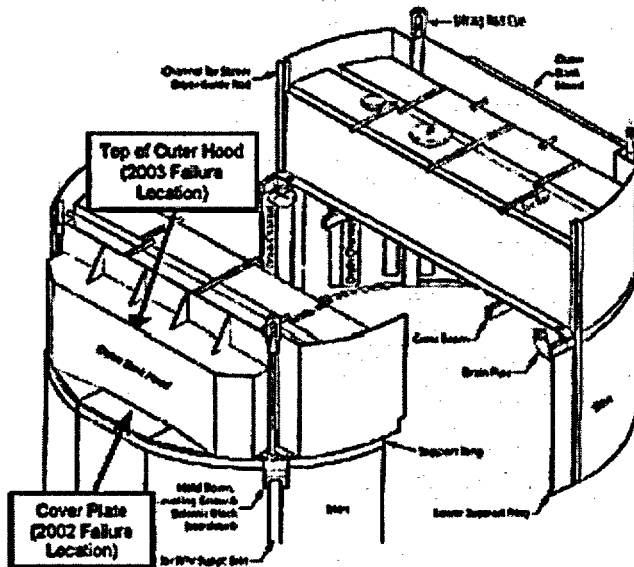
The purpose of this Supplement 1 to SIL No. 644 is to describe a second steam dryer failure that occurred at the same BWR/3 approximately one year following the initial steam dryer failure. The location of the failure (refer to Figure 1) and the root cause are different than the earlier failure. As a result, additional monitoring and inspections are recommended for all BWR plants that are operating, or plan to operate, at power levels greater than the OLTP. SIL 644 applied to BWR/3-style steam dryer design plants. This Supplement 1 to SIL No. 644 presents revised recommendations for plants with BWR/3-style steam dryers and provides recommendations applicable to plants with BWR/4 and later steam dryer designs.

Figure 1 — Steam Dryer Failure Locations, 2002 and 2003

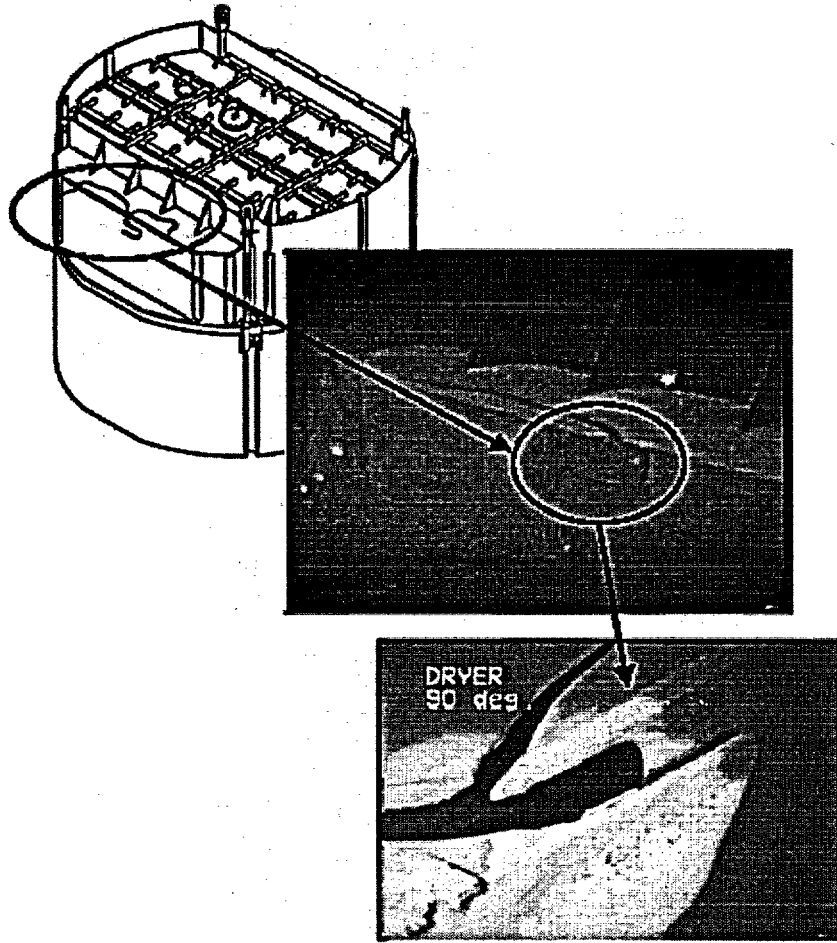
Detailed visual inspection of the accessible external and internal areas of the steam dryer revealed significant steam dryer damage. The damage was most severe on the 90-degree side of the steam dryer, the side that was closest to the PORV that had opened. On the 90-degree side, a through-wall crack approximately 90 inches long and up to three inches wide was observed in the top of the outer hood cover plate and the top of the vertical hood plate (refer to Figure 2). Three internal braces in the outer hood were detached and one internal brace in the outer hood was severed. The detached braces were found on top of the steam separator. All detached parts were accounted for and retrieved. On the opposite side of the steam dryer (270-degree side), incipient cracking was observed on the inside of the outer hood cover

plate and one vertical brace in the outer hood was cracked. No damage was found in the cover plates that had been replaced following the first steam dryer failure in 2002.

Extensive metallurgical and analytical evaluations (e.g., detailed finite element analyses, flow induced vibration analyses, computational fluids dynamics analyses, 1/16" scale model testing and acoustic circuit analyses) concluded that the root cause of the steam dryer failure was high cycle fatigue resulting from low frequency pressure loading. There are two potential contributing factors to the failure:

Figure 2 — Steam Dryer Damage 90 Degree Side

The following repairs and pre-emptive modifications were made to both the 90 and 270-degree sides of the steam dryer:

1. replaced damaged ½ inch outer hood plates with 1 inch plates
2. removed the internal brackets that attached the internal braces to the outer hood
3. added gussets at the outer vertical hood plate and cover plate junction
4. added stiffeners to the vertical welds and horizontal welds on the outer hood

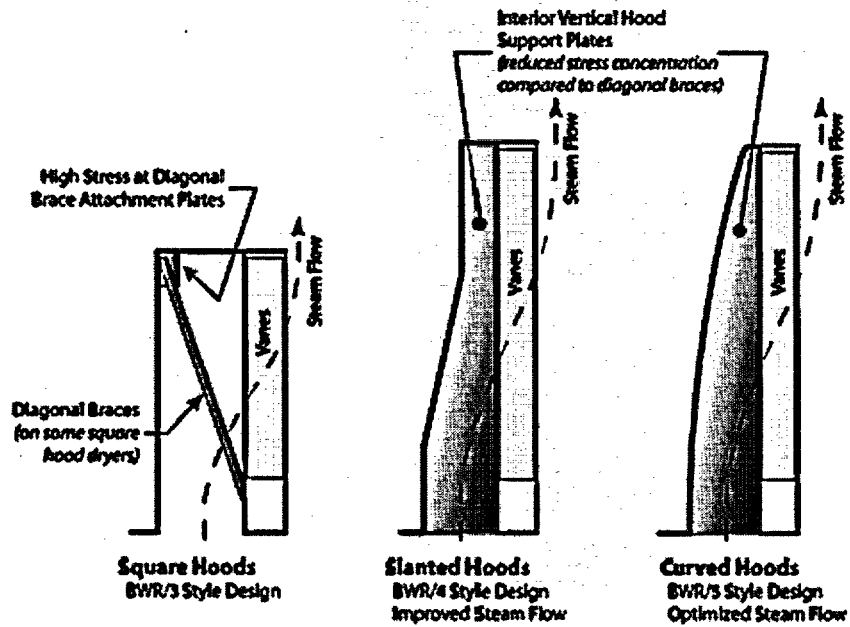
There are two key attributes that determine the susceptibility of a particular plant to steam dryer degradation. The dominant attribute is the steam dryer configuration. There are three general types of steam dryer configurations (refer to Figure 3):

1. BWR/3-style steam dryers with a square hood and internal braces. This design results in maximum stresses where the internal braces attach to the outer hood. The crack initiation at the BWR/3 occurred at this high stress location. Higher stresses result in a greater susceptibility of the components to crack initiation. Some BWR/3-style steam dryers do not incorporate the internal braces. This design eliminates the stress concentration associated with the brace attachment.

2. BWR/4-style steam dryers that have slanted hoods. This design replaced the internal braces with internal plates that substantially reduced the maximum calculated stresses.
3. BWR/5 and later steam dryer designs that incorporated curved hoods to optimize the steam flow. This design retained the internal plates, further reducing the maximum calculated stresses.

Figure 3 — Steam Dryer Hood Configurations

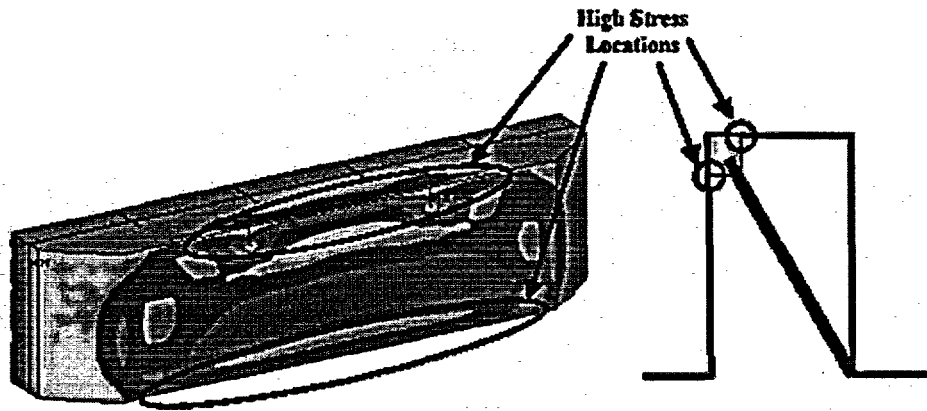
Figure 4 — High Stress Locations
Square Hood with Braces

- e. Perform a visual inspection ("best effort" VT-1) of the steam dryer at the next scheduled refueling outage. This inspection should include the most susceptible locations as determined by a dryer stress analysis (refer to Figure 4). This inspection should include both an external and internal inspection of the accessible areas. Remove trapped bubbles to ensure complete coverage of internal areas.

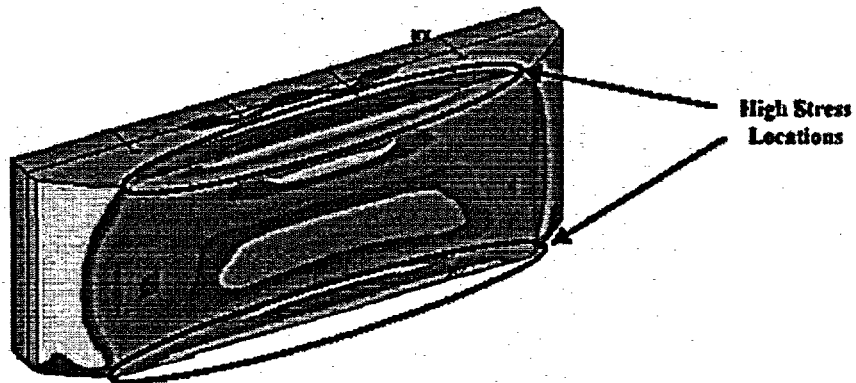
Figure 5 — High Stress Locations
Square Hood without Braces

- c. Perform a visual inspection ("best effort" VT-1) at the outage prior to initial operation above the OLTP or at the next scheduled refueling outage if already operating above the OLTP. This inspection should include the most susceptible locations as determined by a dryer stress analysis (refer to Figure 5). This inspection can be limited to an external inspection of the most susceptible locations.

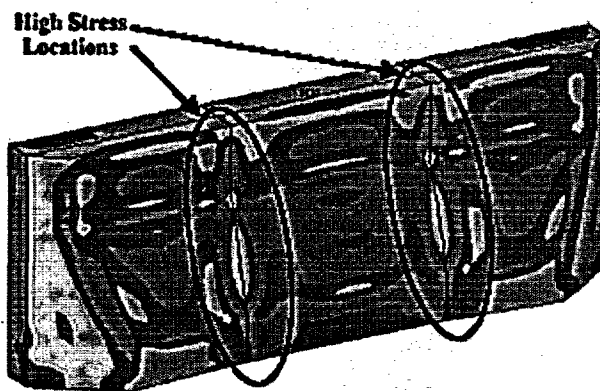
Figure 6 — High Stress Locations
Slanted Hood

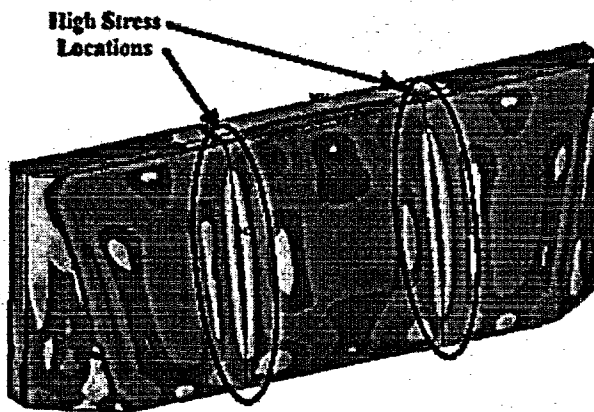
Figure 7 — High Stress Locations
Curved Hood
