AEP:NRC:3691-05  
10 CFR 50.4

Donald C. Cook Nuclear Plant Units 1 and 2  
STEAM GENERATOR INSPECTION – REQUEST FOR ADDITIONAL  
INFORMATION (TAC NOS. MB8121 and MB8122)

**Steam Generator Inspections  
Request for Additional Information**

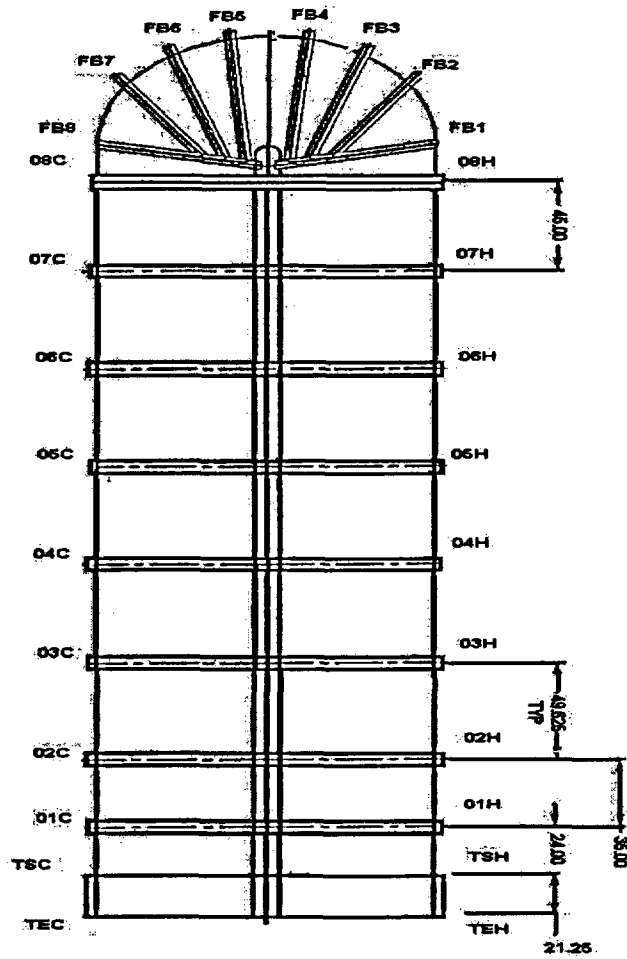
Figure 1  
Unit 1 Steam Generator

\*See Figure 1. The tube support structure consists of eight stainless steel lattice grid assemblies and four sets of flat bar (also called fan bar) restraints. Each lattice grid consists of interlocking “high” (3.15 inches high and 0.135 inches thick) and “low” (1.0 inches high and 0.135 inches thick) bars that form a lattice pattern to provide lateral support in the straight section of the tube. The flat bar restraints are made of the same material and provide support in the U-bend area.

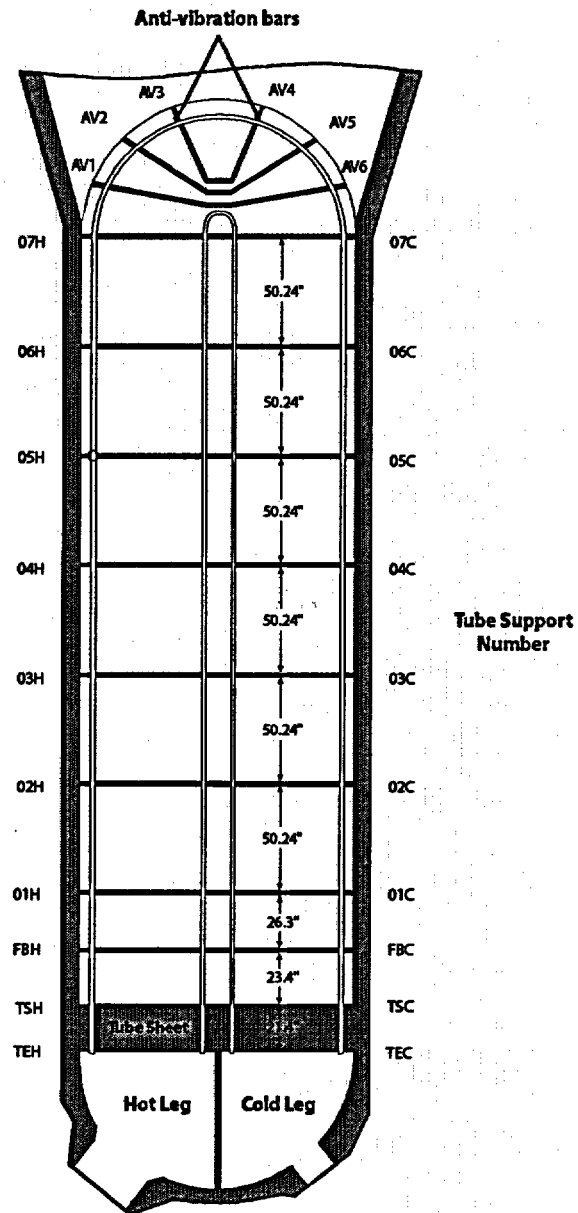
Figure 3  
Unit 2 Steam Generator

\*See Figure 3. The tube support structures consist of seven 1.12 inch thick support plates with quatrefoil holes and six anti-vibration bars that are located in the U-bend region of the tubes. There is also a flow distribution baffle located between the tubesheet and the first support plate. The flow distribution baffle is 0.75 inches thick with octofoil holes. The support plates, anti-vibration bars, and the flow distribution baffle are all constructed of type 405 stainless steel.

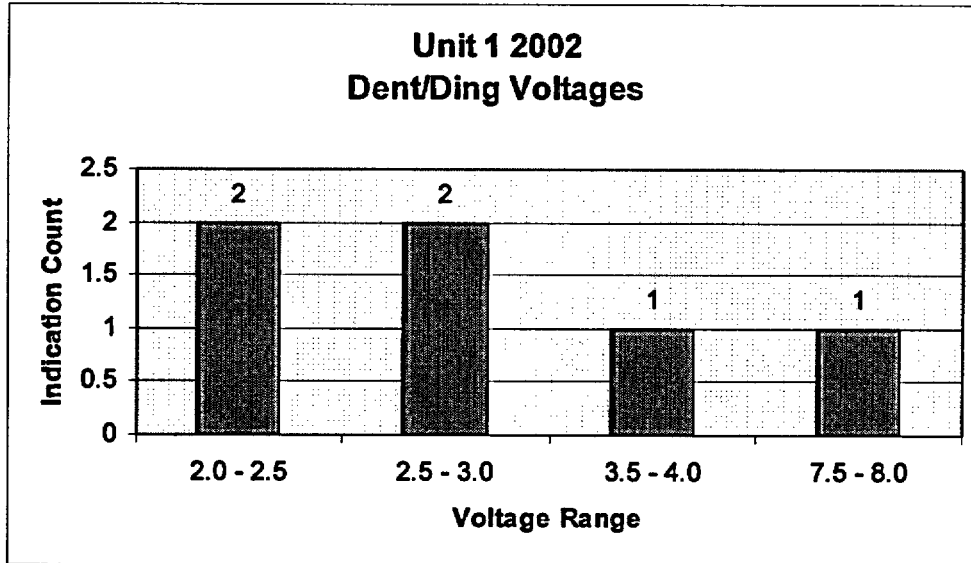
Figure 5  
Unit 1 Bobbin Voltage Amplitude Distribution

The bobbin voltage amplitude distributions for the dent/ding signals reported during the 2002 inspection are presented in Figure 5.

A review of the Unit 1 data noted that of the six indications, five were present in the baseline examination record and had not changed. The sixth tube, SG 14, R34/C26, was found to have a small ding indication (2.15 volts) in the U-bend region that was not present in the baseline data. This indication was most likely caused by either probe interaction when traversing the U-bend region or by steam generator movement during shipping (Note: The baseline examination was performed in the factory and no additional inspections were performed until 2002).

The planned 2002 Unit 1 rotating coil inspection for dents and dings consisted of a random 20 percent sample of all dent/ding indications above two volts. When the inspection results were obtained, it was noted that of the six dents/dings reported, five of the indications were in the U-bend area. However, due to an oversight, a U-bend rotating probe was not available to perform the one additional indication inspection necessary to comply with the 20 percent sample. A decision was made to inspect the accessible freespan indication and to defer the U-bend inspection of the one additional indication until the next scheduled inspection, the Unit 1, Cycle 19 refueling outage. This decision was judged to have no adverse impact on tube integrity due to the small signal amplitudes of the U-bend indications, the limited operating time of the Unit 1 steam generators, the enhanced design features and the degradation resistant properties and operating experience with the alloy 690 thermally treated tubing material. I&M plans to inspect a

sample (inclusive of SG 14, tube R34/C26 discussed above) of U-bend dent/ding indications with a rotating coil during the Unit 1 Cycle 19 refueling outage.

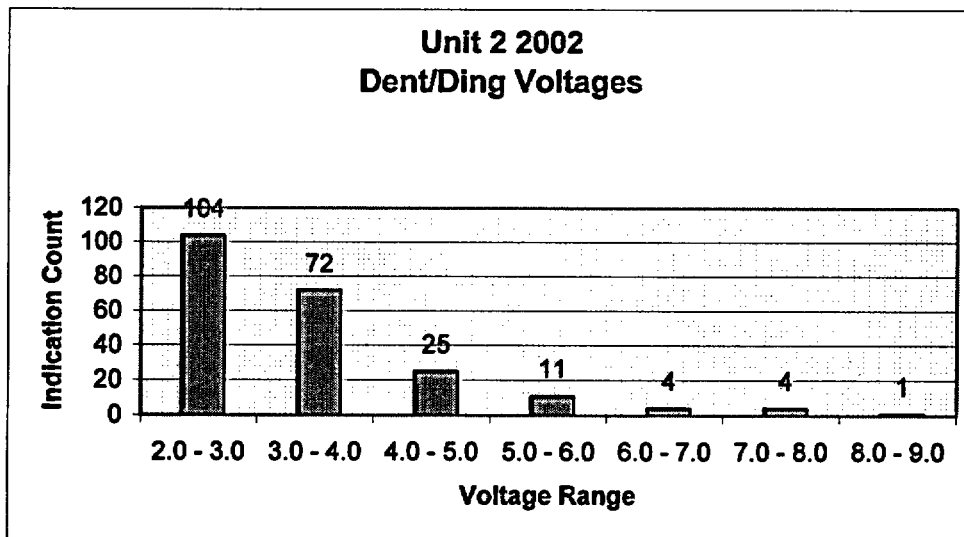
Figure 6  
Unit 2 Bobbin Voltage Amplitude Distribution

The bobbin voltage amplitude distributions for the dent/ding signals reported during the 2002 inspection are presented in Figure 6.

A review of the Unit 2 data provided reasonable assurance that all of the dent/ding indications reported during the 2002 inspection were present in the baseline examination and had not changed. A portion of the baseline data, which was originally recorded on cartridge tape, is unavailable for review because of problems encountered when duplicating the data from the obsolete cartridge tapes to the current industry standard data media (optical discs). Therefore, a review of 100 percent of the indications could not be performed. Over ninety eight percent of the indications were reviewed, and no signal changes were identified. The results of the data review provide confidence that the dents/dings are not service induced. Of the 221 reported dent/ding signals from the 2002 inspection, 217 were confirmed in the baseline data and indicated no change. The traceability of these signals to the baseline data coupled with design features such as the quatrefoil stainless steel support structures and full depth expanded tubesheet are felt to provide reasonable assurance that service induced dents/dings are not occurring in these steam generators.

The Unit 2 rotating coil inspection for dents and dings was based upon a 20 percent random sample of all dent/ding indications above two volts in the freespan region. The inspection consisted of tubes with both single indications and tubes with multiple indications. No U-bend indications were tested. While no degradation is expected in any of the U-bend dent/ding indications due to the service time of the Unit 2 steam generators and the enhanced design features/degradation resistance offered by the alloy 690 thermally treated tubes, I&M plans to inspect a sample of U-bend dent/ding indications with a rotating coil during the Unit 2 Cycle 15 refueling outage.

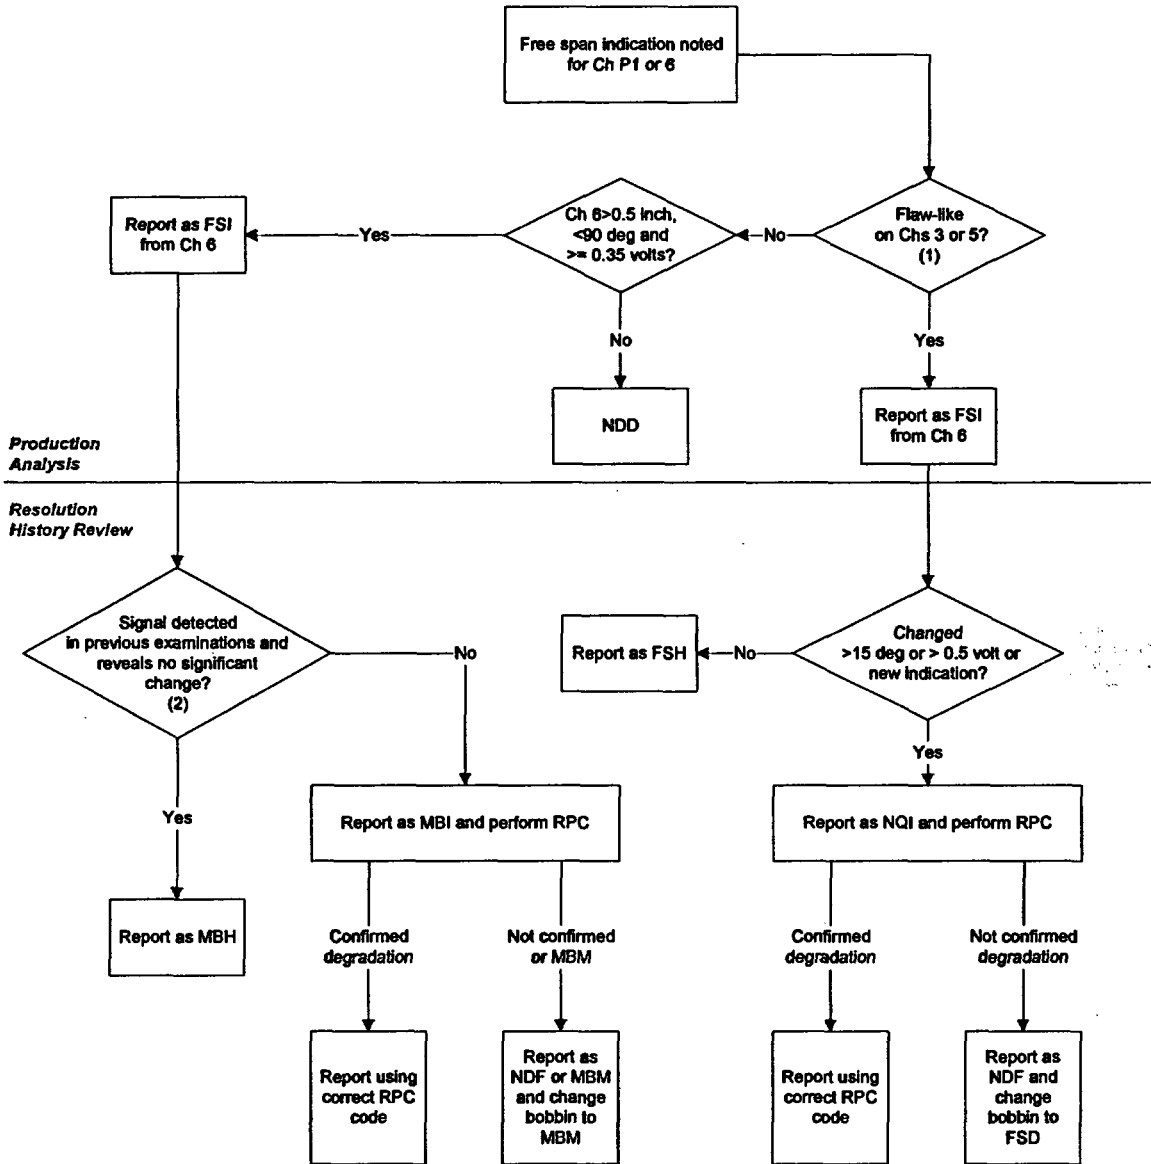
Figure 7  
 Decision Flowchart

The criteria for determining whether a signal had changed was developed by the lead level III analyst and concurred with by an independent level III analyst. The criteria, which are based upon industry experience, are illustrated in Figure 7.

(1) Flaw-like: reads above 0%  
 (2) Significant change: >15 degree positive phase shift. All MBH calls require review by both resolution analysts.
