Florida Power & Light Company, P.O. Box 14000, Juno Beach, FL 33408-0420

NRC Bulletin 2003-02
Leakage From Reactor Pressure Vessel Lower Head Penetrations
And Reactor Coolant Pressure Boundary Integrity

Turkey Point Plant Units 3 and 4 Response NRC Bulletin 2003-02

Seabrook Station Response NRC Bulletin 2003-02

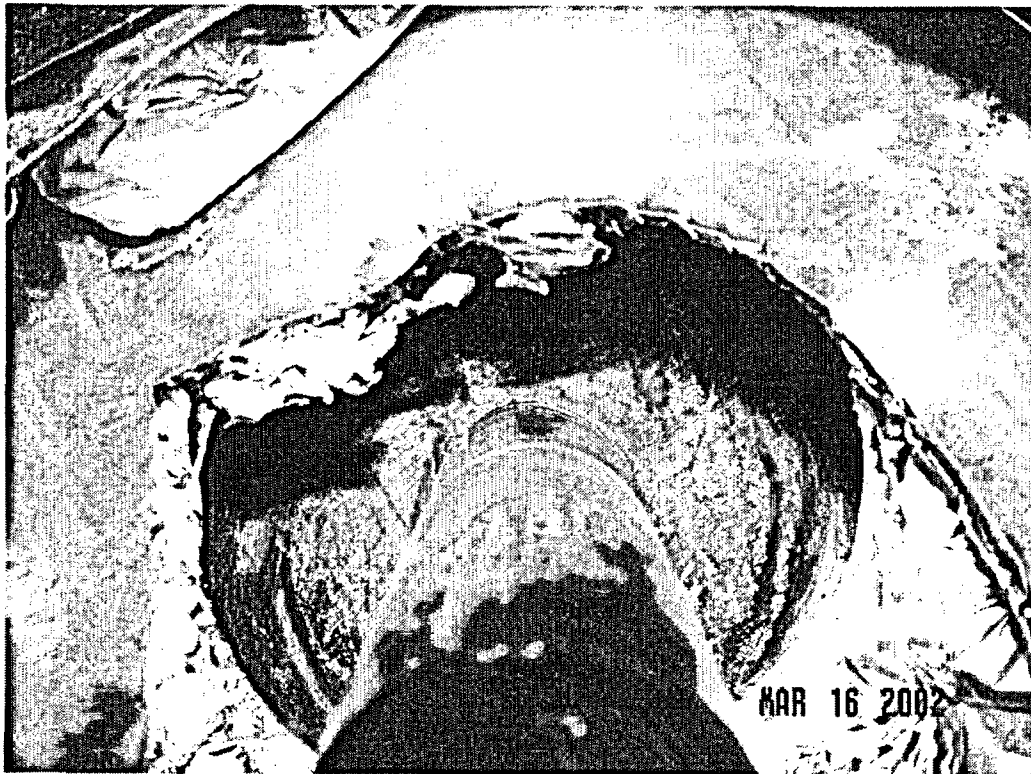
pressure tests and boric acid program walkdowns have never identified any BMI leakage. However, minor discoloration was noted at the last Turkey Point Unit 3 RFO that was dispositioned as cavity seal ring leakage as discussed below:

During the Turkey Point Unit 3 spring 2003 RFO, the leak inspection walkdown of the BMIs revealed a minor discoloration on BMI # 35. A condition report was written as required by our corrective action program. As part of the disposition, insulation cover plates were removed around BMI penetration # 35 to reveal the interface where the nozzle enters the reactor vessel lower head. A direct visual examination was performed by a qualified VT-2 examiner and documented as part of the corrective action program. Digital images of the examination area were also recorded as shown in the figure below. The stain on both the nozzle and the RV surface was described as a dry rust film of no discernible thickness. The stain trail was observed coming from above this outer periphery nozzle (#35) on the vessel surface. No white boron deposits or accumulation was noted on the vessel surface or around the circumference of the nozzle as it penetrated the RV surface (see figure below). The source of the rust stain on the RV lower head surface and BMI penetration #35 was determined to be coming from above, most likely cavity seal ring leakage during refueling and not relevant as a BMI leak since there is no heat source to concentrate boric acid. Similar staining was also noted on the RV cavity walls below the refueling cavity seal ring. A smear sample was taken of the rust stain to analyze the activation products to determine the age of the stain/leak source. However, due to the stain having no discernable thickness (small sample size) the results were inconclusive.

Figure 1: Turkey Point Unit 3 BMI penetration # 35 at the vessel interface during 2003 RFO. Note clean insulation surrounding the penetration and no boron deposits or accumulation.
