PG&E Letter DCL-03-113

Docket No. 50-275, OL-DPR-80  
Diablo Canyon Unit 1  
PG&E Response to NRC Questions on 1R11 Steam Generator Tube Inspections

**PG&E Response to NRC Questions on 1R11 Steam Generator Tube Inspections**

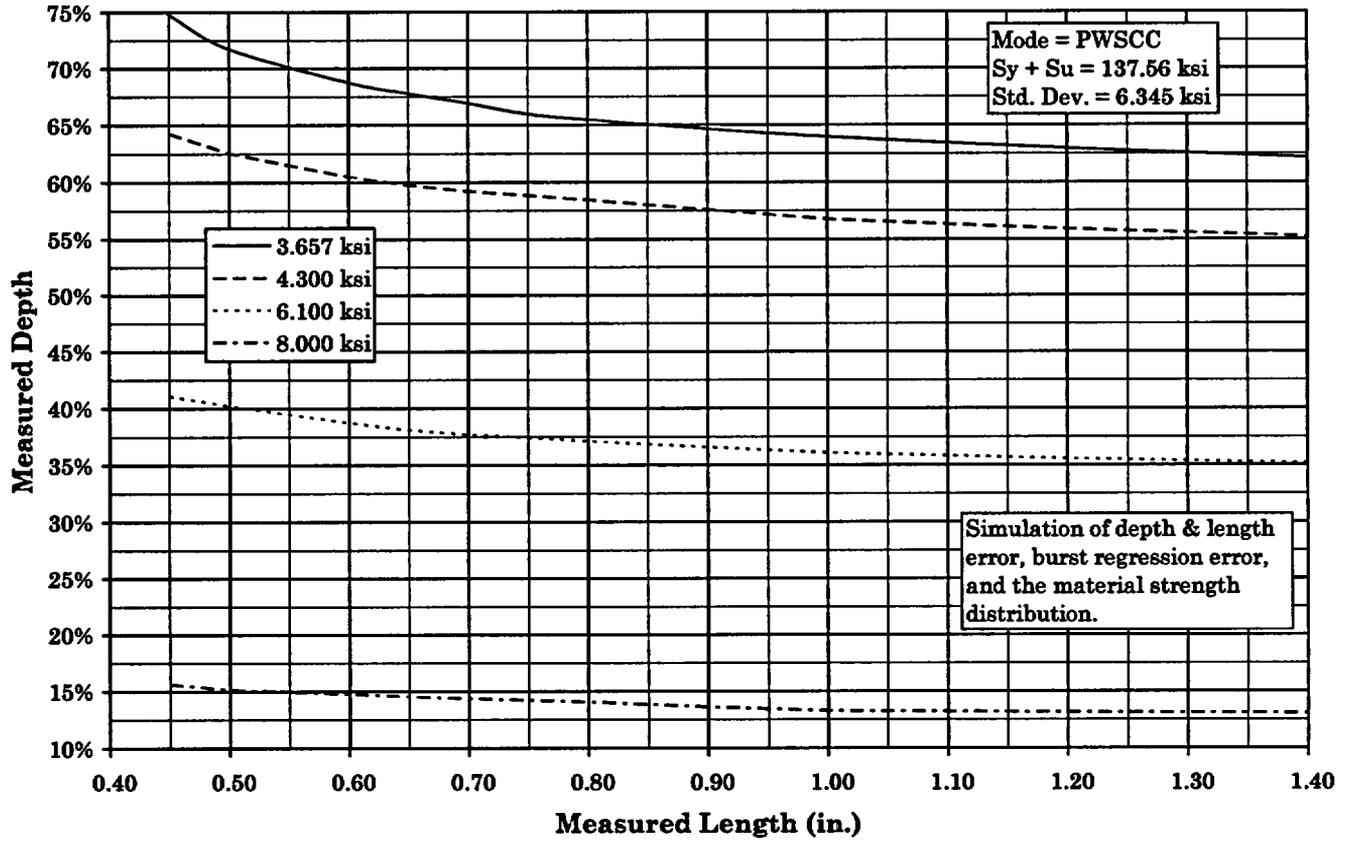
Figure 1

**Axial PWSCC 95%/95% EOC Burst Resistance Acceptance Limits**  
7/8" x 0.050" Alloy 600 MA SG Tubes at 650°F

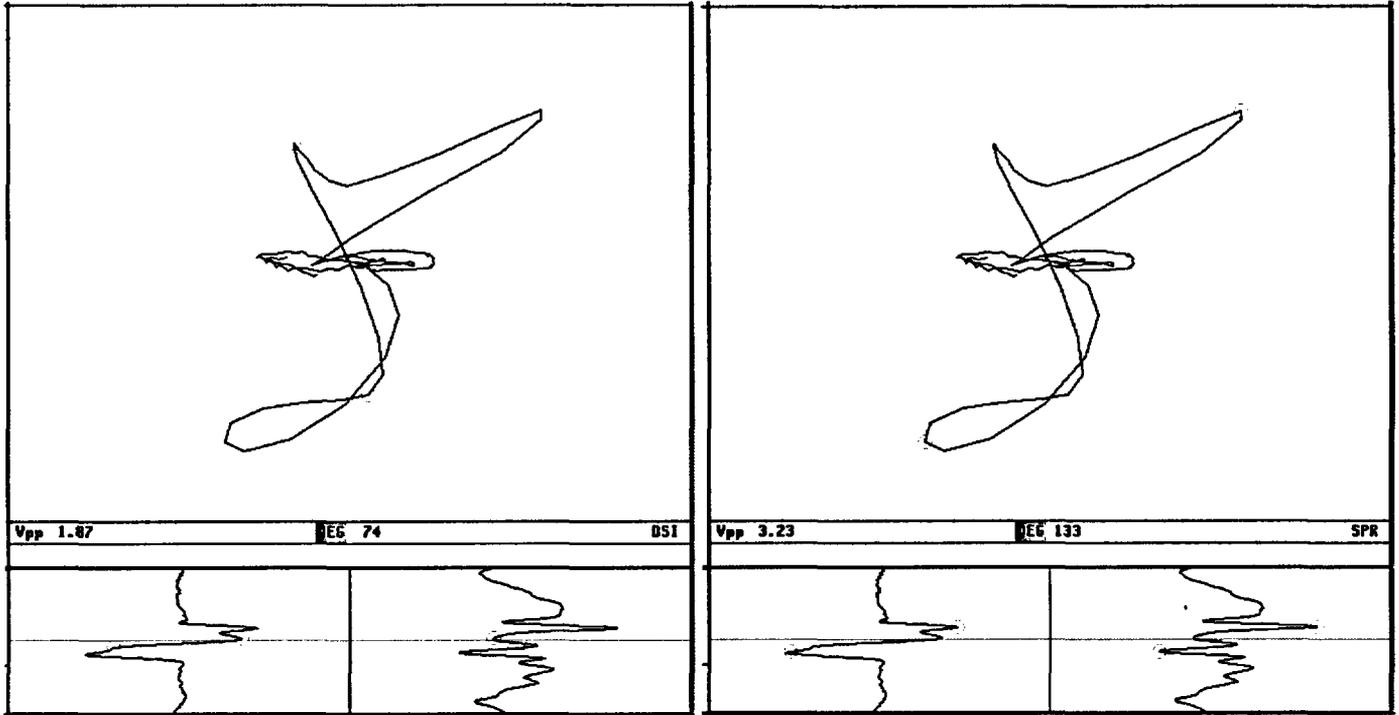
Many of the pulled tubes in the ARC database (and the prior cycle probability of detection or POPCD database) have mix residual signals larger than typically found in currently operating SGs. Figure 2 shows the 1.87 flaw voltage and the 3.23 mix residual voltage for pulled tube R27C54 from plant A-1 in the ARC database. This is only one example of the pulled tube data. Whatever influence the mix residuals may have on voltage sizing for TSP indications is built into the ARC database by the pulled tubes. The mix residuals may be more easily understood as TSP noise. The noise may distort the flaw signal particularly when the two-phase responses are similar.

**Figure 2. Flaw and Mix Residual (400/100 Mix) for Plant A-1 Pulled Tube R27C54-1H**

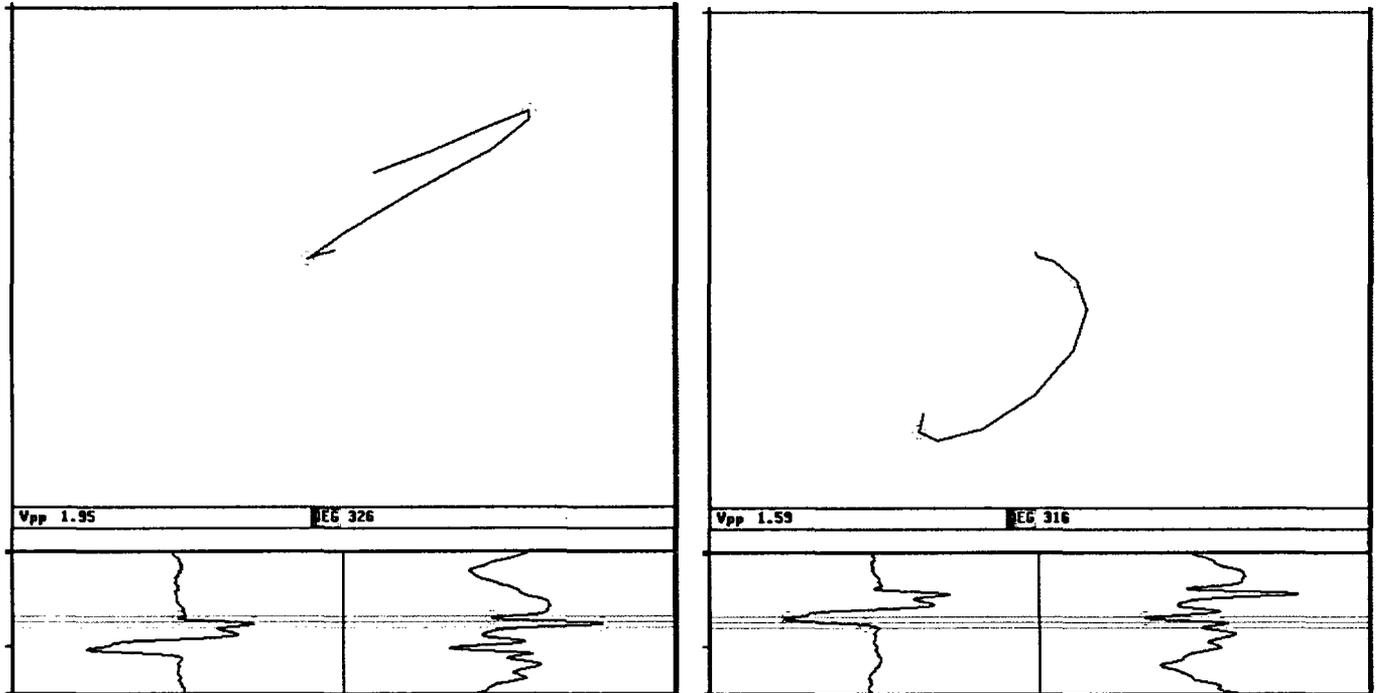
Noise analyses at cold leg TSP intersections have been performed for about 200 intersections spanning DCPD Units 1 and 2. The average peak-to-peak noise amplitudes at the TSP center were about 0.38 volts with an upper 95 percent confidence value of 0.70 volts. At the TSP edges, the average was about 0.51 volts with an upper percentile value of 0.88 volts. It is clear that the noise levels at DCPD TSP intersections are lower than that found for the R27C54 indication and many other indications in the ARC database. The vertical amplitude values at 95 percent confidence that may influence detection are about 0.25 volts at the TSP edges and about 0.2 volts at the TSP center.

**Figure 3. Upper and Lower TSP Noise Signals for Plant A-1 R27C54-1H (Center 1/3 of TSP Cannot be Evaluated Due to Flaw Signal)**

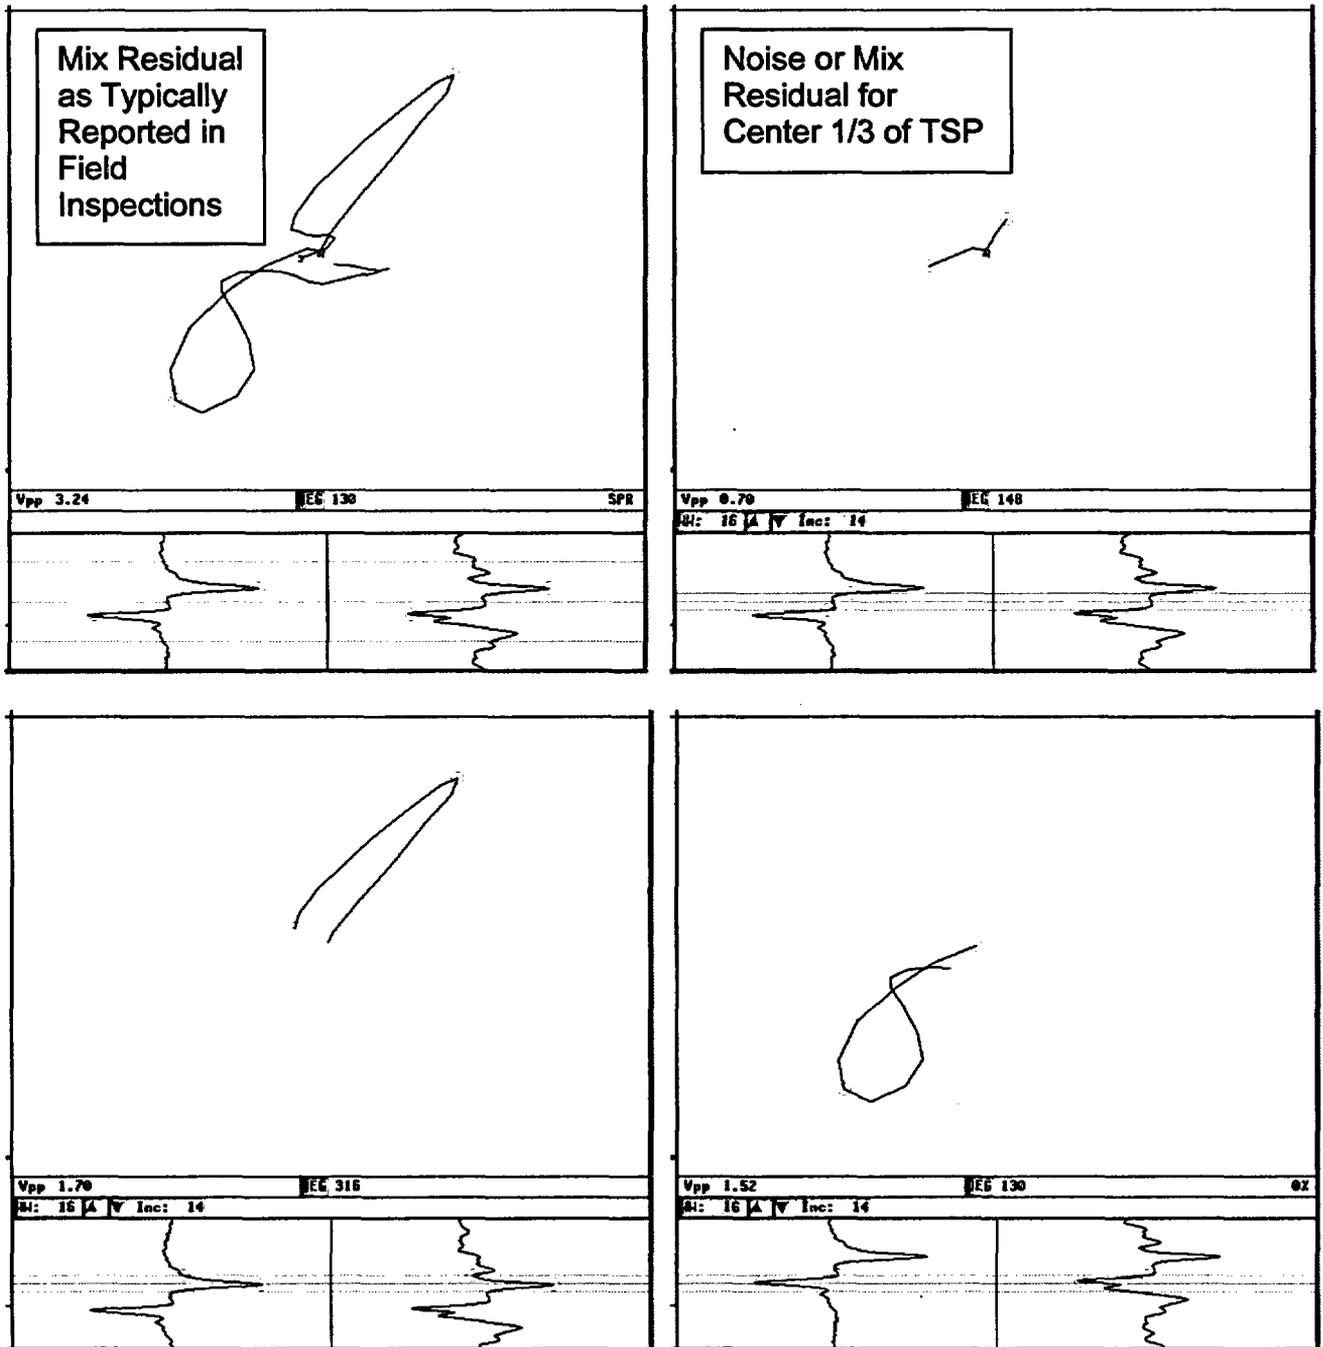
**Figure 4. Mix Residual and Center, Upper and Lower 1/3 TSP Noise Signals (400/100 kHz Mix) for Plant A-1 R27C54 at 2H**
