RE: Permit to Mine 633
 In Situ Uranium Wellfield Release Report

POWER RESOURCES, INC. HIGHLAND URANIUM PROJECT URANIUM IN SITU WELLFIELD FLUID RELEASE REPORT

FAILURE OF 6-INCH PVC INJECTION PIPELINE IN HEADERHOUSE 4-7

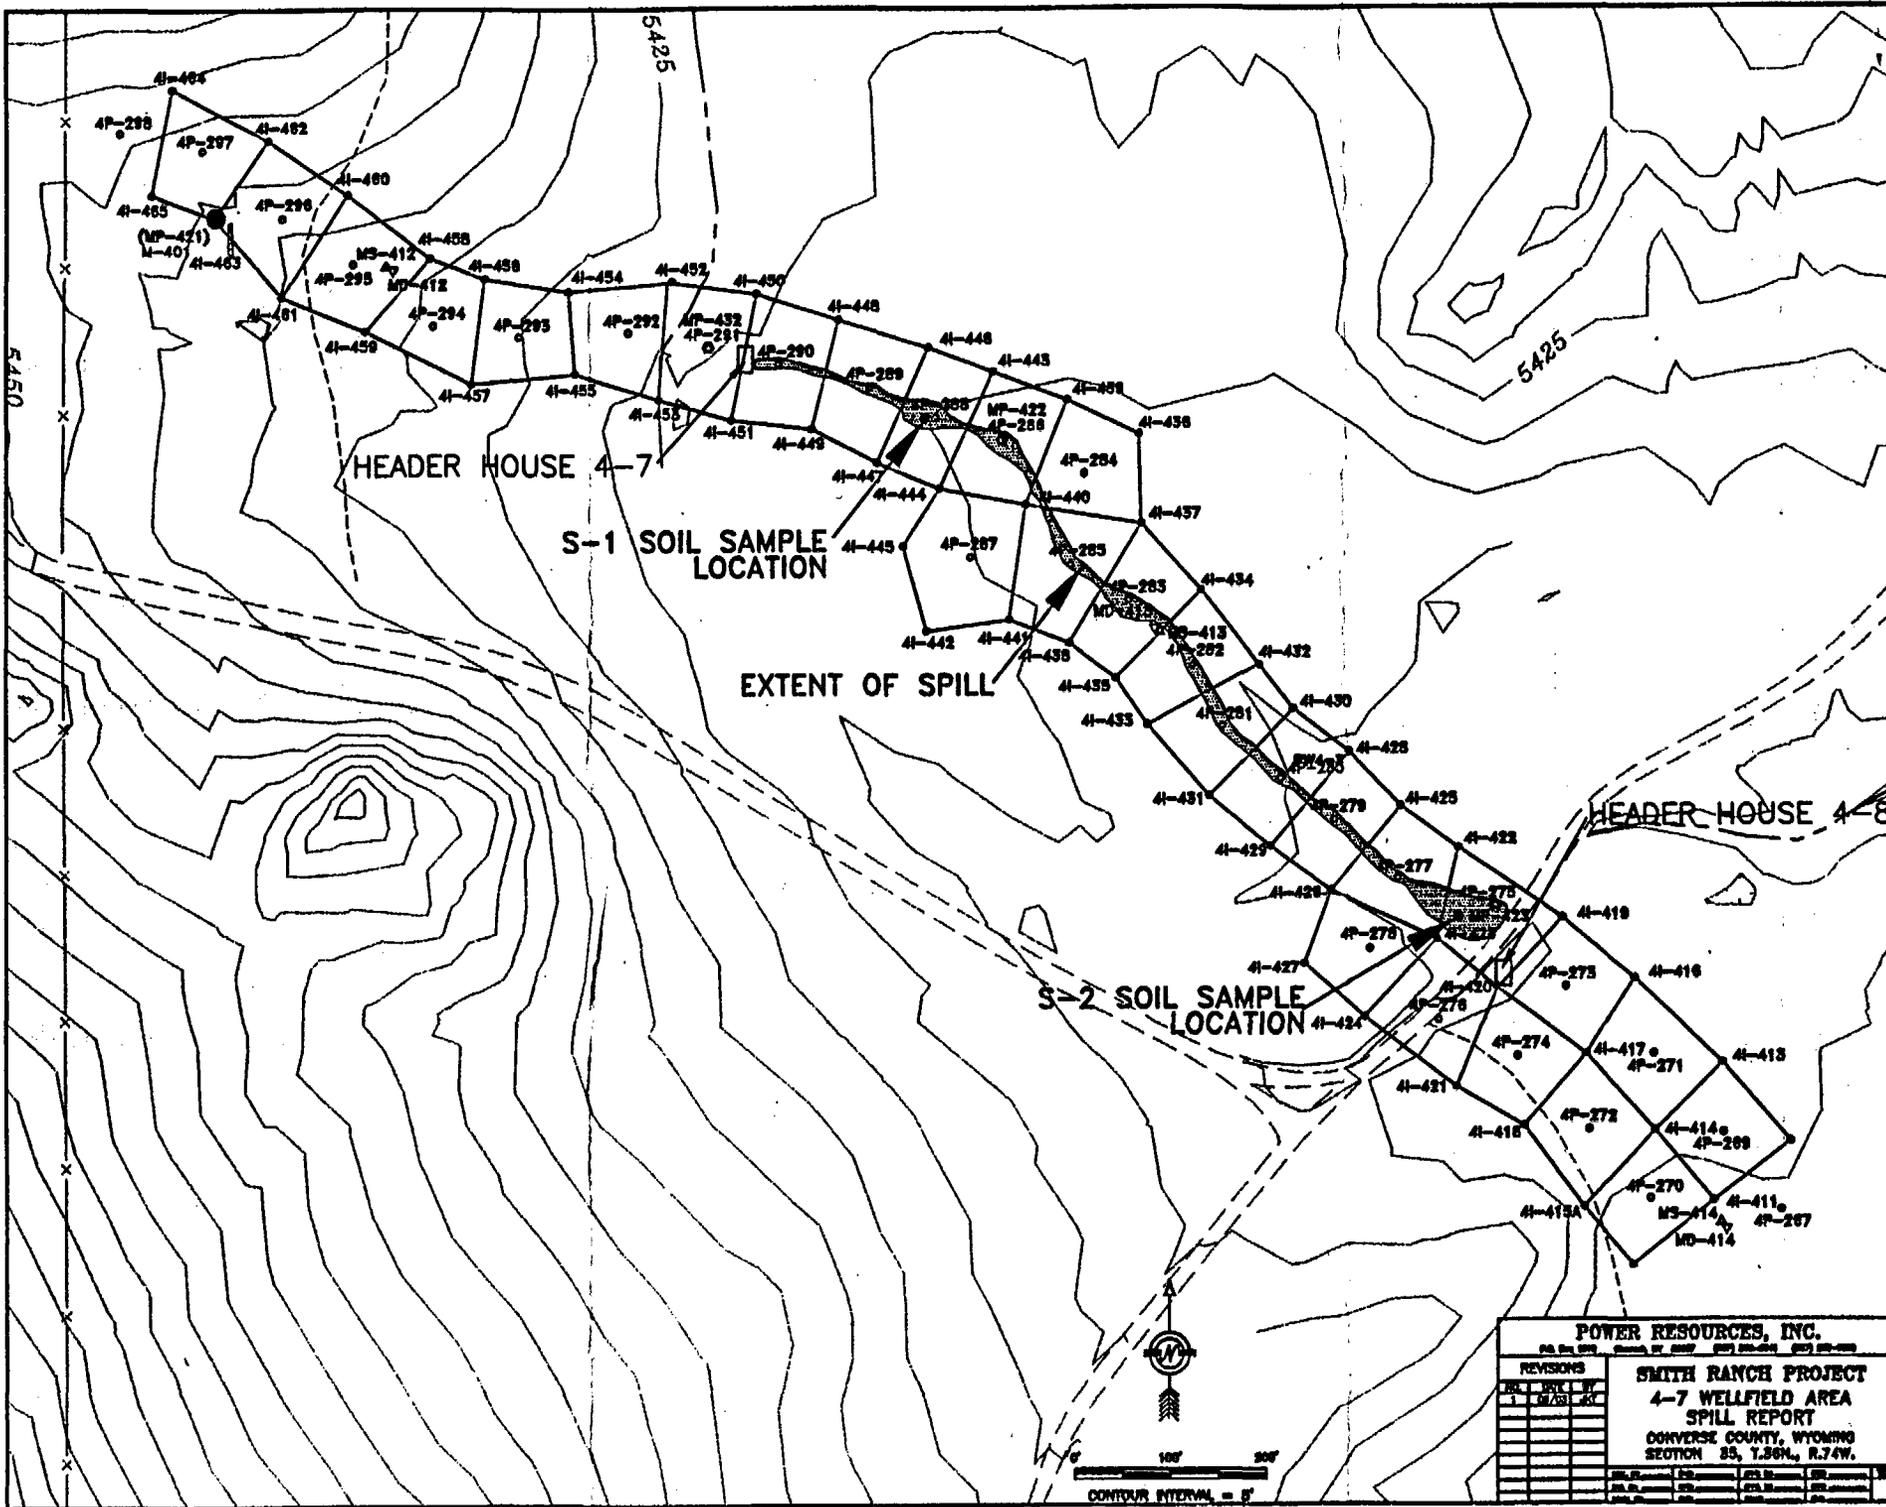
POWER RESOURCES, INC.	
2000 W. 10th Street, Cheyenne, WY 82001 (307) 233-2200	
REVISIONS	SMITH RANCH PROJECT
NO. 1	4-7 WELLFIELD AREA
DATE	SPILL REPORT
BY	CORVERSE COUNTY, WYOMING
	SECTION 35, T.36N., R.74W.
NO. 2	
DATE	
BY	
NO. 3	
DATE	
BY

The extent of the spill is shown on the attached map. Approximately 20,800 gallons of injection fluid was released. The injection fluid contained approximately 1.1 mg/L of natural uranium. The fluid did not enter any "Waters of the State". The release occurred in the NW¼, Section 35, T36N, R74W and affected approximately 0.25 acres. The fluid flowed down a wellfield road and soaked into the ground before any sampling or recovery activities could be initiated.

The entire area affected by the spill is contained within the fenced wellfield area. Two soil samples were obtained from the affected area to assess any impacts to soil (see attached map). The soil samples will be analyzed by Energy Labs Inc. of Casper, Wyoming for selenium, uranium, and radium-226. Depending on the results of the soil analyses, the need for any soil cleanup will be assessed. Nonetheless, the area will be reevaluated during decommissioning of the wellfield to ensure that applicable decommissioning standards for soil are not exceeded.
