RE: Permit to Mine 633  
 In Situ Uranium Wellfield Release Report

### POWER RESOURCES, INC. HIGHLAND URANIUM PROJECT URANIUM IN SITU WELLFIELD FLUID RELEASE REPORT

#### FAILURE OF 6-INCH PVC INJECTION PIPELINE IN HEADERHOUSE 4-7

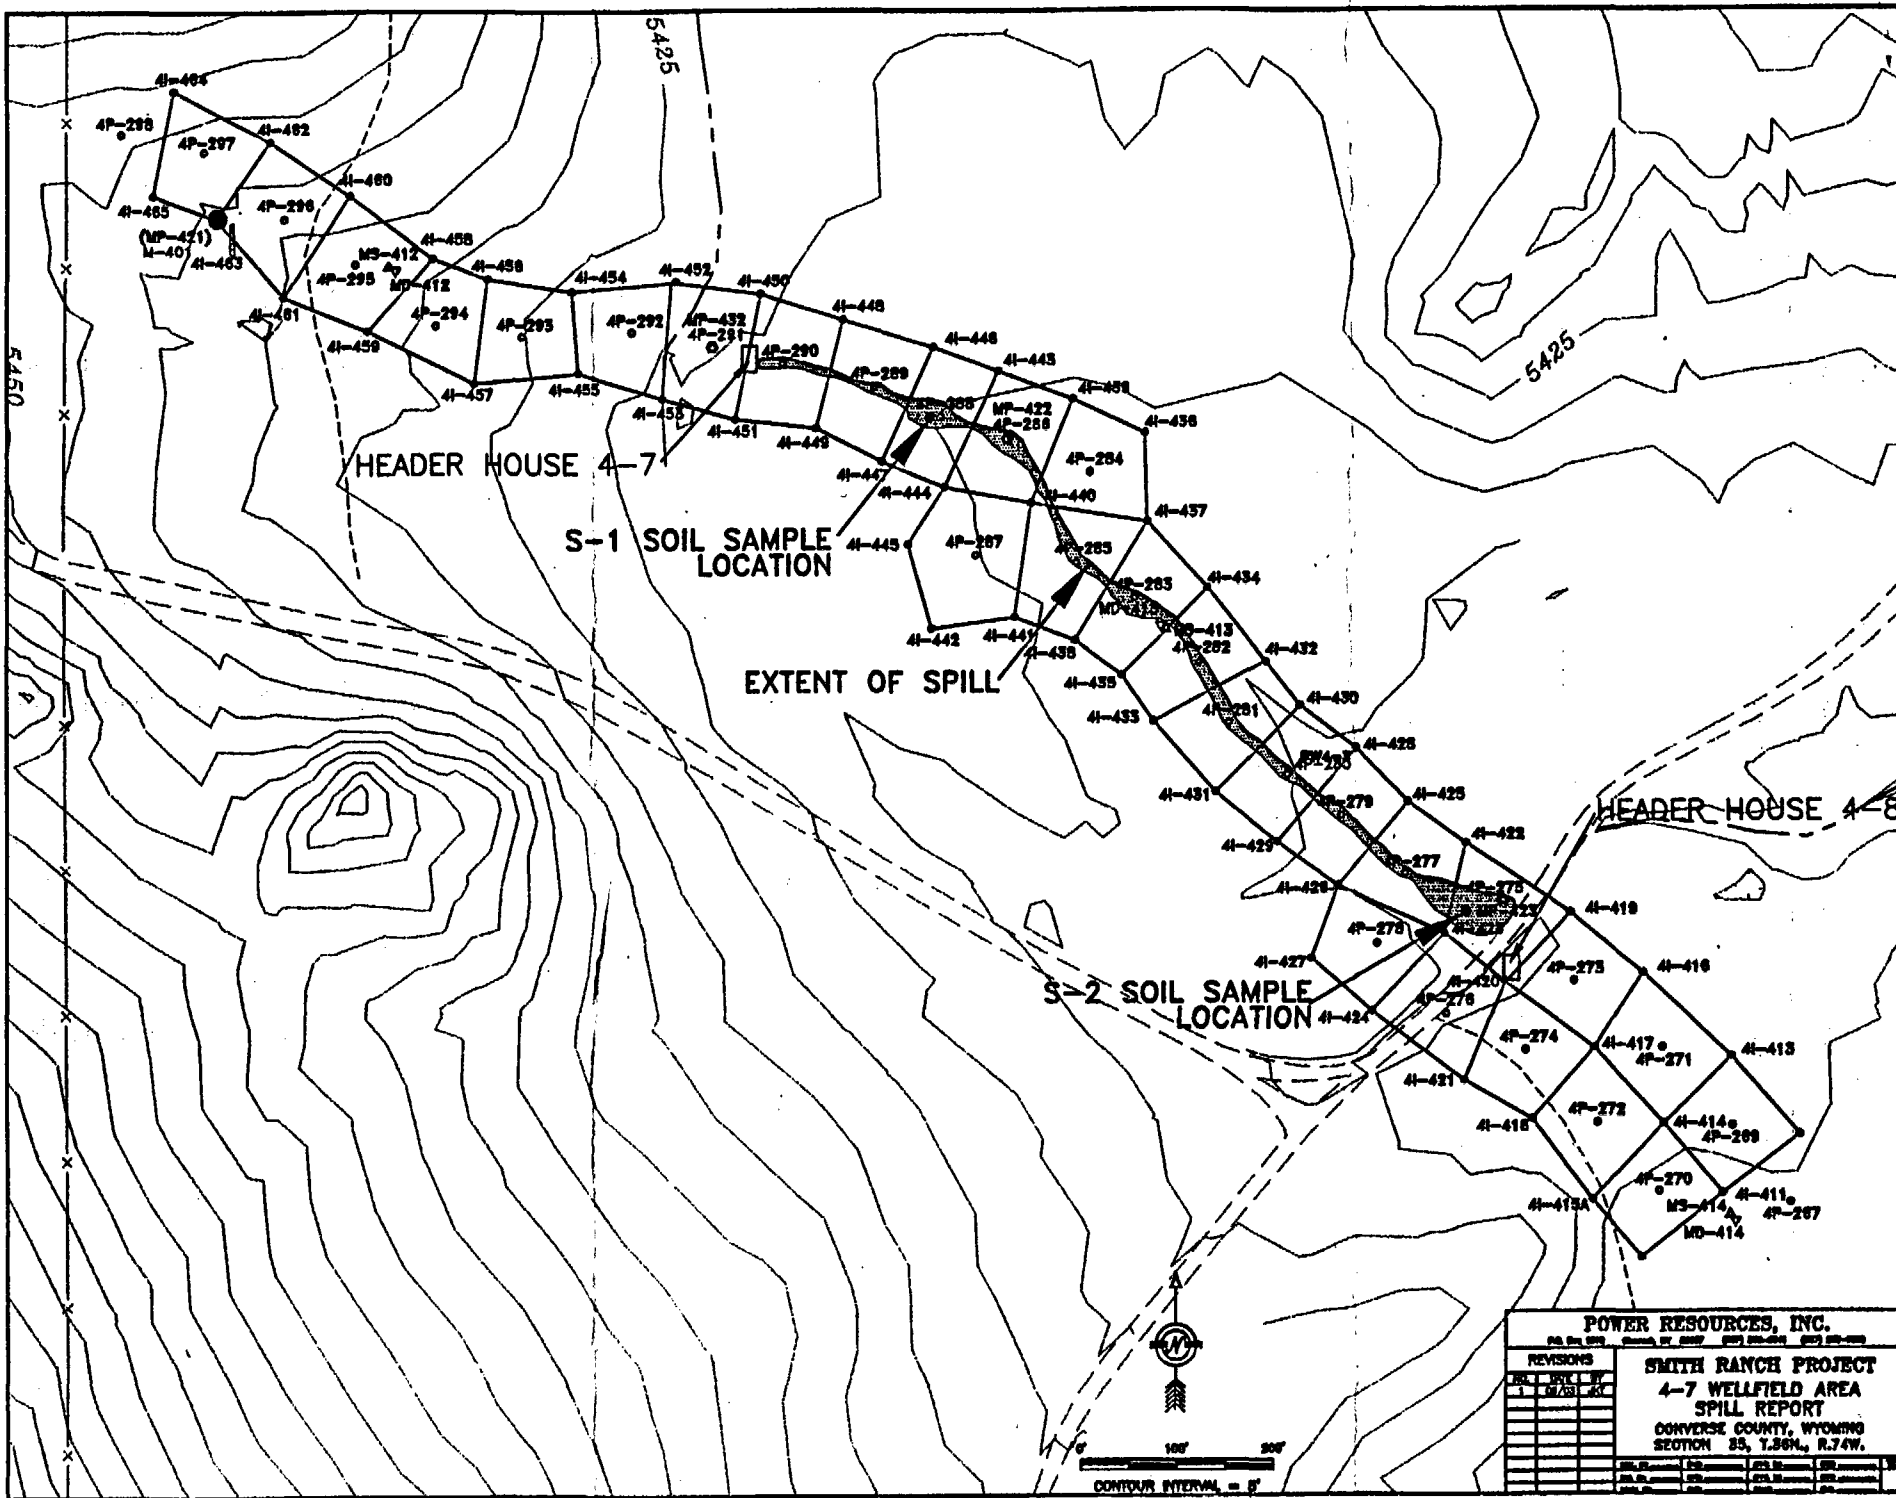
The extent of the spill is shown on the attached map. Approximately 20,800 gallons of injection fluid was released. The injection fluid contained approximately 1.1 mg/L of natural uranium. The fluid did not enter any "Waters of the State". The release occurred in the NW¼, Section 35, T36N, R74W and affected approximately 0.25 acres. The fluid flowed down a wellfield road and soaked into the ground before any sampling or recovery activities could be initiated.

The entire area affected by the spill is contained within the fenced wellfield area. Two soil samples were obtained from the affected area to assess any impacts to soil (see attached map). The soil samples will be analyzed by Energy Labs Inc. of Casper, Wyoming for selenium, uranium, and radium-226. Depending on the results of the soil analyses, the need for any soil cleanup will be assessed. Nonetheless, the area will be reevaluated during decommissioning of the wellfield to ensure that applicable decommissioning standards for soil are not exceeded.
