Palo Verde Nuclear  
Generating Station

**Subject: Palo Verde Nuclear Generating Station (PVNGS)  
Unit 2  
Docket No. STN 50-529  
Special Report 2-SR-2003-001  
Report of Boron Deposit at Control Element Drive Mechanism  
Vent**

**Attachment**  
**Palo Verde Nuclear Generating Station Unit 2**  
**Special Report No. 2-SR-2003-001**  
**Boron Deposit Found at Control Element Drive Mechanism Vent**  
**Docket No. STN 50-529**

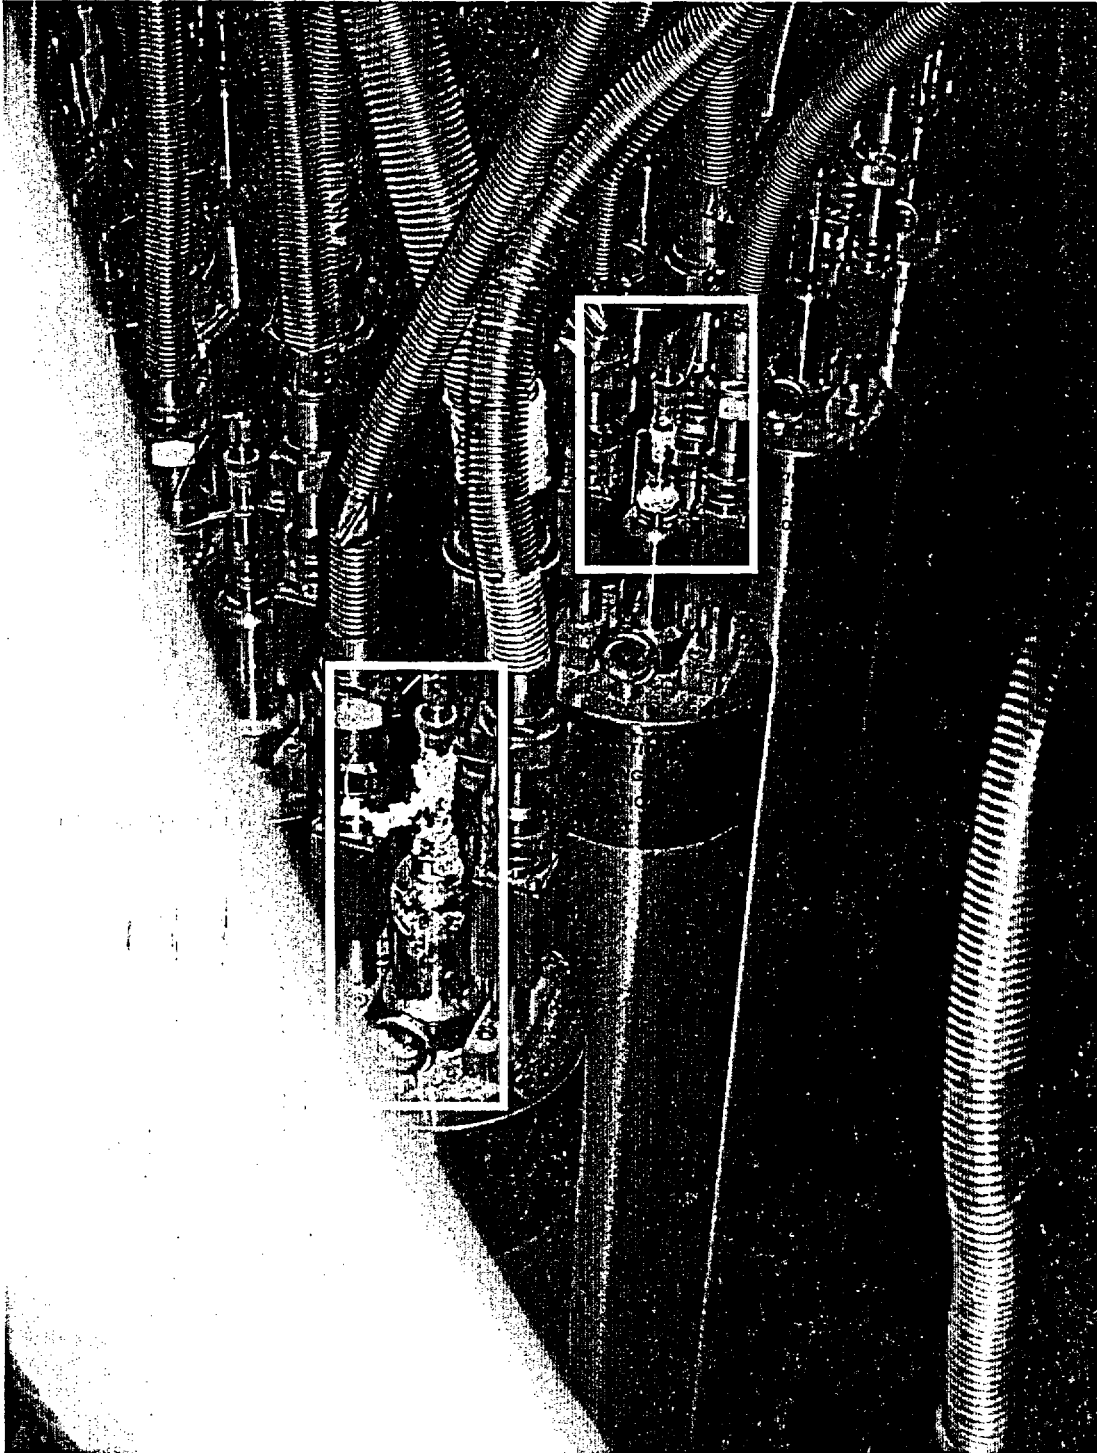
**Palo Verde Nuclear Generating Station Unit 2  
Special Report No. 2-SR-2003-001  
Boron Deposit Found at Control Element Drive Mechanism Vents 7 & 8  
Docket No. STN 50-529  
(As-Found / As-Left Condition)**

During boric acid walk-downs on July 30, 2003, three Unit 2 boric acid residue sites were identified above the RPV head. The sites were located on the Versa-Vents for control element drive mechanisms (CEDM) nos. 7, 8, and 85. These sites exhibited no evidence of being active leaks and the boric acid residue did not contact the RPV head or related insulation. The source of the boric acid residue was most likely the vent ball / seating surface interface of the Versa-Vent.

Versa-Vents 7 & 8 will be cleaned and reworked during the next refueling outage (reference Work Order nos.: 2630537, 2630539). Versa-Vent 85 was cleaned and will be reworked during the next refueling outage (reference Work Order no.: 2630543). The next Unit 2 refueling outage is scheduled to begin September 27, 2003.
