Subject: LER-2003-002-00 [Automatic Reactor Scram (#107) Due To
A Partial Loss of Offsite Power]

Grand Gulf Nuclear Station
Docket No. 50-416
License No. NPF-29

GNRO-2003/00038

4. Title: Reactor Scram Due to a Partial Loss of Offsite Power

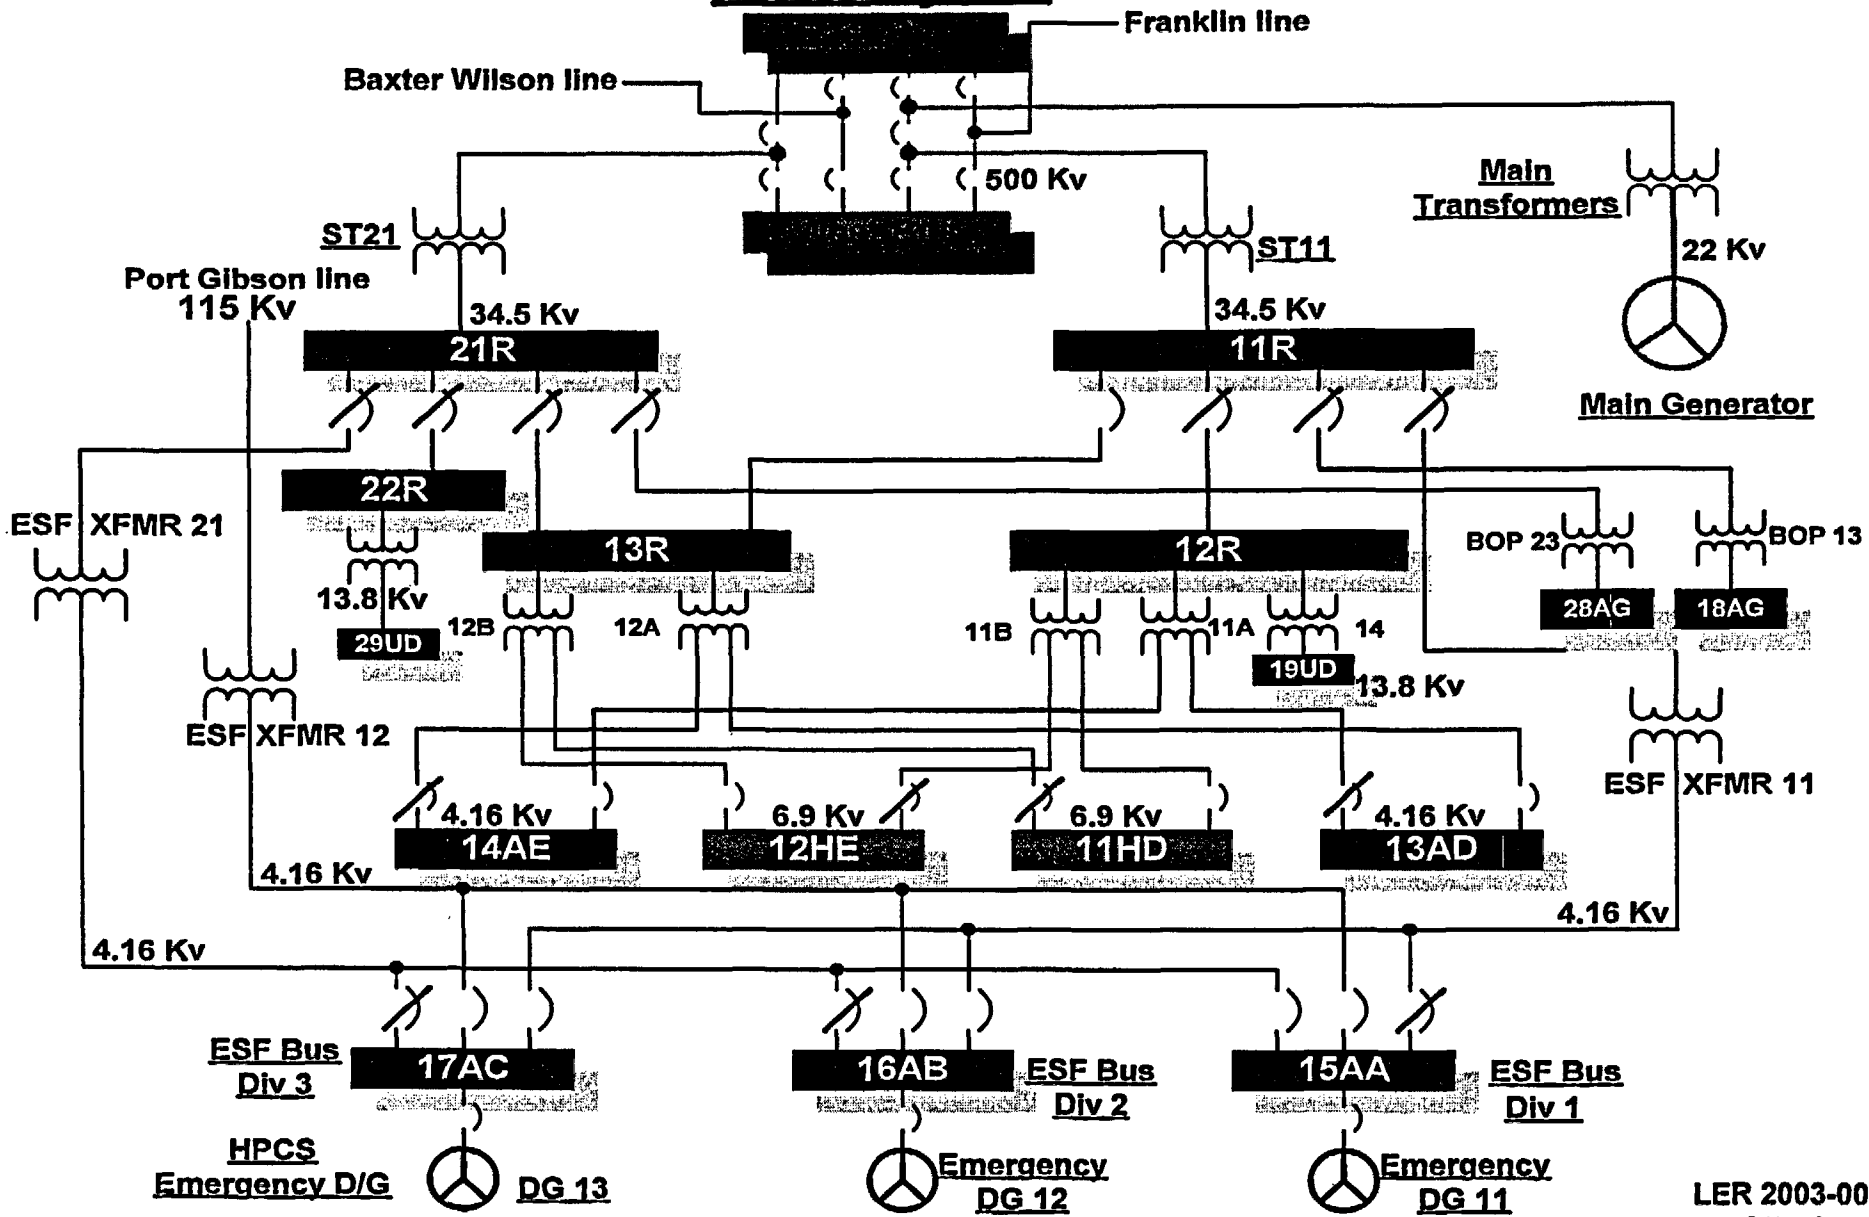
Grand Gulf Nuclear Station Distribution Switchyard

GGNS Reactor Scram 107 occurred at approximately 0948 CDST on 4/24/2003 due to a fault in the 500KV switchyard and a partial loss of offsite power. The partial loss of offsite power resulted from Disconnect J5205 closure sending 500KV to ground through the grounding straps installed for breaker maintenance. This caused the loss of the West 500KV Bus, Service Transformer 21 (ST21) [FK] lockout, and subsequent loss of both 500KV lines. A turbine trip on load reject occurred, resulting in a reactor scram on turbine control valve (TCV) [JI] fast closure.
