Davis-Besse Reactor Vessel Head Damage NRC UPDATE

October 2003

This is the fourteenth periodic update on the NRC response to the reactor vessel head damage at the Davis-Besse Nuclear Power Station. The updates will be available at public meetings of the NRC Davis-Besse Oversight Panel which is coordinating the agency's activities related to the damage. Each update will include background information to assist the reader in understanding issues associated with the corrosion damage.

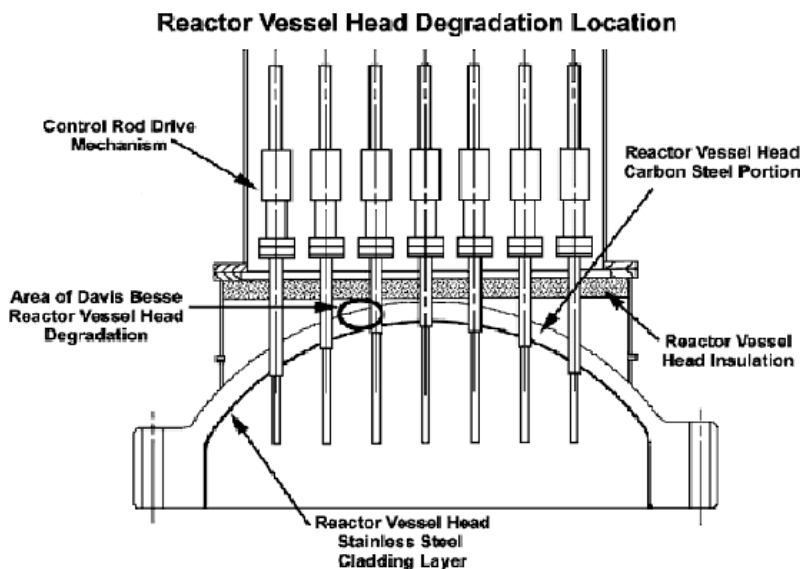
Corrosion, caused by the boric acid, damaged the vessel head next to Nozzle No. 3, creating an irregular cavity about 4 inches by 5 inches and approximately 6 inches deep. The cavity penetrated the carbon steel portion of the vessel head, leaving only the stainless steel lining. The liner thickness varies somewhat with a minimum

design thickness of 1/8 inch. Subsequent examination by Framatome, FirstEnergy's contractor, found evidence of a series of cracks in the liner, none of which was entirely through the liner wall.
