Subject: Inspection of Embedded Flaw Repair of a J-groove Weld

WDF-TJ-013-03 Rev. 1

NDE Process for CRDM Embedded Flaw Repairs

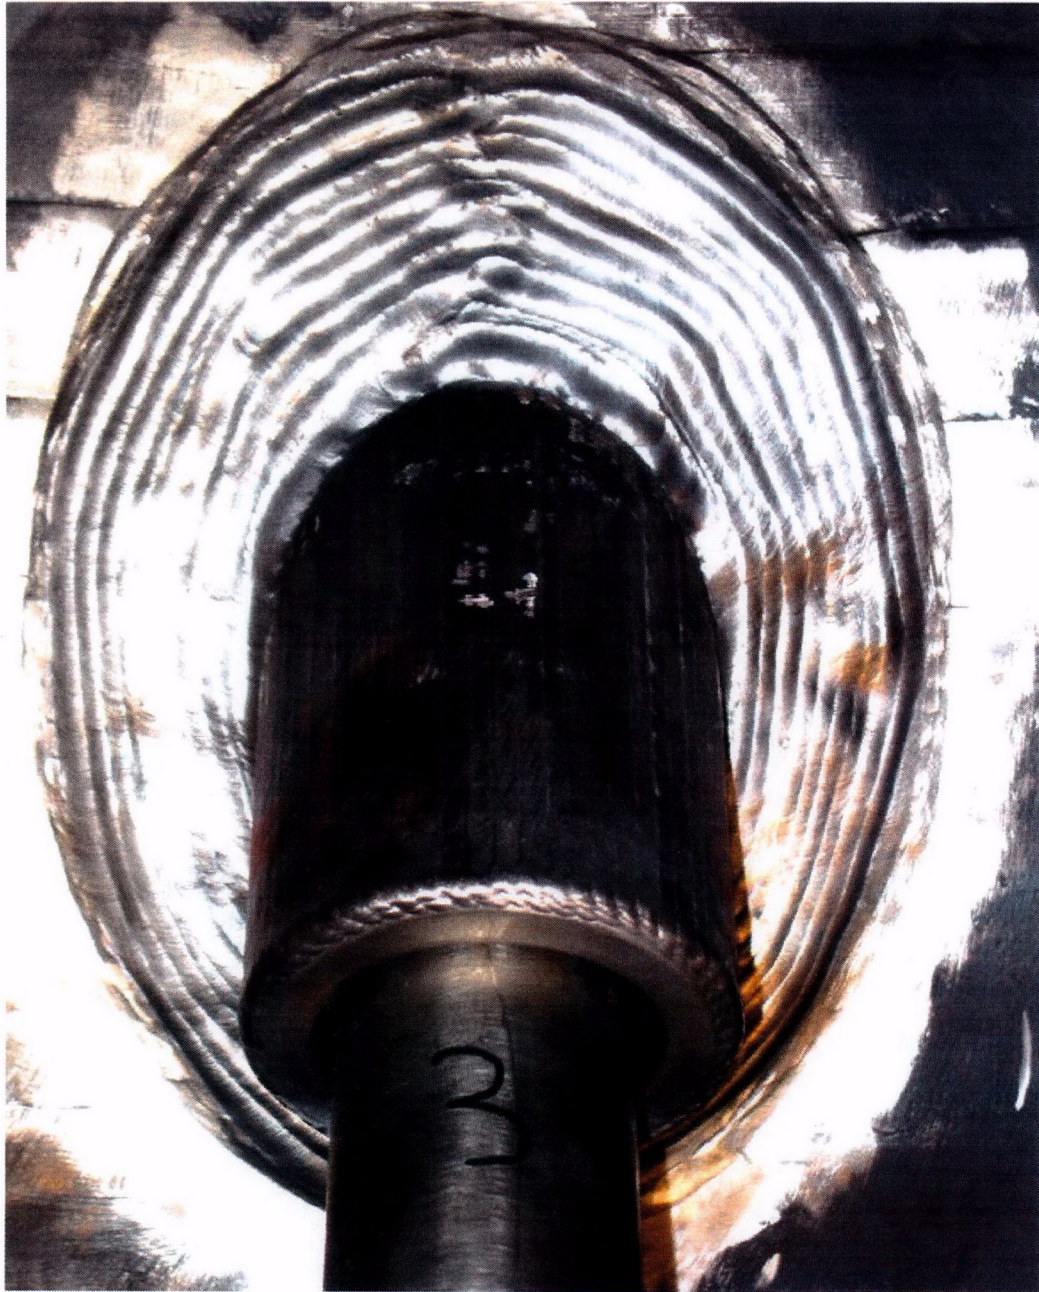
Figures 1 and 2 show the typical resultant surface condition obtained from the automated welding process of the embedded flaw repair. These photographs are from practice repair overlays that were performed on a spare reactor vessel head (Jamesport vessel) located in the Westinghouse Waltz Mill facility. They show the overlay repair as applied over the J-groove weld and over a part of the adjacent penetration nozzle OD surface.

The surface is very rough and it consists of a series of 'hills and valleys'. Machining to eliminate the surface roughness has been considered impractical given the dose rates under the head, the access restrictions, the time constraints, and the irregular geometry about the penetration nozzle. This roughness, however, does not impair the primary role of the weld repair, which is to isolate any cracks from the environment.

Figure 1: Weld Overlay Repair on J-Groove Weld and Nozzle OD in the Jamesport Head Depicting the Rough As Welded Surface Condition over the J-Groove Weld

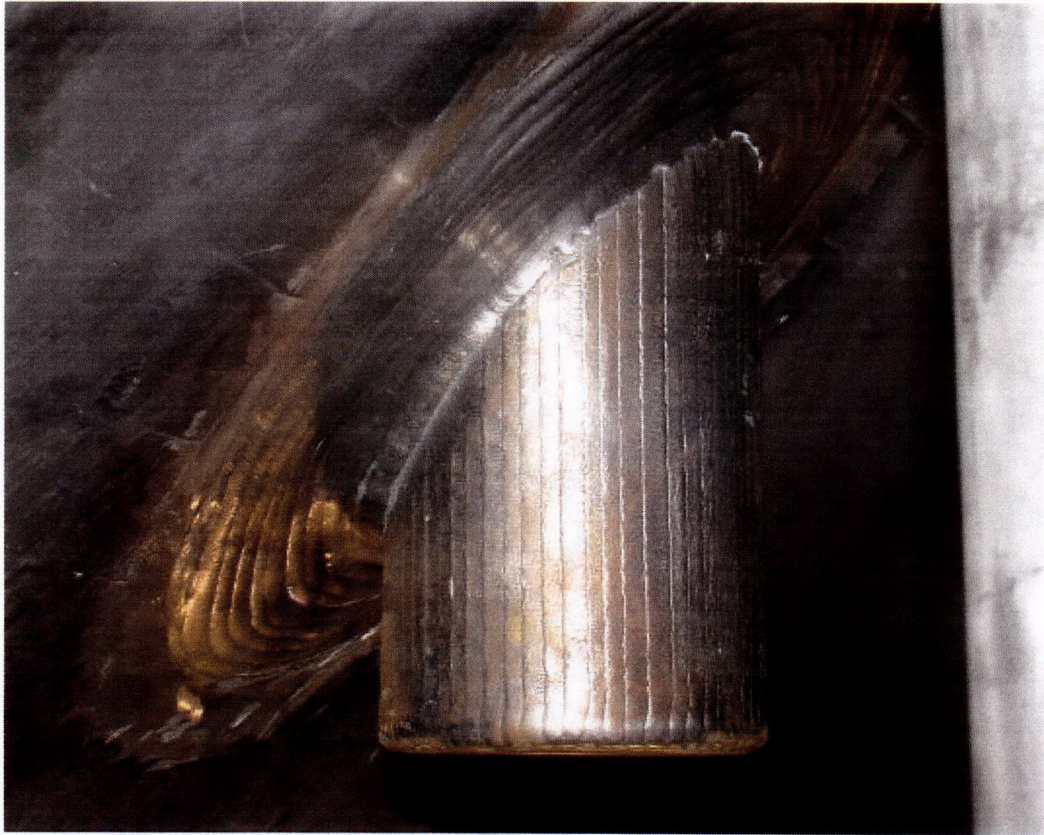
Figure 2: Weld Overlay Repair on another J-Groove Weld and Nozzle OD in the Jamesport Head Depicting the Rough As Welded Surface Condition over the J Groove Weld

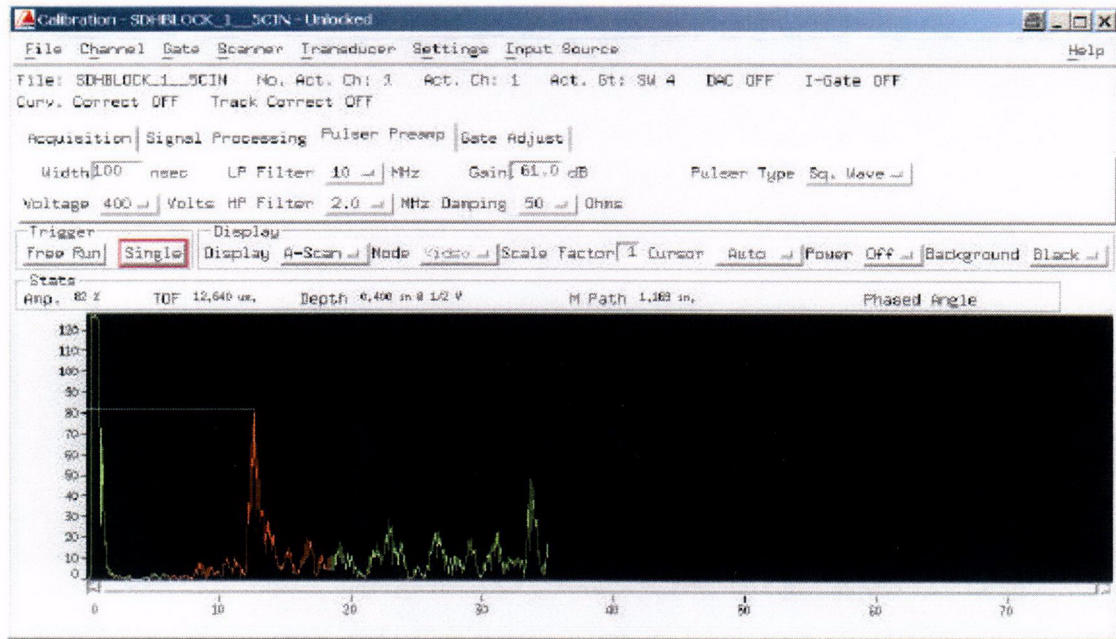
For the investigation on the weld overlays, the UT system was calibrated using a 1/32" diameter side-drilled hole at 0.4" below the surface in a smooth-surfaced IIW block. This reflector is at approximately 25% of the J-groove weld thickness; the calibrated A-scan display is shown in Figure 3 with the side-drilled response at 82% FSH. The signal-to-noise ratio is about 9:1. The probe was then manipulated manually on various J-groove weld surfaces in the Jamesport head using a scanning sensitivity +6dB above the calibration gain.

Figure 3: Calibration Response for the 2.25 MHz, Dual Element 70-degree Refracted Longitudinal Wave Transducer (1/32" diameter side drilled hole set to 82% FSH response)

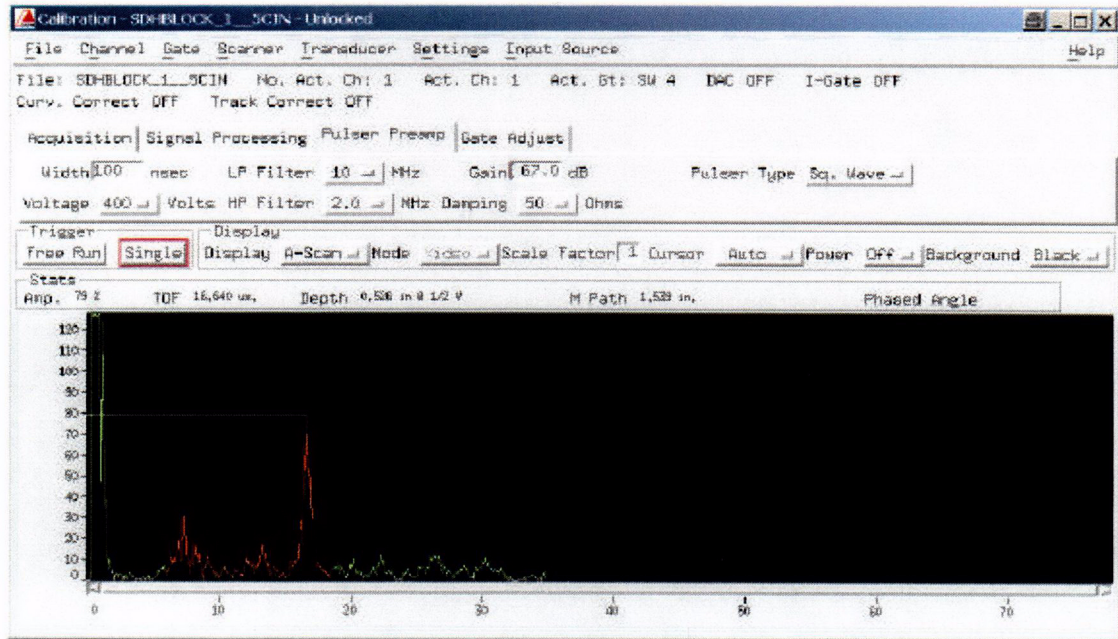
Figure 4 shows results from a non-repaired J-groove weld inspection which indicates the presence of a distinct 79% response that would be comparable to a 40% response at the calibration gain (note that the instrument gain is at +6 dB above the calibration gain). This signal could be associated with metallurgical reflector or a weld discontinuity. Such signals are to be expected in the coarse dendritic grain structure of the weld and from welds that were inspected in fabrication using ASME Code Section III criteria (PT at defined intervals). If the region were examined after the weld overlay repair and such a signal was observed it may have to be incorrectly interpreted as emanating from PWSCC or a flaw initiated as a result of the repair process. This misinterpretation would result in unnecessary repairs (which could only be done manually) and an increased dose exposure to repair personnel.

Figure 4: Axial Scan Results from a Non-Repaired J-Groove Weld Depicting Distinct Reflector in the Weld (79% FSH response, approx. 40% FSH response at calibration gain)

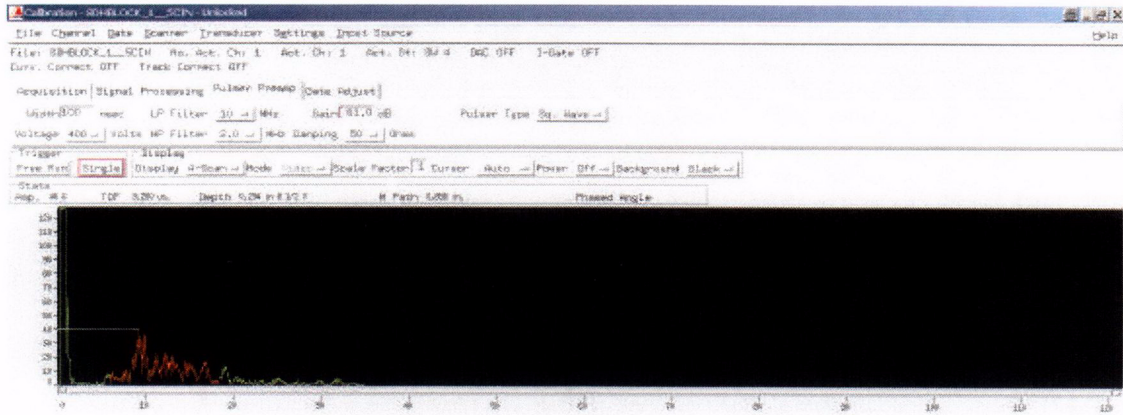
Figures 5 and 6 depict representative results from scans (axial and circumferential, respectively) on overlay repairs covering the J-groove weld. In these examples, the noise associated with the rough surface ranges from 40% to 63% at the calibration gain level. Such responses could mask signals from planar flaws.

Figure 5: Axial Scan on a Weld Overlay Surface Depicting the High Noise Background from the Irregular Surface (background noise from the irregular coupling surface is nominally 50% of the calibration response)

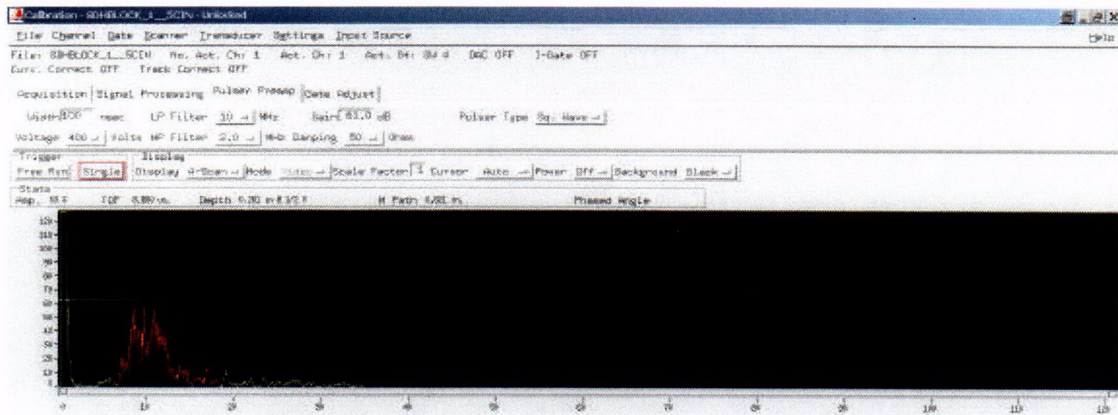
Figure 6: Circumferential Scan On a Weld Overlay Surface Depicting High Noise Level from the Irregular Surface (background noise from the irregular coupling surface exceeds 50% of calibration response)

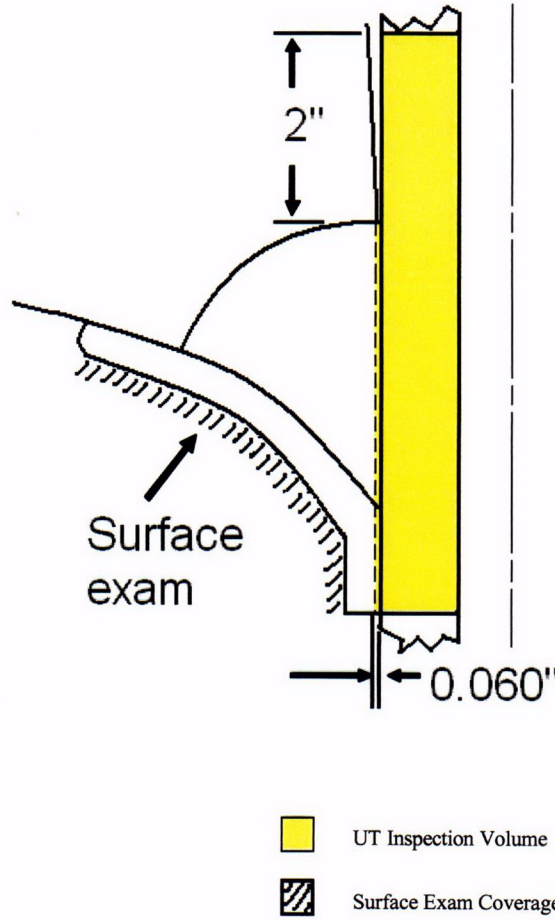
Figure 7: NDE Examinations and Coverage Associated with the J-Groove Weld and Adjacent Penetration Outside Diameter Surface Embedded Flaw Repair

Given these limitations to the use of ultrasonic inspection techniques on the weld overlay surface, the following nondestructive test methods are to be implemented for the embedded flaw repair on J-groove welds (Figure 7):

- Surface examination (PT) of the weld overlay surface consistent with ASME Code requirements.
- Ultrasonic examination (UT) from the penetration nozzle inside diameter surface using techniques demonstrated to the MRP. Such techniques would examine the volume of the penetration plus 0.06" inside the J-groove weld adjacent to the penetration for flaw growth and leak paths.

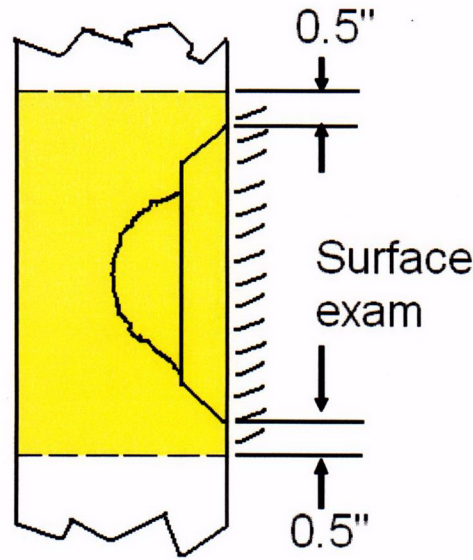
The inspection coverage for the penetration ID and OD surface embedded flaw weld repairs is shown in Figure 8.

Figure 8: NDE Examinations and Coverage Associated with Penetration Inside Diameter Surface and Penetration Outside Diameter Surface Embedded Flaw Repair (surface examination is PT for OD repair and ET for ID repair)
