Palo Verde Nuclear
Generating Station

**Subject: Palo Verde Nuclear Generating Station (PVNGS)
Unit 3
Docket No. STN 50-530
Special Report 3-SR-2003-004
Report of Boron Deposit at Control Element Drive Mechanism
Vents**

Attachment
Palo Verde Nuclear Generating Station Unit 3
Special Report No. 3-SR-2003-004
Boron Deposit Found at Control Element Drive Mechanism Vent
Docket No. STN 50-530

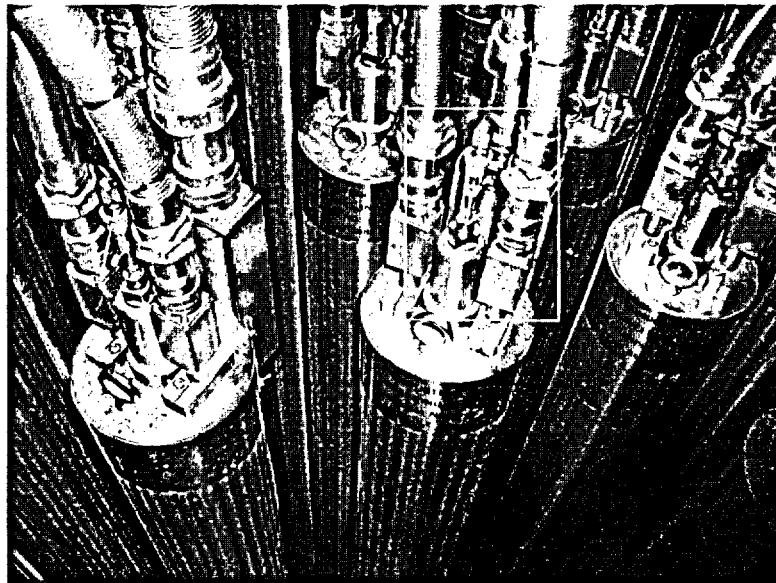
(CEDM Vent 73 As-Left Condition)

Versa-Vents for CEDMs 51 and 73 were cleaned and reworked during the outage following the Unit 3 trip.

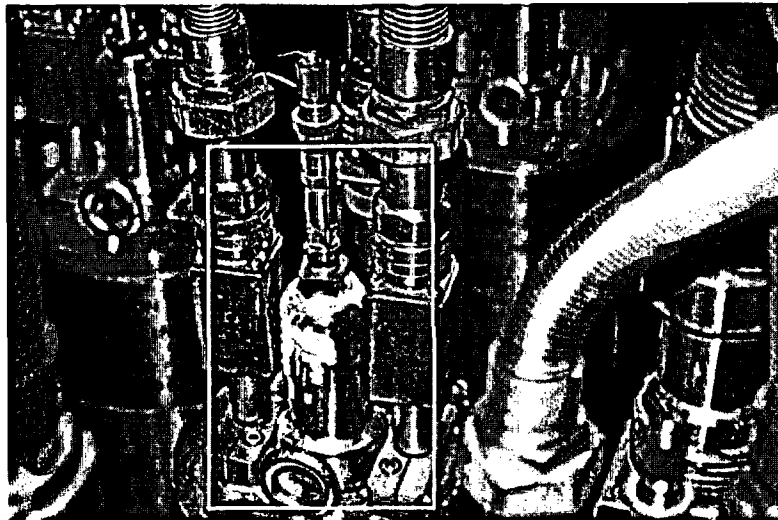
During boric acid walk-downs on July 29, 2003, two Unit 3 boric acid residue sites were identified above the RPV head. The sites were located on the Versa-Vents for control element drive mechanisms (CEDM) nos. 51 and 73. These sites exhibited no evidence of being active leaks and the boric acid residue did not contact the RPV head or related insulation. The source of the boric acid residue was most likely the vent ball / seating surface interface of the Versa-Vents.

(CEDM Vent 51 As-Found Condition)

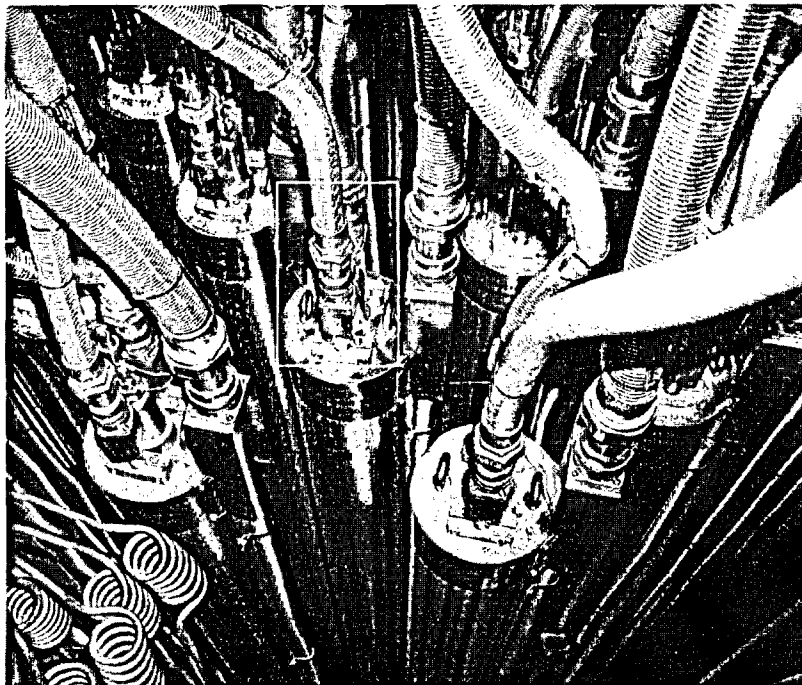
(CEDM Vent 51 As-Left Condition)
