Palo Verde Nuclear
Generating Station

**Subject: Palo Verde Nuclear Generating Station (PVNGS)
Unit 3
Docket No. STN 50-530
Special Report 3-SR-2003-004
Report of Boron Deposit at Control Element Drive Mechanism
Vents**

**Attachment
Palo Verde Nuclear Generating Station Unit 3
Special Report No. 3-SR-2003-004
Boron Deposit Found at Control Element Drive Mechanism Vent
Docket No. STN 50-530**

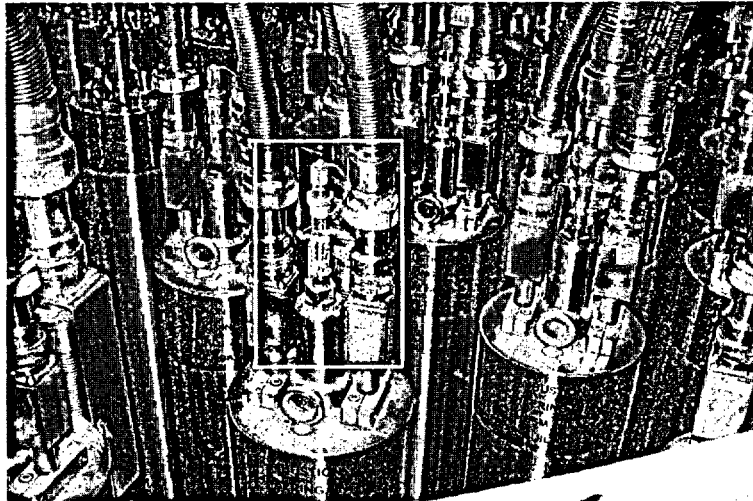
(CEDM Vent 73 As-Found Condition)

During boric acid walk-downs on July 29, 2003, two Unit 3 boric acid residue sites were identified above the RPV head. The sites were located on the Versa-Vents for control element drive mechanisms (CEDM) nos. 51 and 73. These sites exhibited no evidence of being active leaks and the boric acid residue did not contact the RPV head or related insulation. The source of the boric acid residue was most likely the vent ball / seating surface interface of the Versa-Vents.
