**Pacific Gas and
Electric Company**

PG&E Letter DCL-03-125

Docket No. 50-275, OL-DPR-80
Docket No. 50-323, OL-DPR-82
Diablo Canyon Units 1 and 2
Licensee Event Report 2-2003-007-01
Technical Specification 3.8.4 Violation Due To Common Mode Battery
Charger Failures

TITLE (4)
Technical Specification 3.8.4 Violation Due To Common Mode Battery Charger Failures

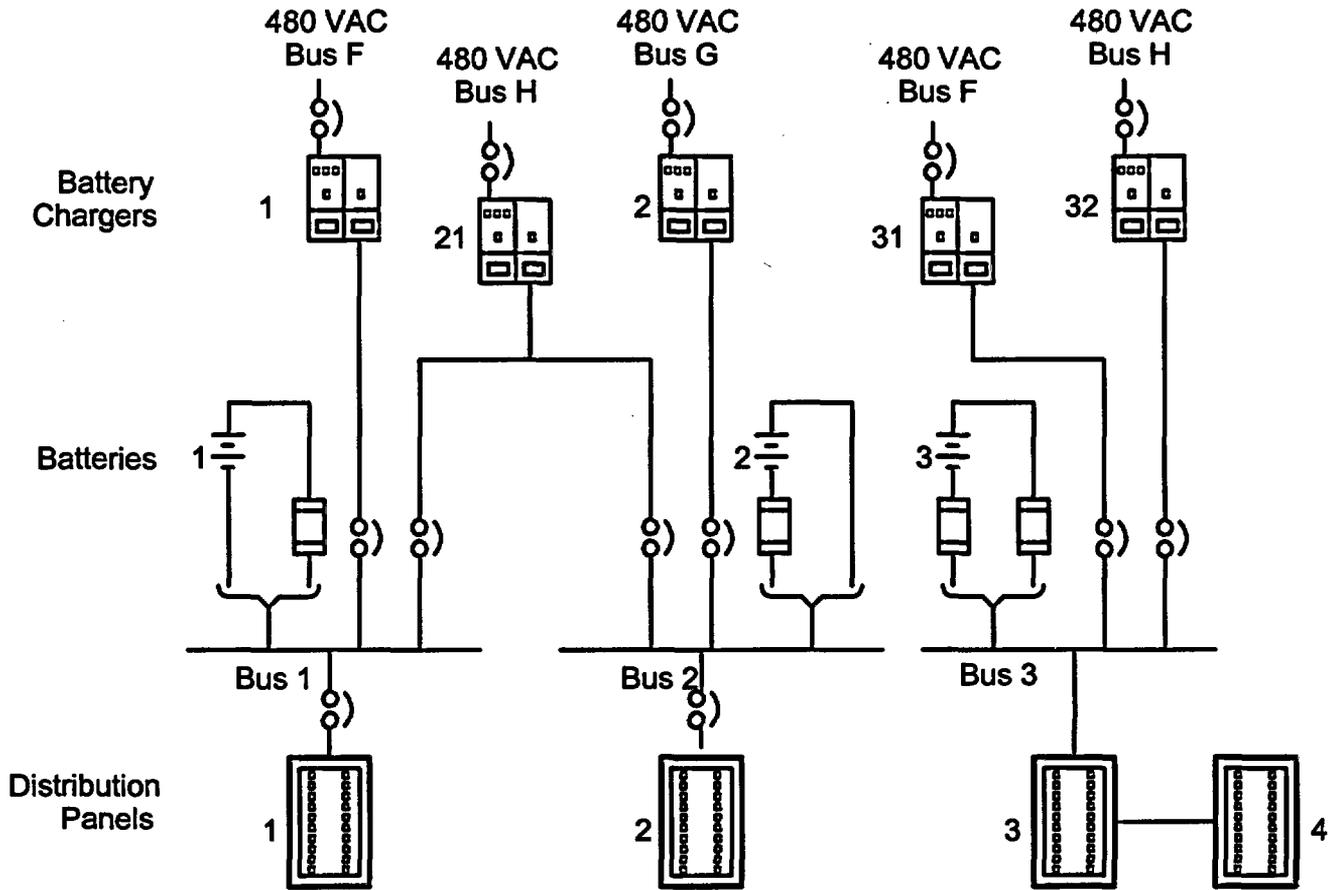
Figure 1 – Single Line Diagram of the 125 Volt DC Vital Power Supply System

Each Diablo Canyon Power Plant (DCPP) Unit has three 60-cell, 125 Volt DC (VDC) vital batteries and 5 full capacity battery chargers (BTCs)[BYC]. Each of the three vital 125 VDC busses has a dedicated battery and charger. The design of the vital 125 VDC system is such that a battery may be supplied by two full capacity chargers: one supplied from its associated 480 volt alternating current (480 VAC) vital bus, or an alternate charger supplied by another 480 VAC vital bus. The first additional charger can be switched to either of two of the batteries. The second charger is a dedicated backup charger for the third vital battery. See Figure 1 – “Single Line Diagram of the 125 Volt DC Vital Power Supply System.”
