**TENNESSEE VALLEY AUTHORITY - BROWNS FERRY NUCLEAR PLANT (BFN) -  
UNIT 2 - DOCKET 50-260 - FACILITY OPERATING LICENSE DPR - 52 -  
LICENSEE EVENT REPORT (LER) 50-260/2003-005-00**

| <b>4. TITLE</b><br>Unplanned Start of DG A and DG B from Momentary Board Undervoltage | | | | | | | | | | | |

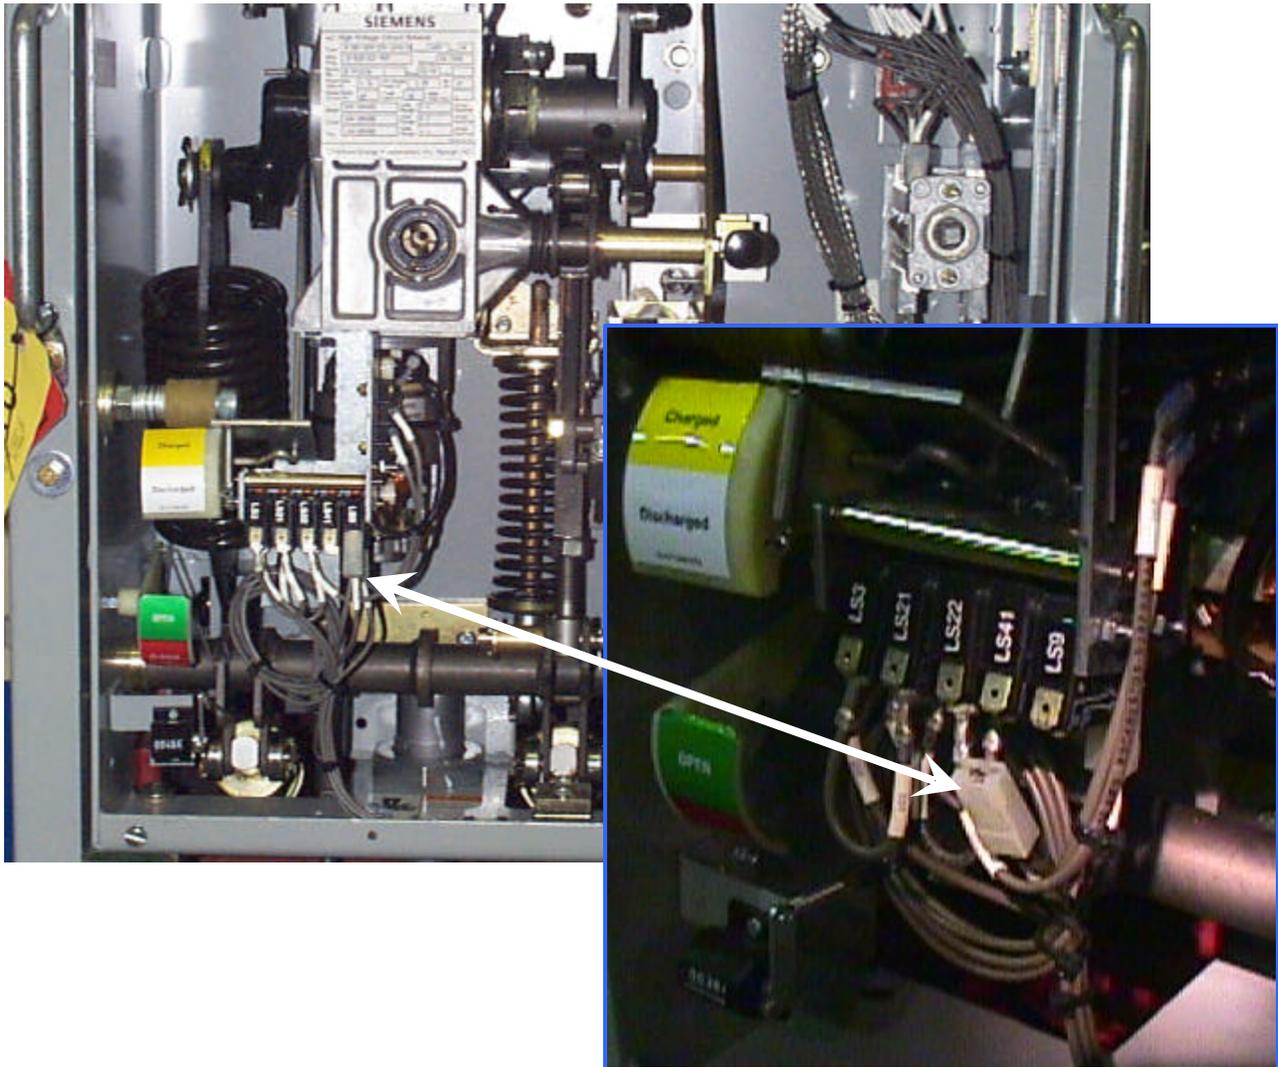
1. The connection at switch 52 SMLS, LS-9, internal to breaker 1622 came loose. This breaker is a Siemens model 5-3AF.

Post-event troubleshooting identified that a connector internal to breaker 1622 had come off its termination point (see section VII.A below for additional details on this component). On these type Siemens breakers, the amber light on the breaker front panel is used to indicate that the breaker closing spring is properly charged, but this open connection in the breaker internal electrical circuitry prevented it from illuminating. The extinguished amber light on breaker 1622 had been identified by plant staff, and an open work document existed to address it. It had not been recognized, however, that this same open connection also prevented current flow through the breaker closing coil, thus preventing closure of the breaker.

Shutdown Bus 1 alternate supply breaker 1622 is a Siemens model 5-3AF. In the larger picture below, a Siemens breaker identical to 1622 is shown. The inset picture shows the as-found condition of breaker 1622 when it was inspected following this event. The white arrow points to the example of the properly connected lug in the larger picture and to the same lug, found disconnected from LS-9, on breaker 1622 during post-event troubleshooting. Breaker 1622 was initially placed in service at BFN in March 1999.

1. The vendor has been notified of the condition and will be consulted for possible actions to be taken to improve the reliability of the SMLS terminal connections.
2. All plant 4 kV boards were walked down to verify that the amber light was illuminated on all breakers racked into the connect position.
3. Applicable Operations and Electrical Maintenance procedures and training materials will be revised to address the relationship between the amber light circuit current path and the breaker closing coil circuit current path.
