W3F1-2003-0083

Subject: Waterford 3 SES  
Docket No. 50-382  
License No. NPF-38  
Reporting of Licensee Event Report (LER 2003-001-00)

1. FACILITY NAME: **Waterford Steam Electric Station, Unit 3**

4. TITLE: **Loose Breaker Fuse Rendered One Bank of Pressurizer Proportional Heaters Inoperable**

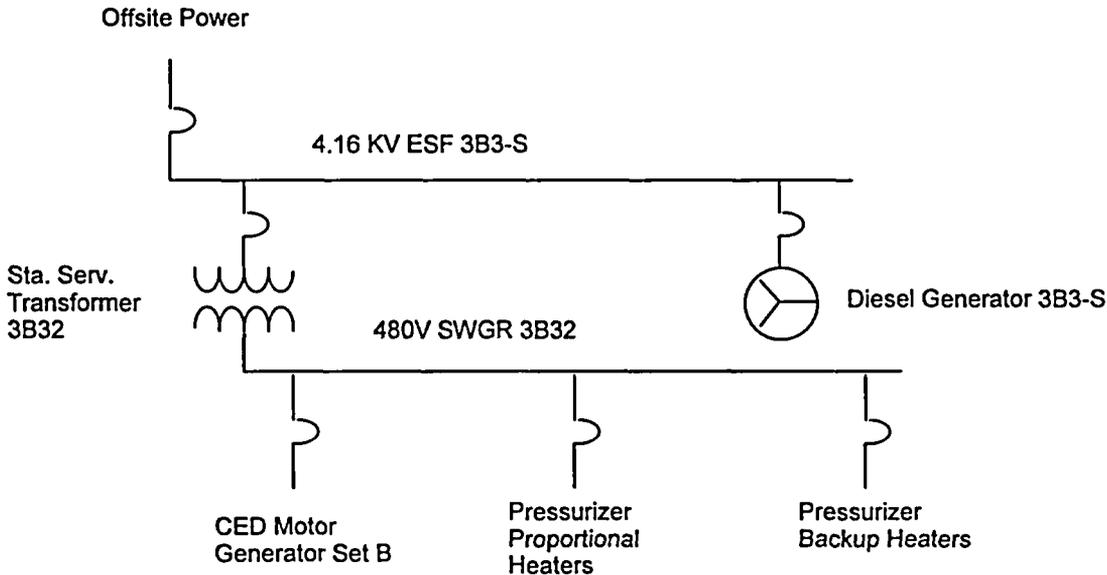
The pressurizer heater power supply design provides the capability to supply, from either the offsite power source or the emergency power source (when offsite power is not available), two groups of pressurizer proportional heaters and associated controls necessary to establish and maintain natural circulation at hot standby conditions. The two groups of proportional heaters, along with other loads, are powered from the 480 volt non-safety switchgear buses 3A32 and 3B32 [EC]. These non-safety related buses are fed from the Class 1E buses [ED] protected by safety grade circuit breakers [BKR]. Upon loss of offsite power, the safety related Class 1E feeder breakers providing power to these buses will trip. The Class 1E feeder breakers reclose on the diesel generator sequencer [JE] after 0.5 seconds as long as no Safety Injection Actuation Signal (SIAS) is present and all of the load breakers on the 3A32 or 3B32 bus are open. The diagram below shows the power supply arrangement:
