Crystal River Nuclear Plant  
Docket No. 50-302  
Operating License No. DPR-72

Subject: Crystal River Unit 3 - Special Report 03-01: Once Through Steam Generator (OTSG) Notifications Required Prior to MODE 4

**Special Report 03-01  
Once Through Steam Generator Notifications Required Prior to MODE 4**

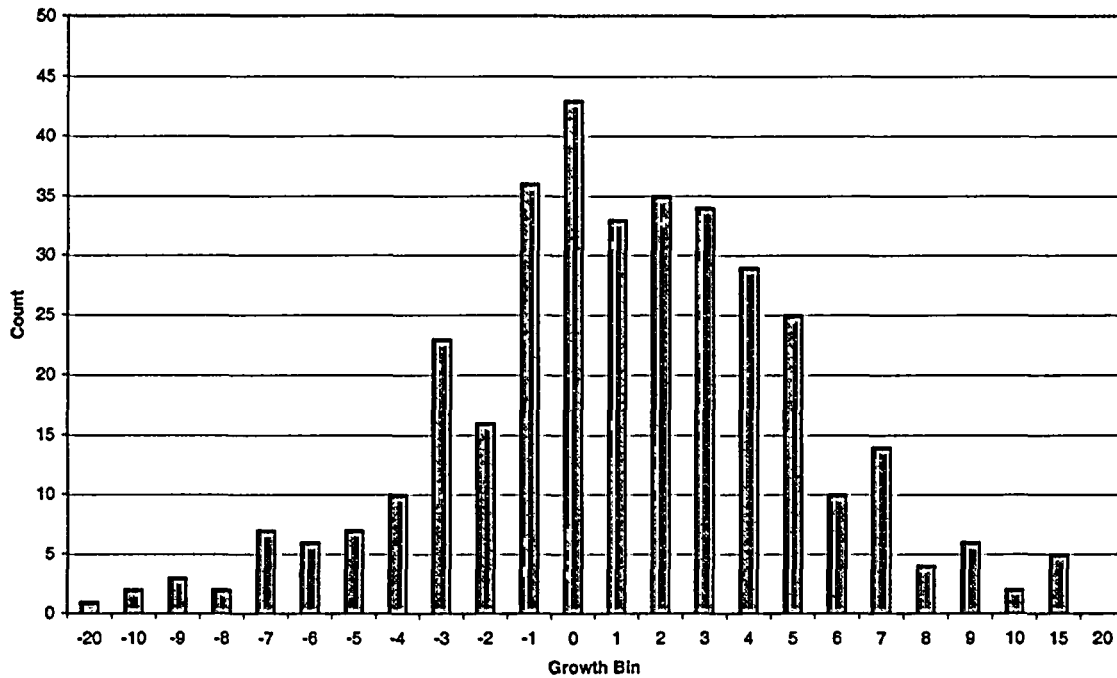
CR3 SG B Distribution of Freespan IGA Growth

The "first span" is defined as those lengths of tubing which span the region from the secondary face of the lower tubesheet to the first support plate. As required by technical specification 5.6.2.10.4.c, inservice tubes with pit-like intergranular attack (IGA) have been monitored for growth by using a test probe equivalent to the high frequency bobbin probe used in 1997.

Based on the distribution of freespan IGA, there is no significant change in the growth rate.

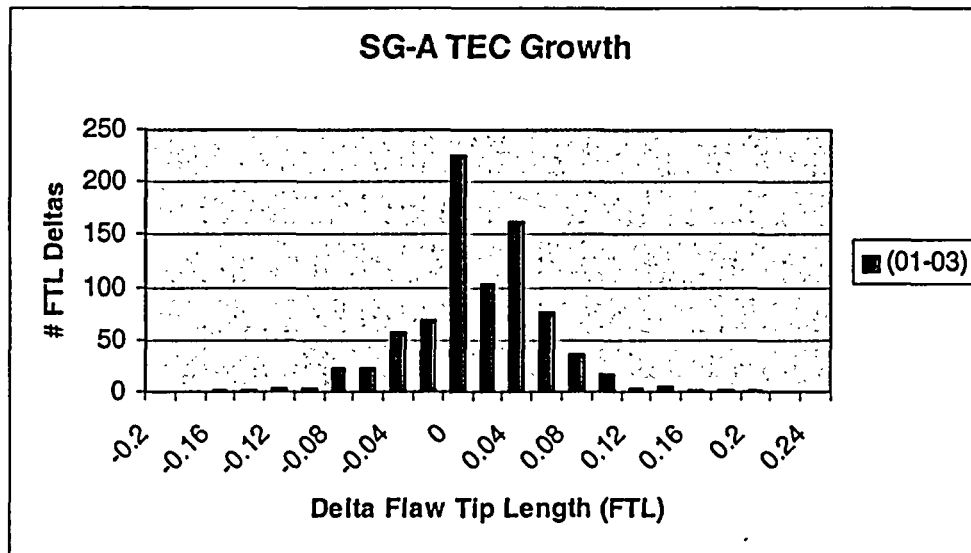
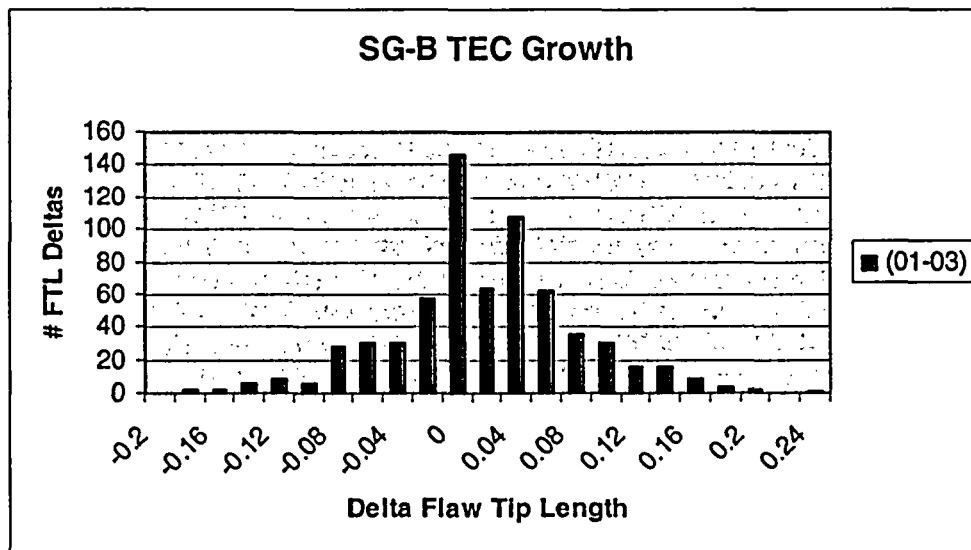
TEC growth rates for both the "A" and "B" OTSGs show there is no significant change in the Flaw Tip Length from 2001 to 2003.

There were no TEC indications that extended past the cladding and into the carbon steel of the tubesheet.
