UNITED STATES
NUCLEAR REGULATORY COMMISSION
OFFICE OF NUCLEAR REACTOR REGULATION
WASHINGTON, D.C. 20555-0001

October 11, 1996

NRC INFORMATION NOTICE 95-04, Supplement 1: EXCESSIVE COOLDOWN AND DEPRESSURIZATION OF THE REACTOR COOLANT SYSTEM FOLLOWING LOSS OF OFFSITE POWER

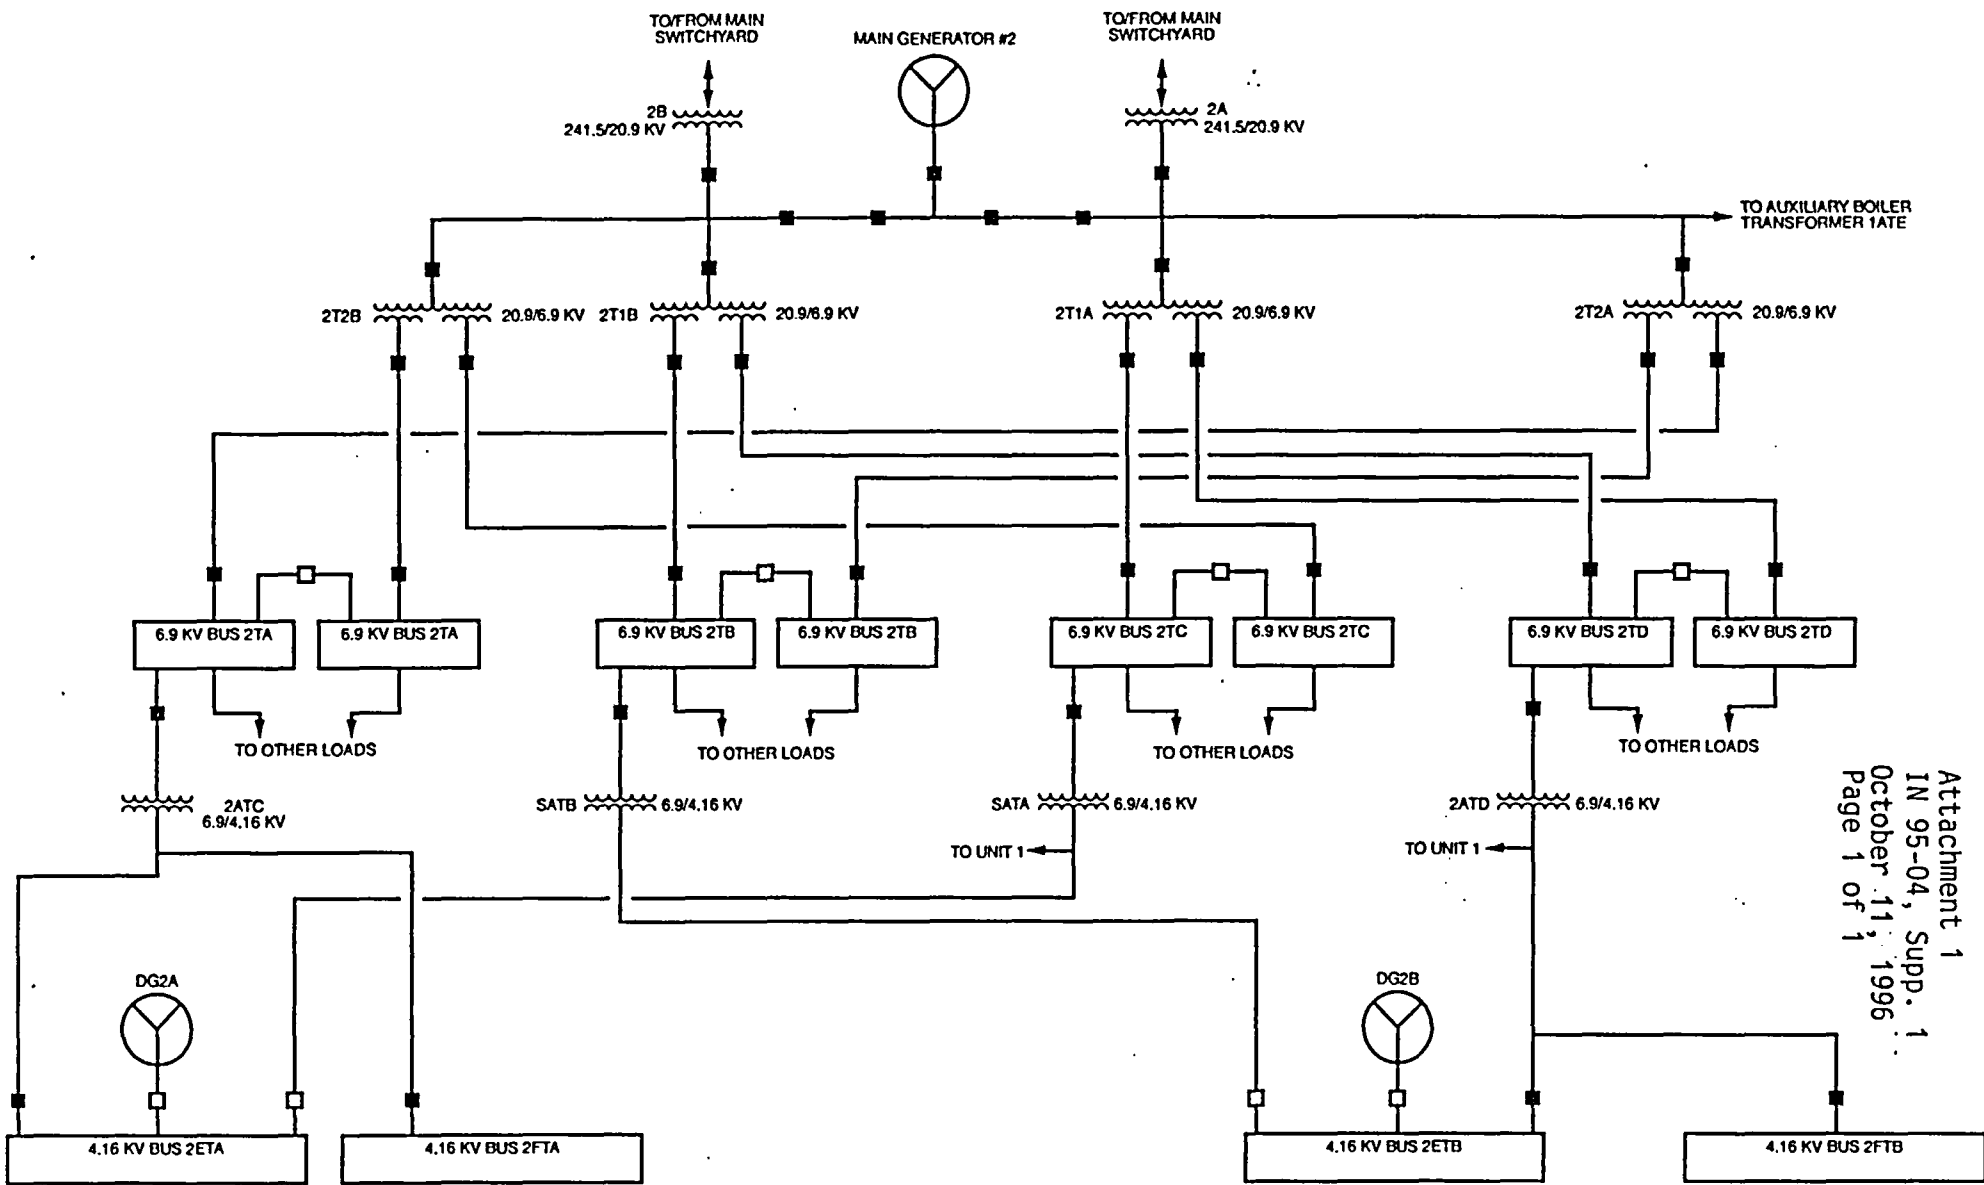
Figure 1. Catawba 2 Electric Power Distribution System

The main generator at Catawba Unit 2 normally supplies power to the onsite electrical distribution system through auxiliary transformers. Power to the offsite electrical grid is supplied by way of two half-size stepup transformers (designated 2A and 2B) using a dual-output circuit-breaker design (Figure 1). When the main generator is shut down, the two output circuit breakers are opened and offsite power is supplied (backfed) to onsite loads by means of two separate circuits via the two stepup transformers. An isolated-phase bus system connects the generator and transformers.

A loss of offsite power and safety injection occurred at Catawba Unit 2 on February 6, 1996, when two potential transformer resistor bushings in the 22-kV isolated-phase bus system simultaneously shorted to ground. This caused a phase-to-phase fault that resulted in a generator lockout followed by a turbine trip and reactor trip. The lockout interrupted power supply to the 22-kV isolated-phase buses 2A and 2B and led to the loss of offsite power.
