In Situ Uranium Wellfield Release Report

Power Resources, Inc Smith Ranch-Highland Uranium Project URANIUM IN SITU WELLFIELD FLUID RELEASE REPORT

NEAR SURFACE BREAK IN CI-28 WELL CASING IN C-WELLFIELD

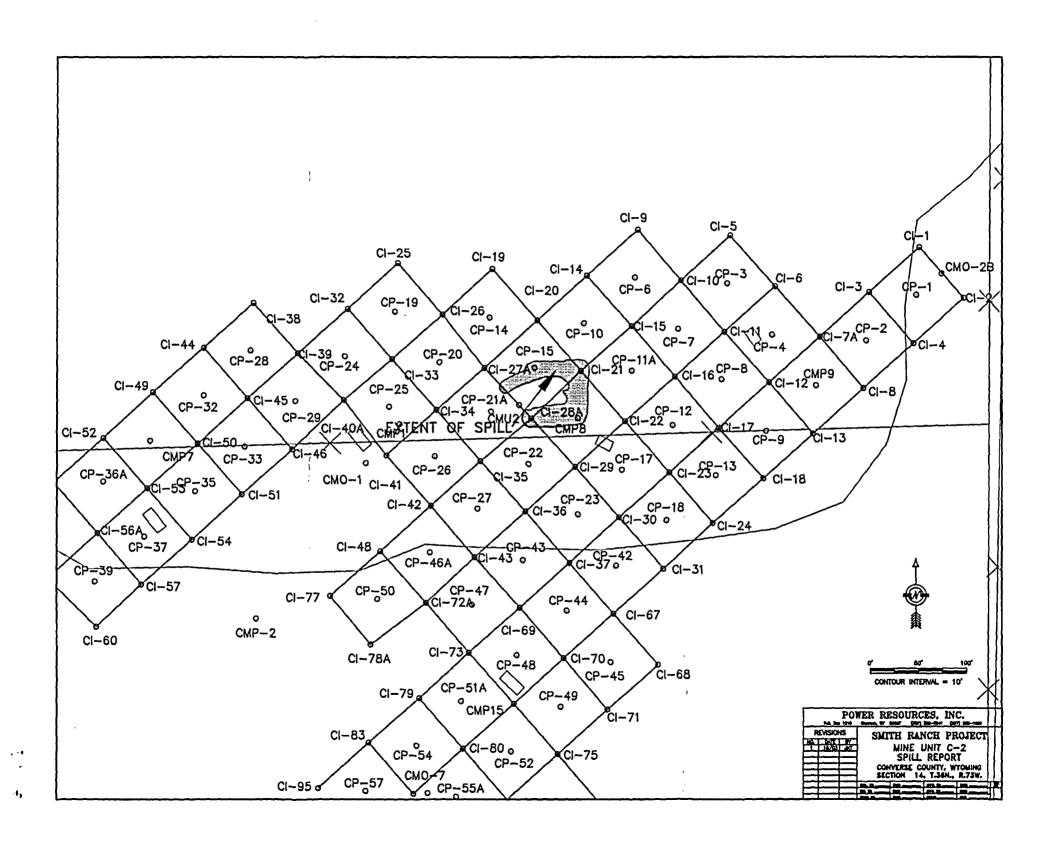
On October 20, 2003 at approximately 14:30 p.m., a sizable amount of fluid was discovered by personnel at Well CI-28 in the C-Wellfield. Investigation found that the fluid was leaking from Injection Well CI-28, located in the C-Wellfield. At this time, the well was immediately shut off. The cause of the leak is believed to be the result of a near surface break in the well casing.

The total amount of released Injection Fluid was estimated at 2800 gallons. It was not possible to retrieve any of the released fluid. The approximate uranium concentration of the released Injection Fluid was 1.5 mg/L. The release occurred in the SW ¼, NE ¼, Section 14, T36N, R72W and affected approximately 0.5 acres. The exact location and extent of the spill is shown on the attached map.

The cause of the release was likely due to a break in the well casing just below the surface of Injection Well CI-28. This type of failure was most probably due to structural failure of the casing or a joint.

Prevention of this type of release can only be prevented by regular scheduled MITs, which determine if a well is suitable for continued use. PRI has and continues to conduct regular scheduled MITs on every well it maintains and uses. Any well failing an MIT is either repaired or abandoned and plugged.
