Subject: 2003 Annual Pond Inspection Report
Source Materials License SUA-1534
Docket Number 40-8943

**CROW BUTTE MINE
DAWES COUNTY, NEBRASKA**

2003 POND INSPECTION REPORT

October 20, 2003

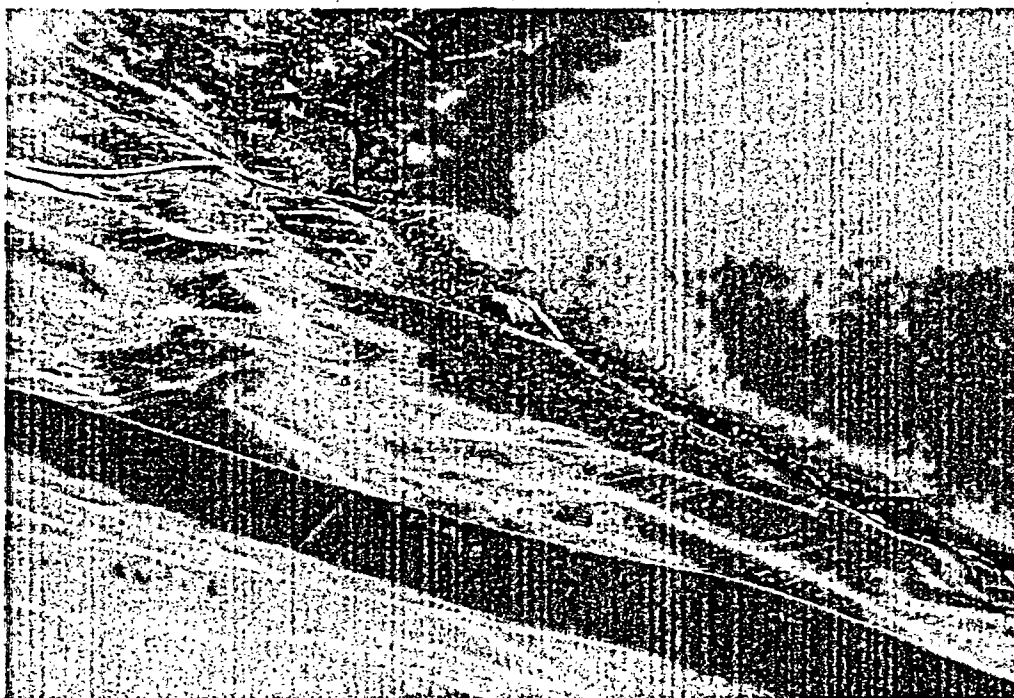
I noticed a dead muskrat or other type of rodent floating on the northwest water line of pond #1.

Northwest corner of pond #1, dead muskrat at water edge. Date: 10/09/03

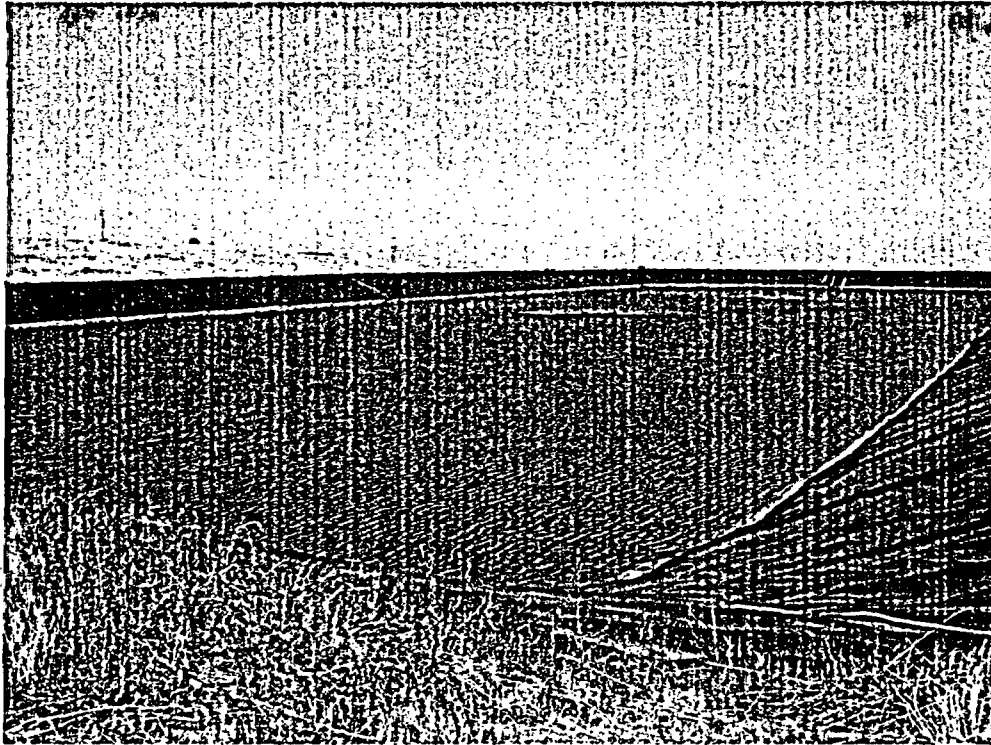
Northwest view of pond #3. Date: 10/09/03

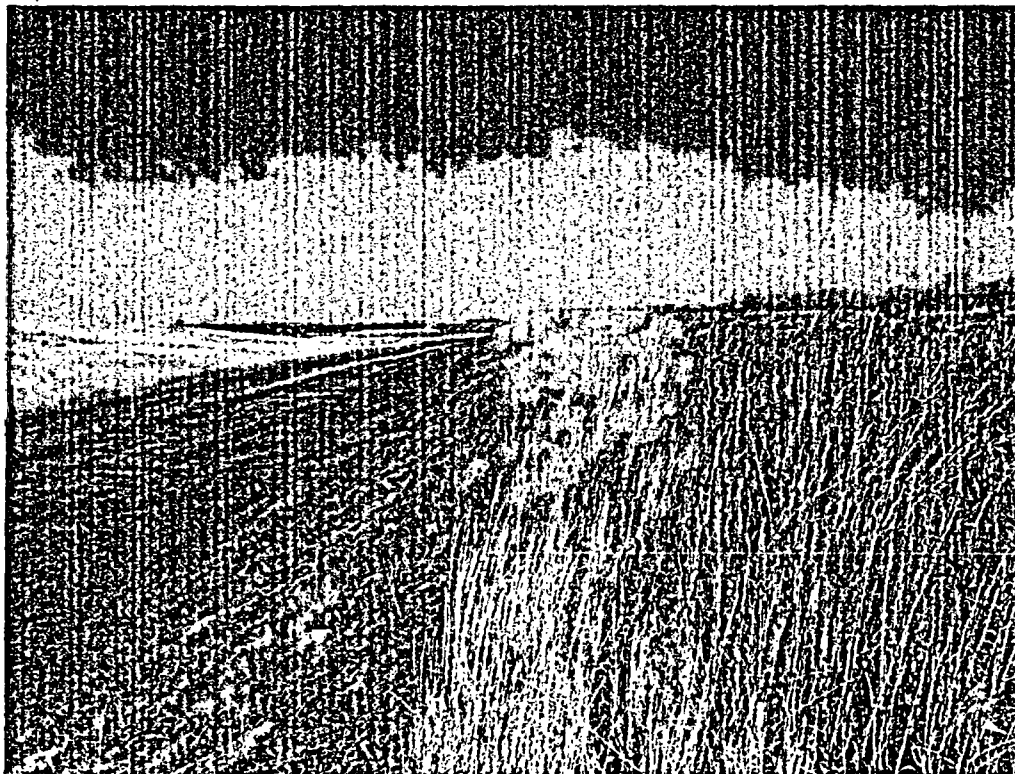
Pond number 3 had several muskrat boring holes near the pond liners. Pond number 3 had burrow holes on the east and west embankments. The vegetation on the west embankment slope was in excellent condition. I noticed the vegetation along the embankments had been mowed this summer or fall. The primary runoff drainage channel runs along the west embankment of pond number 3. I did not notice any seepage areas along the west and north embankments at the toe of the slopes. On the northeast drainage diversion channel of pond number 3 I noticed minor surface erosion. The erosion did not appear to be from recent rain storms. There were a few areas with head cuts of about one foot in depth. The vegetation on the north embankment of pond number 3 is in good shape.

North view of west embankment of pond #3. Date: 10/09/03

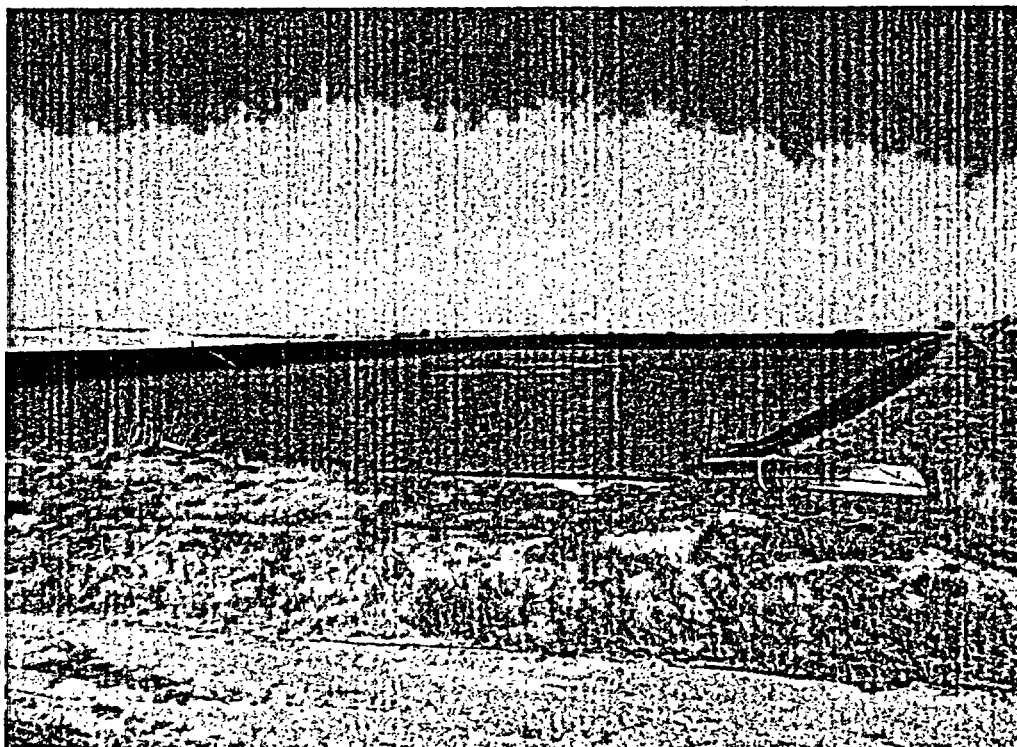
The northwest and southwest corner of pond #4 had dead vegetation accumulating at the water surface level. The vegetation along the embankments was in good condition. There has been some improvement in the vegetation during the last year. I did not notice any leaks along the toe of the embankment areas of pond number 4. The current water depth appeared to be about 5'-9". The depth markers on the north embankments were difficult for me to read.

Northwest view of pond #4. Date: 10/09/03

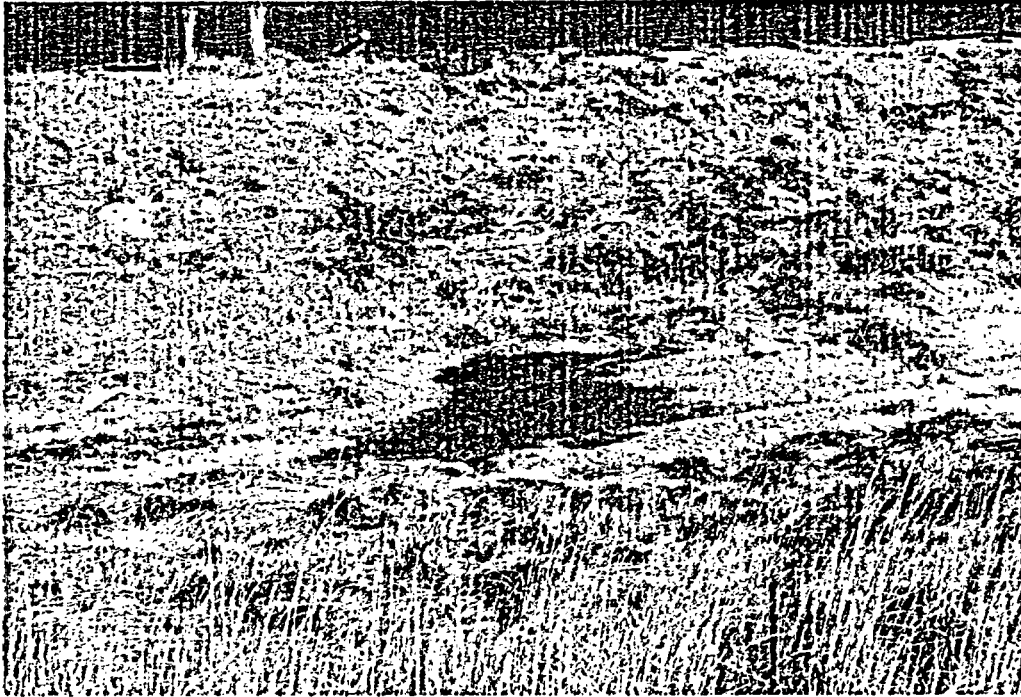
I noticed a wet area at the toe of the embankment of pond number 3. This was in the bottom of the diversion ditch between ponds 3 & 4. The wet area was in the north vehicle track. The wet area showed no signs of flowing water. I concluded the wet area was the result of a recent rain storm. The diversion ditch of the R & D ponds also had wet areas in the bottom of the channels.

Damp area in roadway between ponds #3 & #4. Damp area was in line with wheel way of vehicle traffic. Pond in upper part of photo is #3. Date: 10/09/03

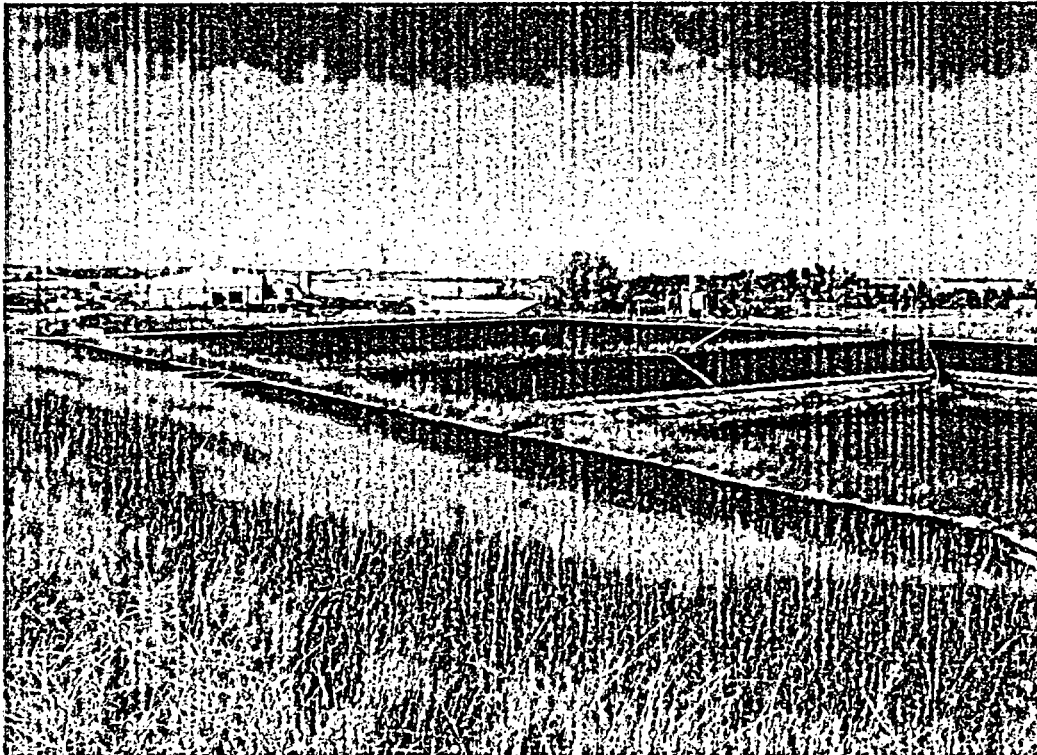
Northwest view of R&D pond cells. Diversion "V" ditch on the center left of photo. Note excellent vegetation. Date: 10/09/03

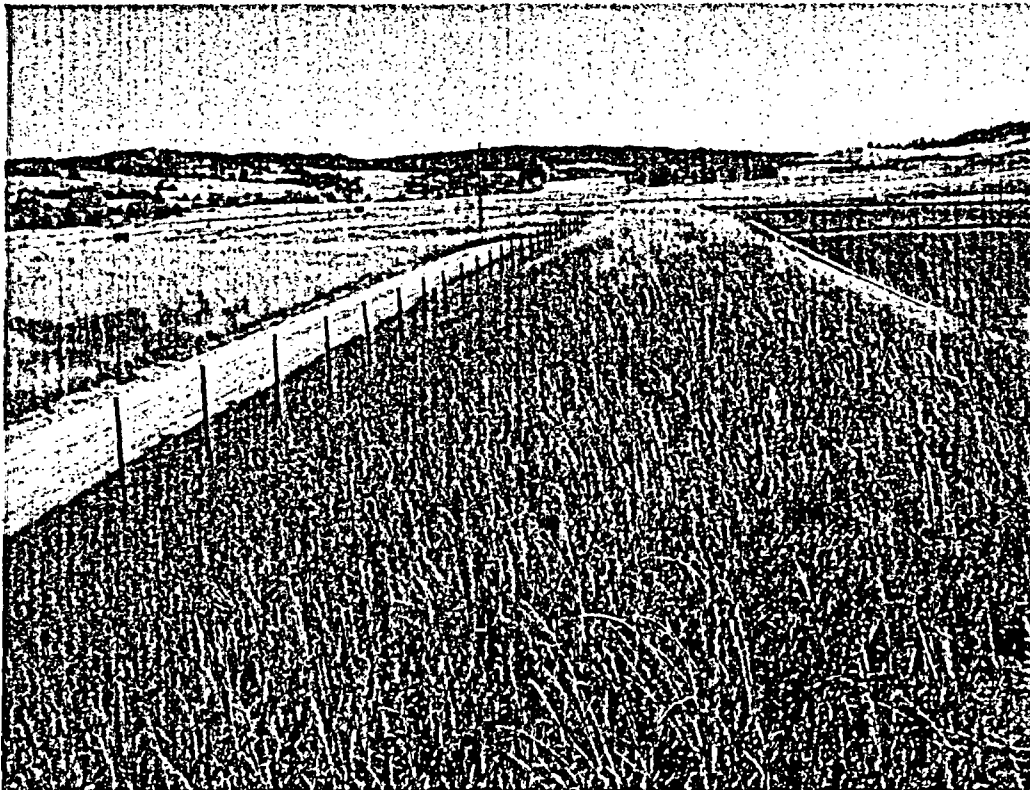
**East view of north embankment of R&D ponds. Excellent vegetative cover.
Date: 10/09/03**
