**CROW BUTTE RESOURCES, INC.**

**CROW BUTTE MINE  
DAWES COUNTY, NEBRASKA**

**2003 POND INSPECTION REPORT**

**By: David V. Coe, PE  
Nebraska Registration No. E - 4295**

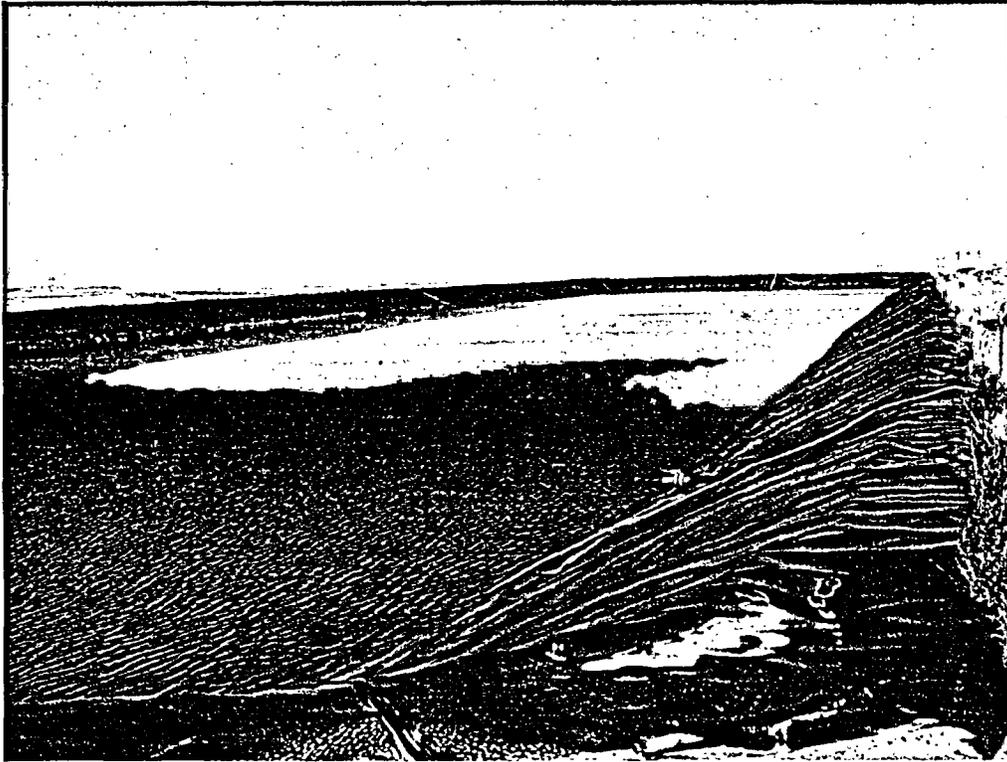
**Northwest view of evaporation pond #1, date: 10/09/03**

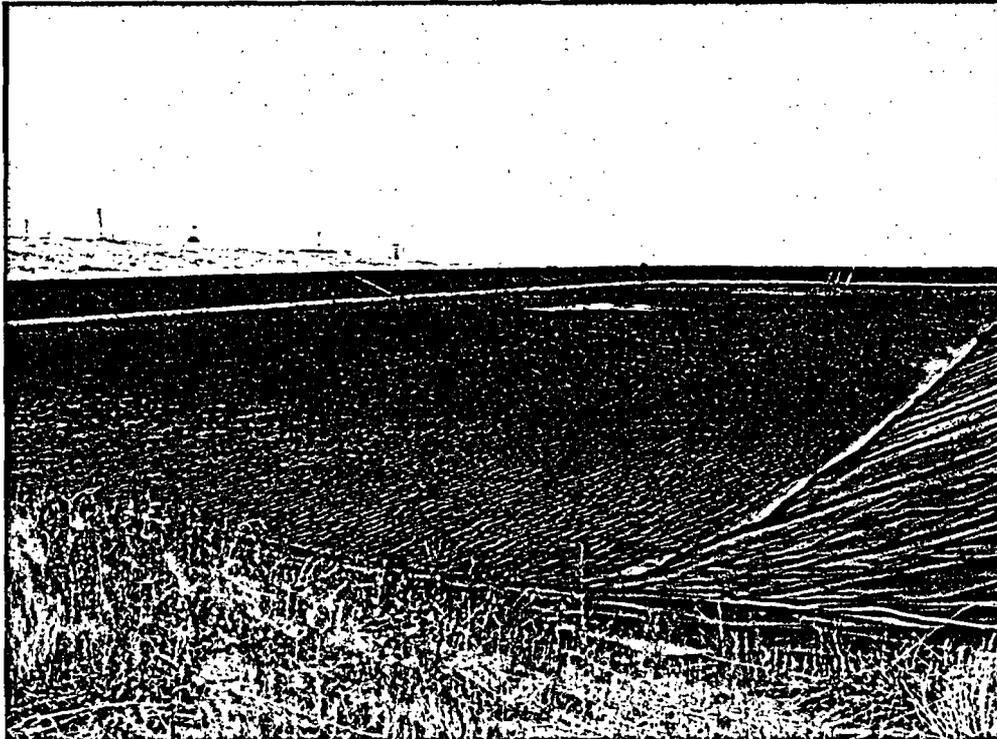
**Northwest view of pond #3. Date: 10/09/03**

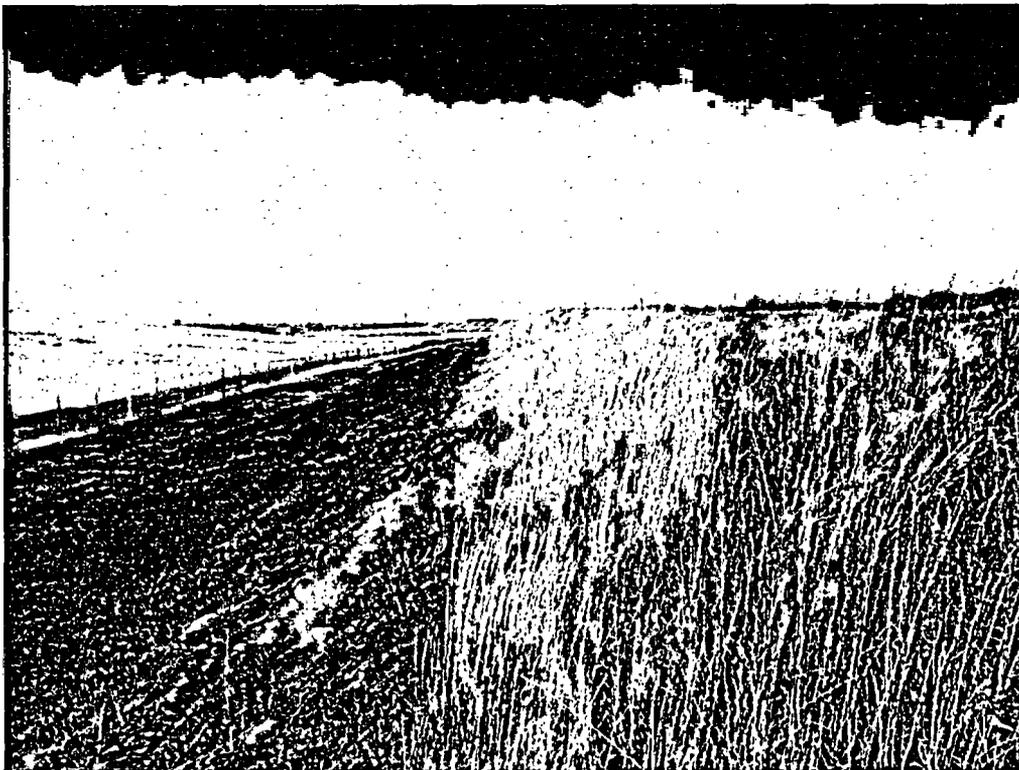
Pond number 3 had several muskrat boring holes near the pond liners. Pond number 3 had burrow holes on the east and west embankments. The vegetation on the west embankment slope was in excellent condition. I noticed the vegetation along the embankments had been mowed this summer or fall. The primary runoff drainage channel runs along the west embankment of pond number 3. I did not notice any seepage areas along the west and north embankments at the toe of the slopes. On the northeast drainage diversion channel of pond number 3 I noticed minor surface erosion. The erosion did not appear to be from recent rain storms. There were a few areas with head cuts of about one foot in depth. The vegetation on the north embankment of pond number 3 is in good shape.

**North view of west embankment of pond #3. Date: 10/09/03**

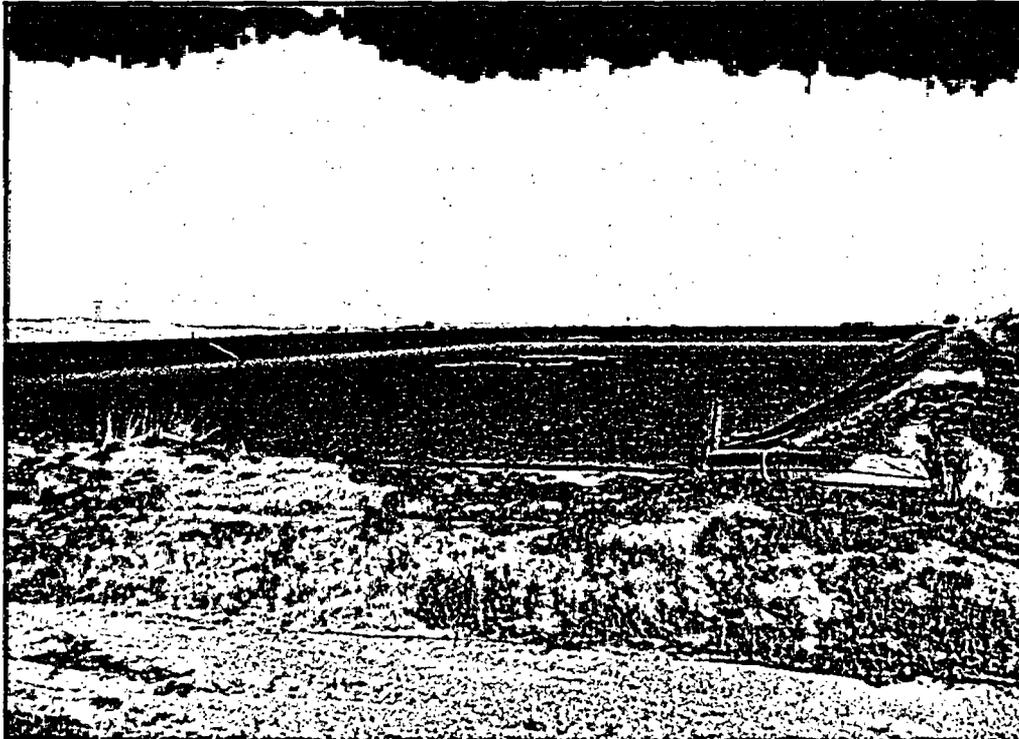
The northwest and southwest corner of pond #4 had dead vegetation accumulating at the water surface level. The vegetation along the embankments was in good condition. There has been some improvement in the vegetation during the last year. I did not notice any leaks along the toe of the embankment areas of pond number 4. The current water depth appeared to be about 5'-9". The depth markers on the north embankments were difficult for me to read.

**Northwest view of pond #4. Date: 10/09/03**

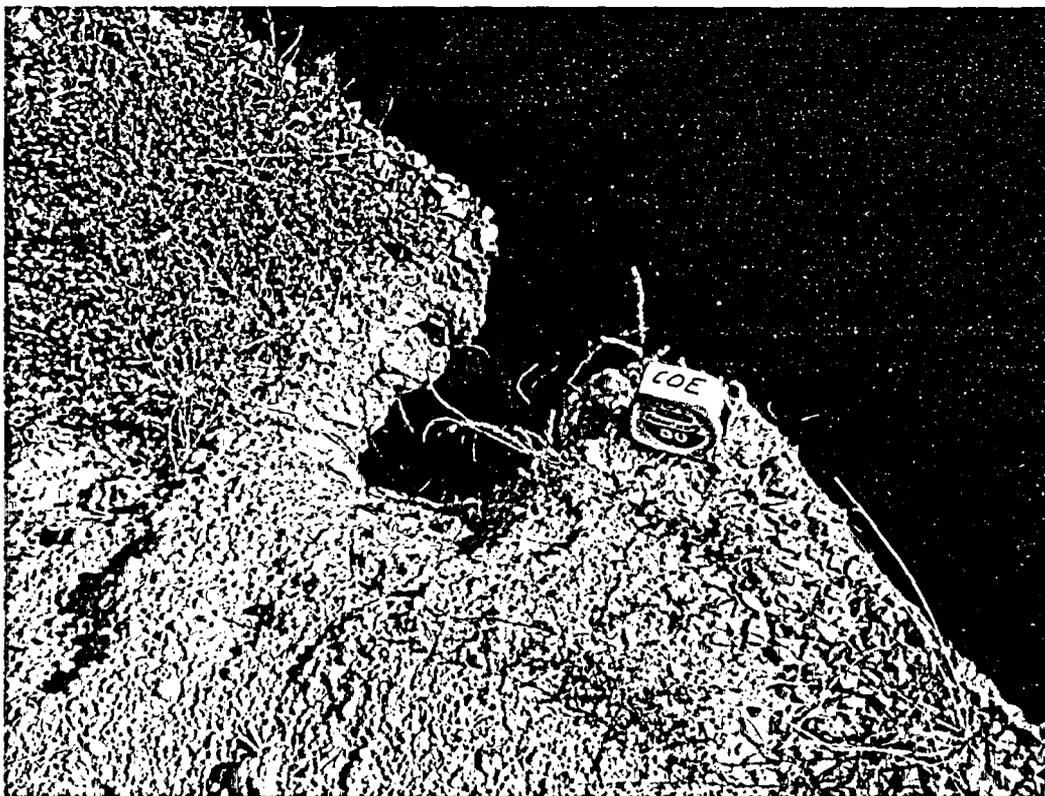
As I walked to the south along the berm of pond 1, I noticed several <sup>burrows</sup> <sup>holes</sup> <sup>in</sup> <sup>the</sup> <sup>soil</sup> <sup>which</sup> <sup>I</sup> <sup>would</sup> <sup>assume</sup> <sup>were</sup> <sup>muskrats</sup> <sup>or</sup> <sup>gophers</sup>. I did not notice any damage of the HDPE liner resulting from rodents chewing on the liner. I did not observe any tremmie tubes attached to the influent line.

**Burrow hole of muskrat or badger adjacent to pond liner. Date: 10/09/03**

The addition of gravel surfacing on the top of the embankment berms helps stabilize the embankments. Continuation of this practice would enhance the areas without gravel surfacing. Gopher and rodent maintenance should be reviewed and control of these varmints should be accomplished if dirt mounds continue to appear along the embankment slopes. A program working with the USDA animal damage control officer related to the muskrat burrows and their likely presence should be pursued.

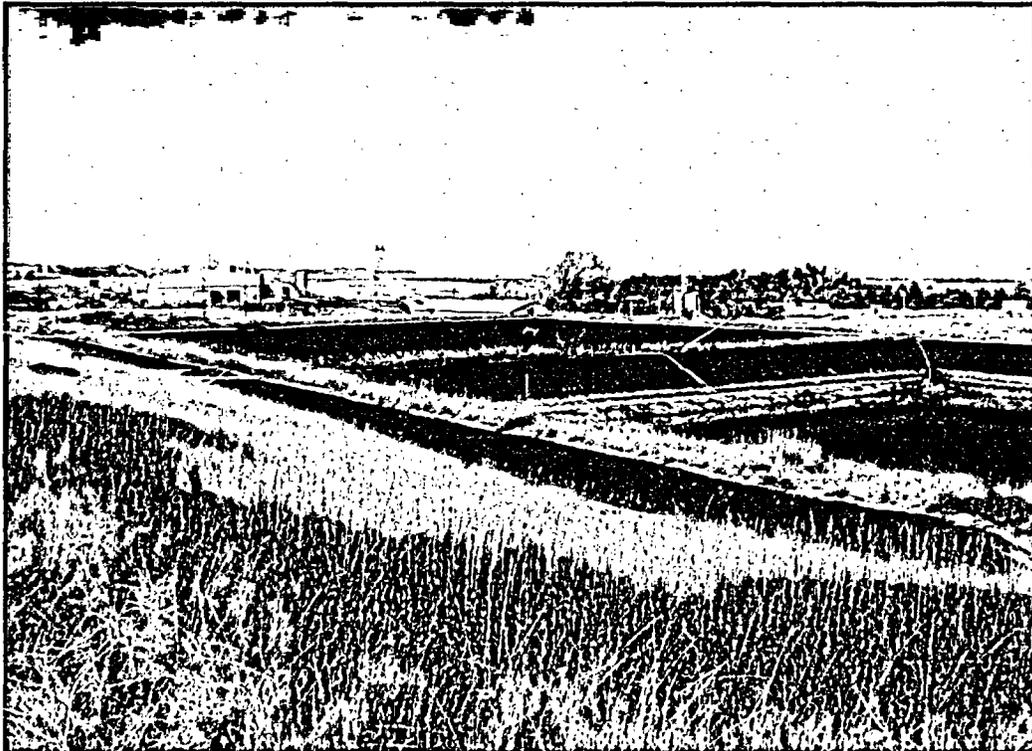
**Northwest view of R&D pond cells. Diversion "V" ditch on the center left of photo. Note excellent vegetation. Date: 10/09/03**

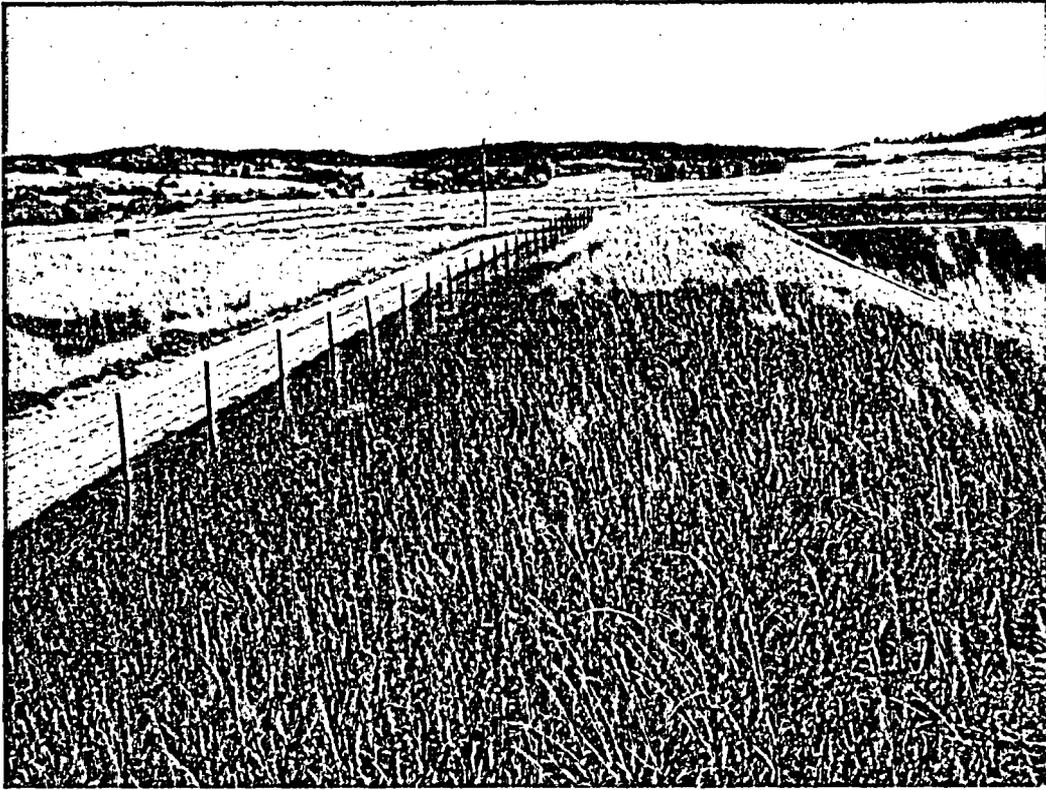
**East view of north embankment of R&D ponds. Excellent vegetative cover.  
Date: 10/09/03**
