Subject: Routine Inspection No. 88-001

Report Nos. 030-05982/88-001
030-05980/88-001

Facility Name: Safety Light Corporation

Inspection Conducted: July 8, 1988

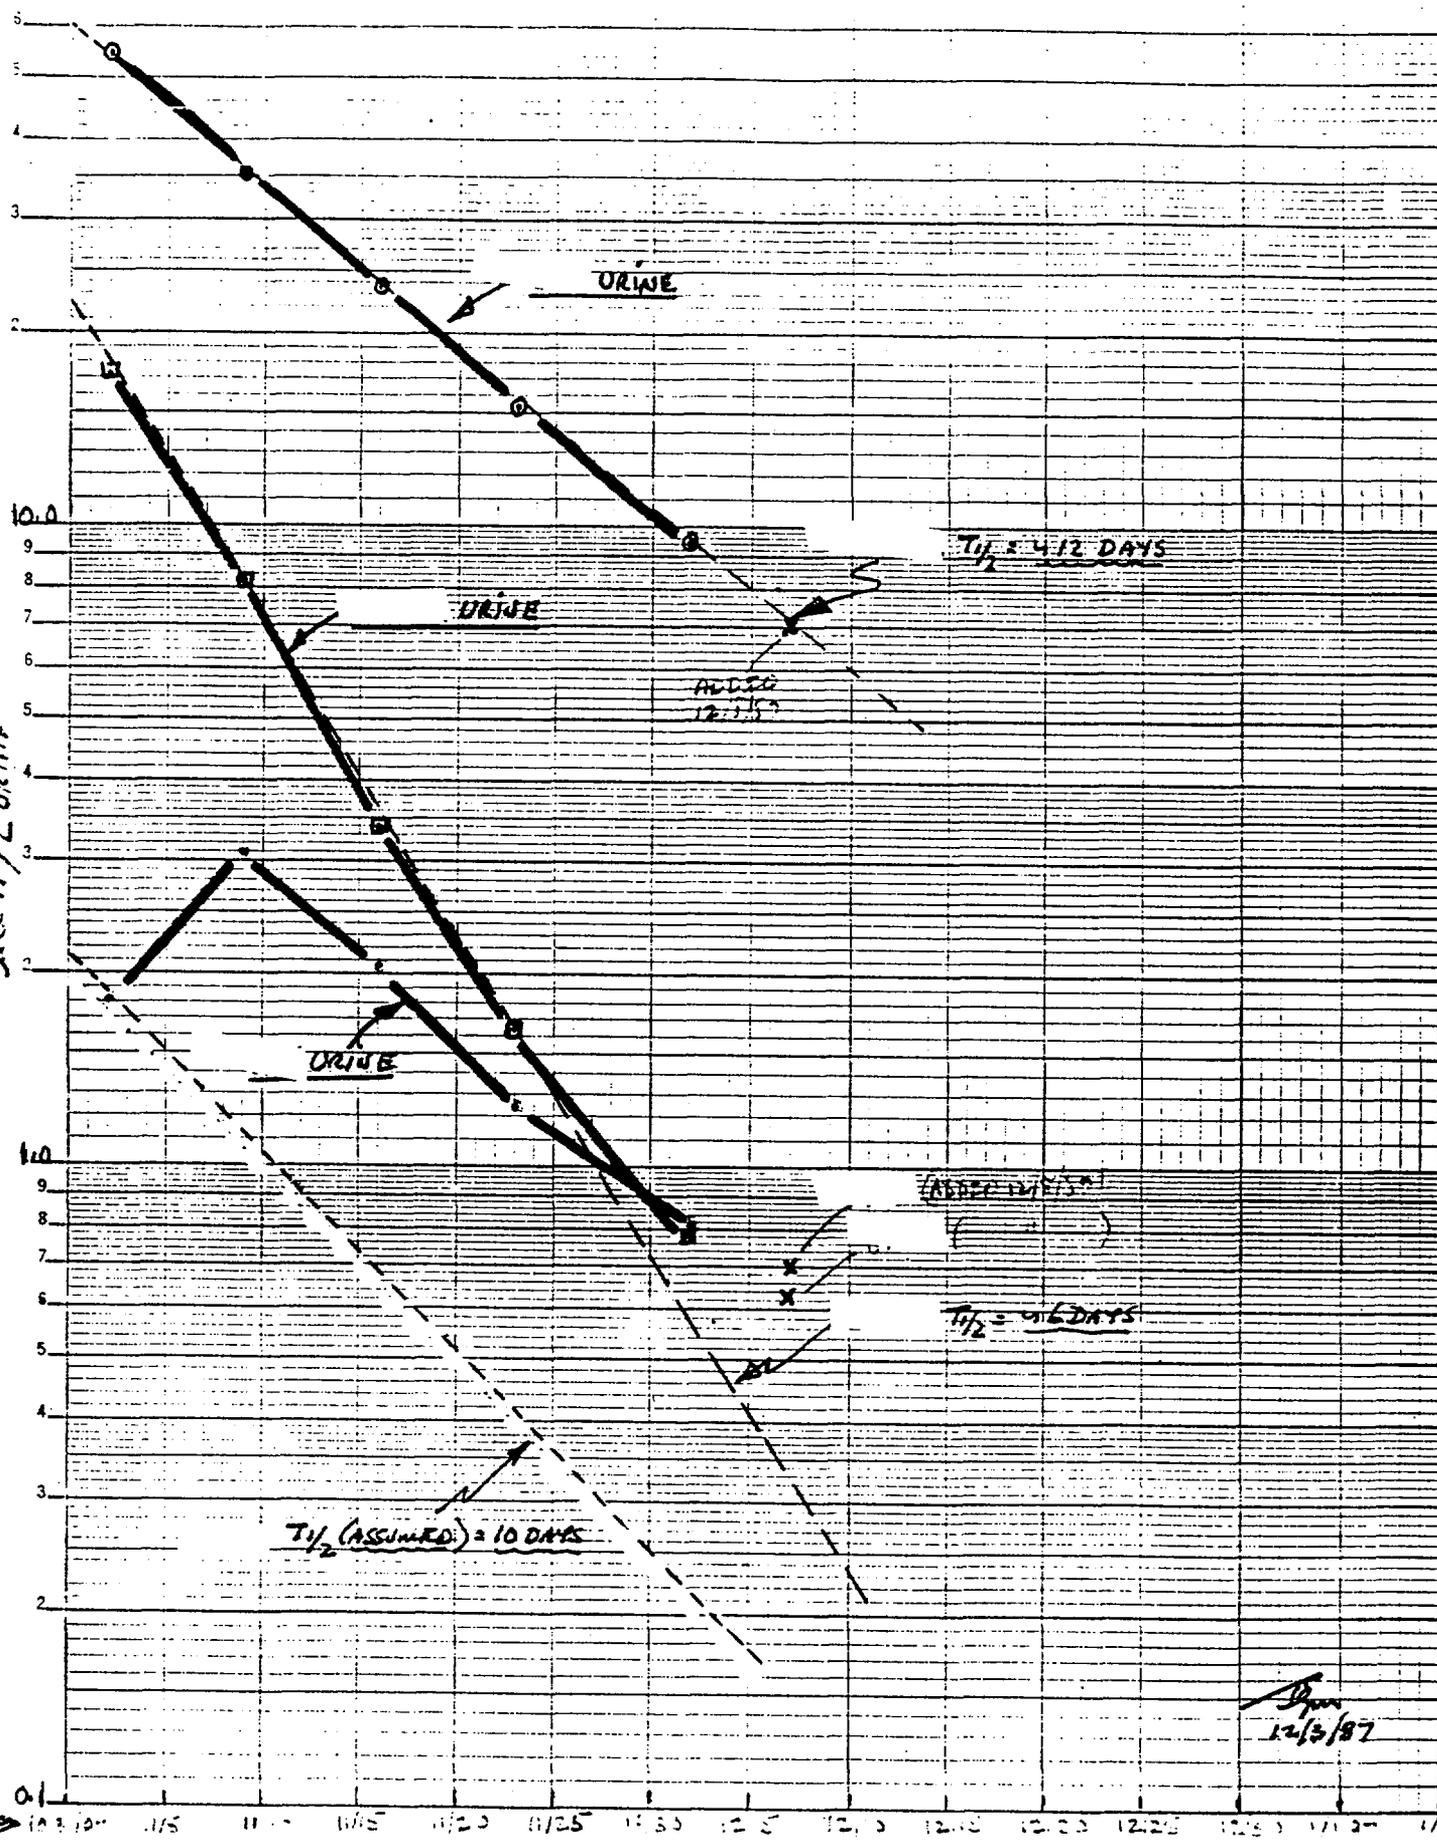
BIOASSAY DATA

The above estimates were based on the $\mu\text{Ci H}^3/\text{L}$ urine data obtained as of 11/2/87 (Monday) a.m., whereas the actual uptakes of H occurred two (2) days previously on 10/31/87 (Saturday) a.m. The previously reported values must therefore be corrected to include dosage from the estimated amount of H³ excreted between Saturday and the following Monday a.m. Also, because of the above-normal tritium uptakes which occurred in this instance with CB and GM, the SLC customarily-assumed 10 day average biological half-life for excretion of tritium was not used in estimating their respective whole body dose commitments; rather, use was made of their actual elimination rates determined experimentally after the incident occurred (See Fig. I attached). The whole body water volume assumed was that for "Standard Man", i.e. 43 L. The 'corrected' whole body doses, determined in accordance with the above (except in the case of AS), are shown in Table I.

NOTES: (1) & (2): From Fig. I
