Licensee Event Report 2003-005-00

The enclosed Licensee Event Report (LER) 2003-005-00, "HPCI and RCIC Systems Inoperable due to De-energized Train 'A' Electrical Loads Caused by Circuit Breaker Current Transformer Malfunction," is submitted in accordance with 10 CFR 50.73

**FACILITY NAME (1)**  
**PILGRIM NUCLEAR POWER STATION**

**TITLE (4)**  
**HPCI and RCIC Systems Inoperable due to De-energized Train 'A' Electrical Loads Caused by Circuit Breaker Current Transformer Malfunction**

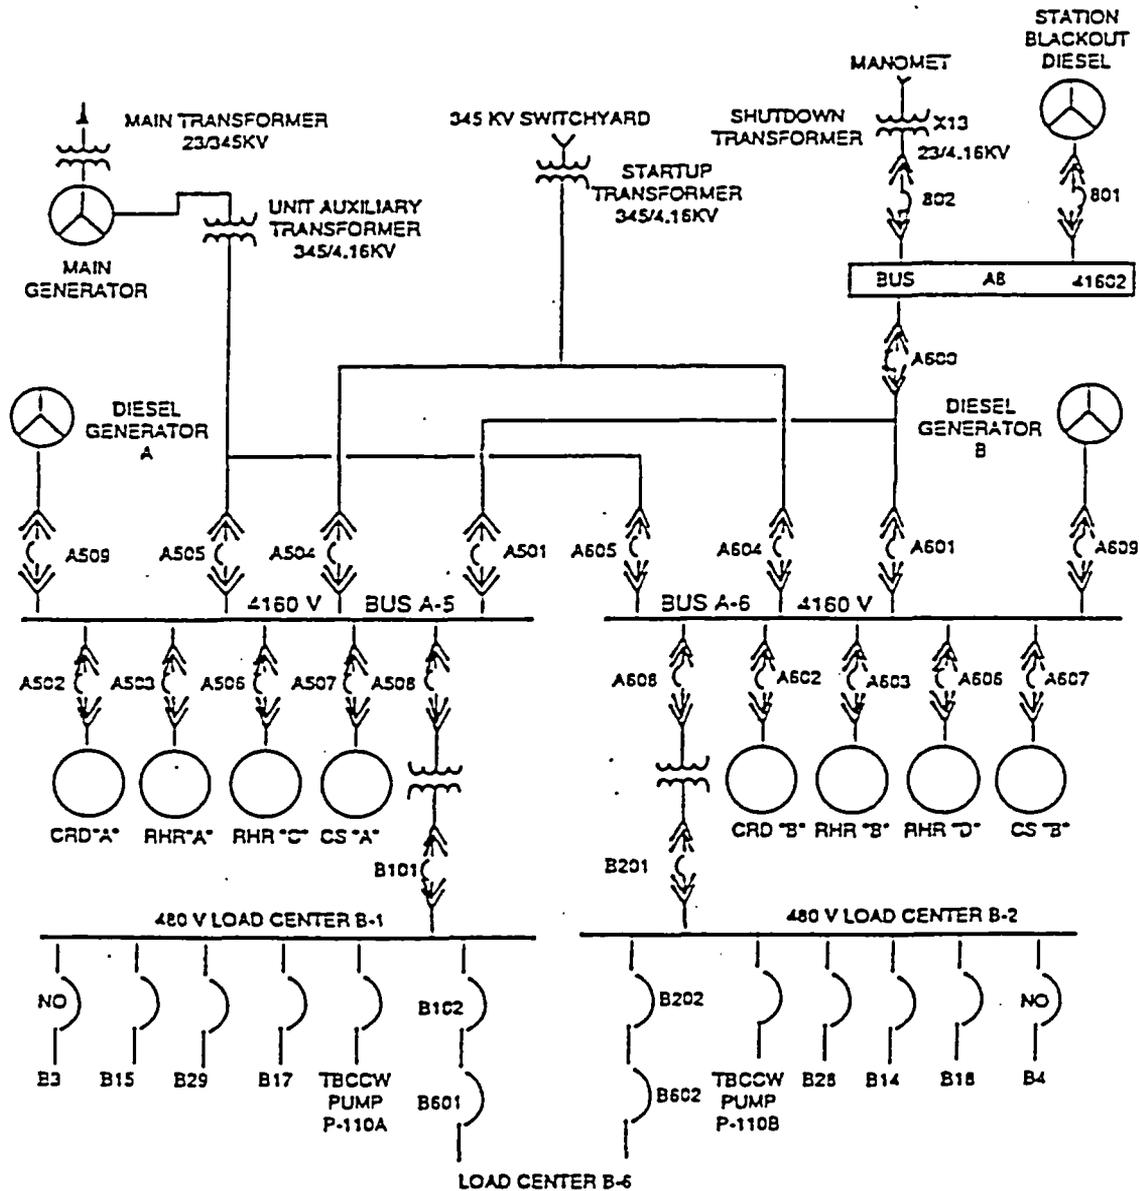
Figure of APDS

Safety-related 480-volt train 'A' load center B1 is powered from 4.16 kV Bus A5 via a step-down transformer (X-21) and circuit breaker (B101). Safety-related 480-volt train 'B' load center B2 is powered from 4.16 kV Bus A6. Safety-related 480-volt swing load center B6 is normally powered from B1 and is designed to automatically transfer from B1 to B2 if B1 becomes de-energized. Located at the end of this report is a figure that depicts a simplified single-line diagram of the APDS including load centers B1, B2, and B6.
