Robert C. Mecredy
Vice President
Nuclear Operations

November 10, 2003

Subject: LER 2003-003, Containment Sump As-found Condition not in Accordance
With Design Requirements
R.E. Ginna Nuclear Power Plant
Docket No. 50-244

4. TITLE
 Containment Sump As-found Condition not in Accordance with Design Requirements

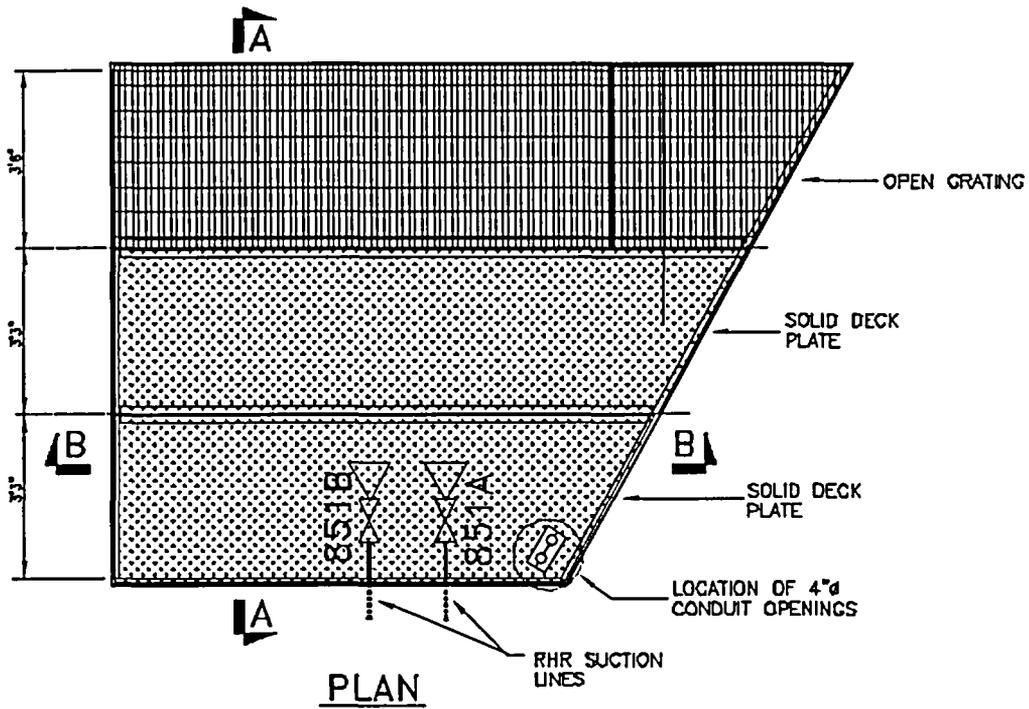
Figure 1

On September 18, 2003, engineering was performing inspections of the Containment Sump B (see Figures 1, 2, and 3). Specifically, the RFO examinations were to confirm that no by-pass flow areas existed around the Sump B inner screen. As a result of this initial external inspection, it was identified that a bypass area existed. This area consisted of three holes through the steel deck plate over the sump. Two holes were approximately 4 inches in diameter with 1.25 inch electrical conduit running through them. The third hole was approximately 2 inches in diameter. The total surface area of the bypass holes was approximately 26 square inches.

- The Sump B bypass flow paths were corrected by a modification during the 2003 RFO to return the sump to original design conditions.
- The solid material and embedded foreign material that was found on the floor of Sump B were removed during the Fall 2003 RFO.

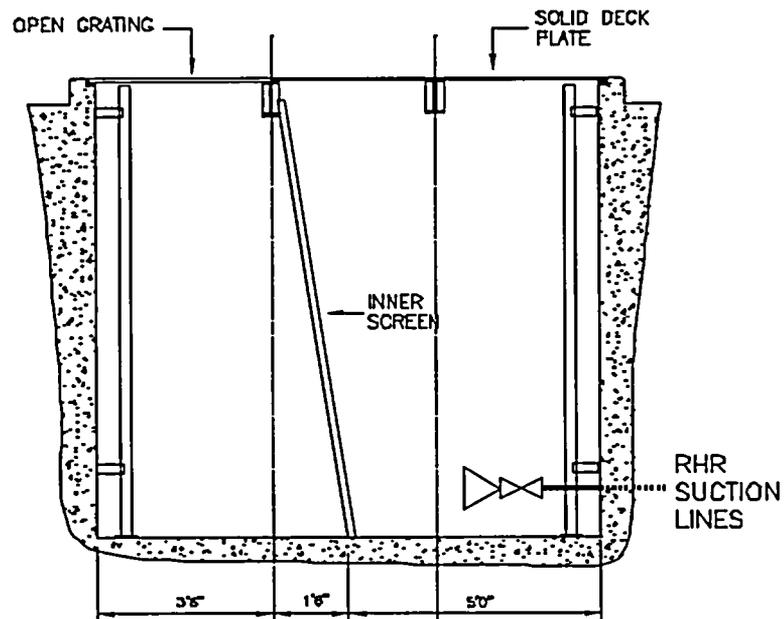
Figure 2

Initial attempts to enter Sump B to perform the internal by-pass area inspection were delayed due to the presence of standing water in Sump B. After plant personnel entered the sump to remove the water, it was discovered that the sump floor was completely covered by a solid mass of material approximately 1 inch thick. Additionally, during the clean-up of the sump to remove the solid material, miscellaneous foreign objects were found embedded within the solid material. The solid material on the sump floor and the embedded foreign material were discovered on both sides of the Sump B inner screen (see Figure 2).

With respect to the solid material on the sump floor and the embedded foreign material which were discovered on both sides of the Sump B inner screen, it appears that this material existed for some period of time prior to the inspection. The solid material found on the sump floor was estimated to be approximately 1 inch thick and the result of the evaporation of borated water. The Sump B does not have a drainage system and borated water is periodically drained to the sump during the repositioning of the Emergency Core Cooling System (ECCS) suction valves located within the sump. This activity drains borated water each refueling outage and during each periodic valve test. The embedded foreign material (less than six ounces) that was found in the sump is the result of poor house keeping and inadequate inspections prior to this refueling outage. The inspection procedure that was utilized prior to this outage only required a visual inspection to verify that the ECCS suction inlets were not restricted by debris.

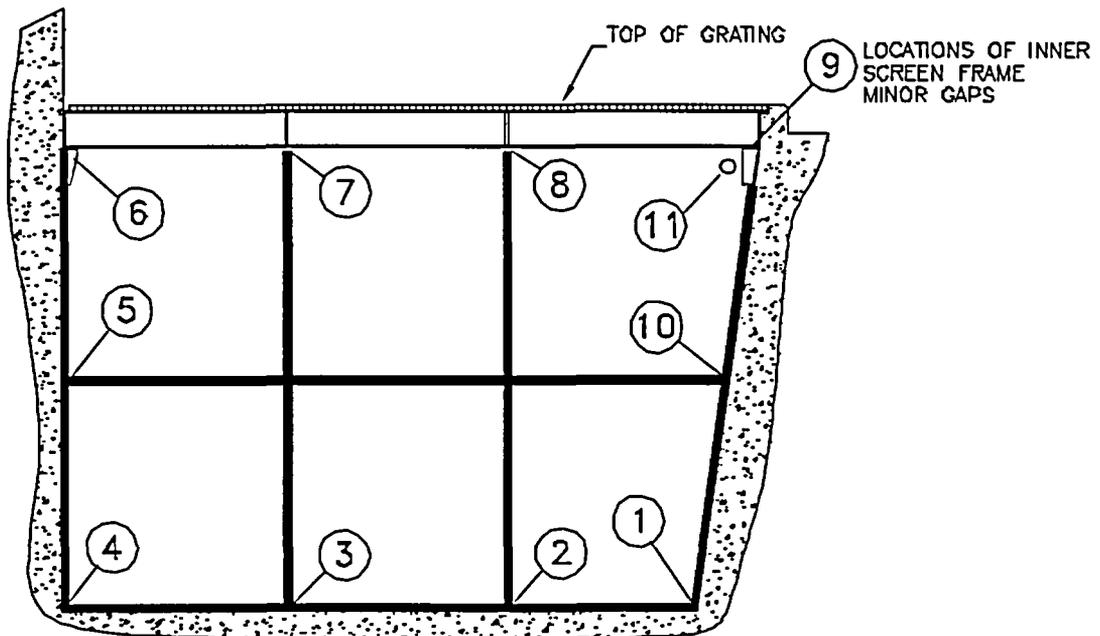
Figure 3

Supplemental inspections identified several other small gaps in the inner screen frame located within Containment Sump B and the steel deck plate. The total sum of these gaps is estimated at < 60 square inches. In addition, the dimensions of the mesh of the Sump B inner screen were confirmed to be approximately 3/16 inch wide by 9/16 inch tall. The Ginna UFSAR description implies a 0.25 inch mesh.

With respect to the gaps identified in the inner screen frame, these gaps have existed since original construction in the late 1960s. These gaps are generally of small diameter (< 1/2 inch) and are reflective of general construction practices at that time. These are also the result of a lack of understanding and consideration of the requirements associated with the Sump B design.
