Re: St. Lucie Unit 1
Docket No. 50-335
Order (EA-03-009) Relaxation Requests 1 and 2
Examination Coverage of Reactor
Pressure Vessel Head Penetration Nozzles

**ST. LUCIE UNIT 1 RELAXATION REQUEST NO. 1 Revision 0
FROM US NRC Order EA-03-009**

**ST. LUCIE UNIT 1 RELAXATION REQUEST NO. 2
FROM US NRC Order EA-03-009**

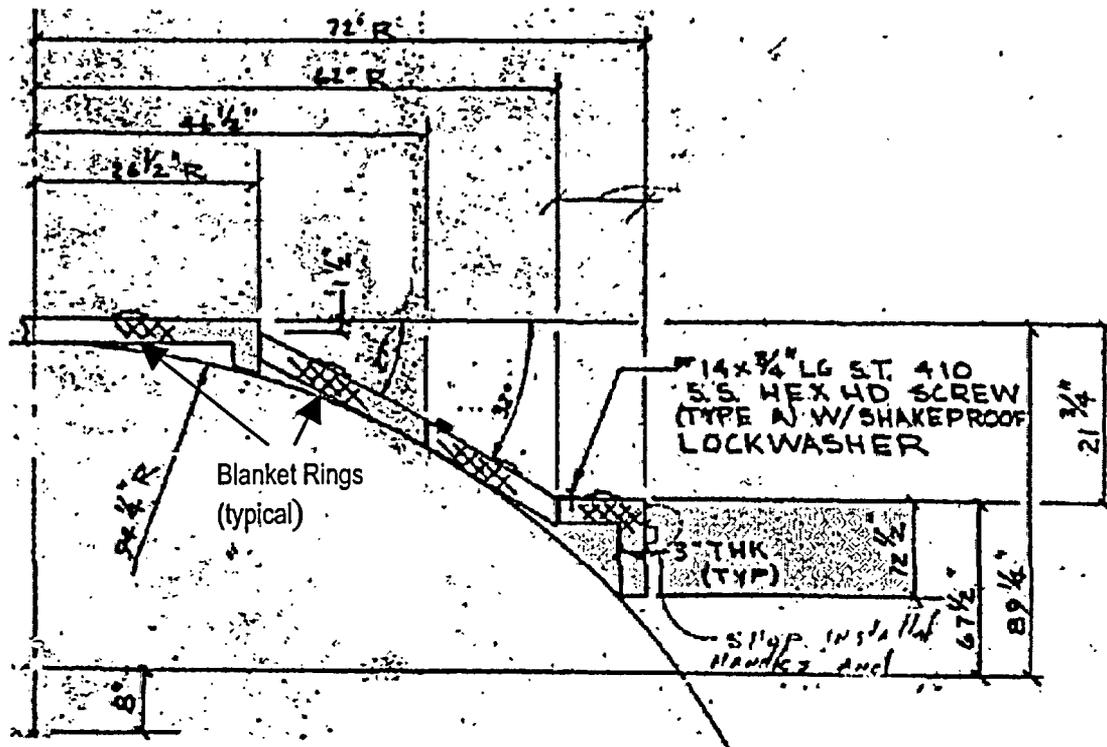
Figure 1: RPV Head Side View showing close conforming Insulation Panel Layout

The insulation covering the RPV head at St. Lucie Unit 1 is metal reflective encapsulated mineral wool. The insulation conforms to the head as do the lower CEDM pressure housings. The insulation is made up of 33 panels, 21 of which encircle the 1 (1.050-inch OD) vent, 69 (3.85-inch OD) CEDM, and 8 (5.563-inch) ICI nozzles. Holes of 8.125-inch diameter for CEDM penetrations, 16.625-inch diameter for the ICI penetrations, and a 2-inch square hole for the vent line are cut in the insulation panels. The encircling panels were installed over the lower CEDM pressure housing flanges during initial construction. The gap between the insulation panels and the CEDM/ICI penetrations is filled with blanketed plug rings (4-inch ID and 8-inch OD for CEDM and 5.625-inch ID and 16.5-inch OD for ICI) made up of calcium-silicate wrapped in asbestos cloth. These rings were installed prior to the panels and secured with a metal band. A side view of the RPV head showing the blanket rings and the close conforming insulation panels (Figure 1) is included below.

inaccessible areas are a result of the blanket rings that fill the gap between the insulation panels and the penetrations. Some of these blanket rings have partially dropped and are in contact with the head base material in areas between the penetrations that will be inspected for evidence of leakage. The lack of access to these small areas (less than 1% of the total surface area) does not preclude performance of an effective bare metal visual examination of the nozzle-to-top-of-head interface region or the RPV head to identify evidence of wastage and/or leakage.
