**UNITED STATES  
NUCLEAR REGULATORY COMMISSION  
REGION IV  
611 RYAN PLAZA DRIVE, SUITE 400  
ARLINGTON, TEXAS 76011-4005**

**SUBJECT: DIABLO CANYON POWER PLANT - NRC SPECIAL INSPECTION TEAM  
REPORT 05000275/2003010 AND 05000323/2003010**

Enclosure:  
Inspection Report 05000275/2003010  
and 05000323/2003010

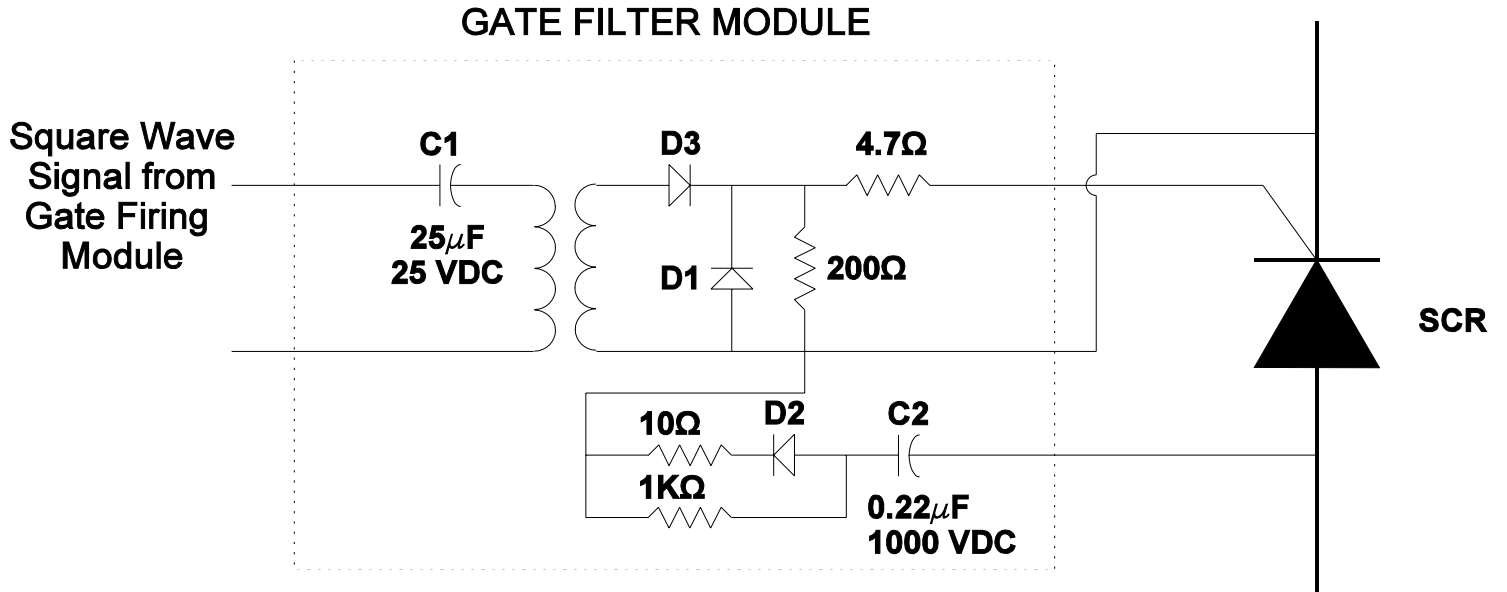
# Gate Filter Module

The C1 capacitor is a polarized electrolytic capacitor. As such, it is designed for only positive voltages from the gate firing module. If negative voltages are experienced on a continual basis, the service life of the electrolytic capacitor is sharply reduced. If the C1 capacitor fails, the respective gate filter module will not send a turn-on signal to its respective SCR. If the capacitor loses capacitance, the gate filter module will send a degraded pulse and the SCR may or may not turn on. Such a failure would leave five SCRs functioning, which would be sufficient to maintain output voltage and current under normal plant loads. However, under full load, the demand would increase the load experienced by the remaining SCRs to the point where protective fuses would be challenged. The battery chargers experienced full load conditions only a limited number of times during the previous operating cycles. These occurred during battery charger or battery surveillance testing. The team noted that normal equipment monitoring would not likely detect the condition, such that a battery charger could operate with a failed SCR for an extended period of time.

During troubleshooting to support the fault tree root cause analysis, PG&E staff discovered that the square wave signal to the gate filter modules ranged from approximately -3 Vdc to 14 Vdc. The negative voltage component of the square wave was determined to sharply decrease the life of the electrolytic capacitors.
