Subject: 2003 Annual Site Inspection and Monitoring Compliance Report for UMTRCA Title II Disposal Sites

2003 Annual Site Inspection and Monitoring Compliance Report for Uranium Mill Tailings Radiation Control Act Title II Disposal Sites

November 2003

**Bluewater, New Mexico
Edgemont, South Dakota
Sherwood, Washington**

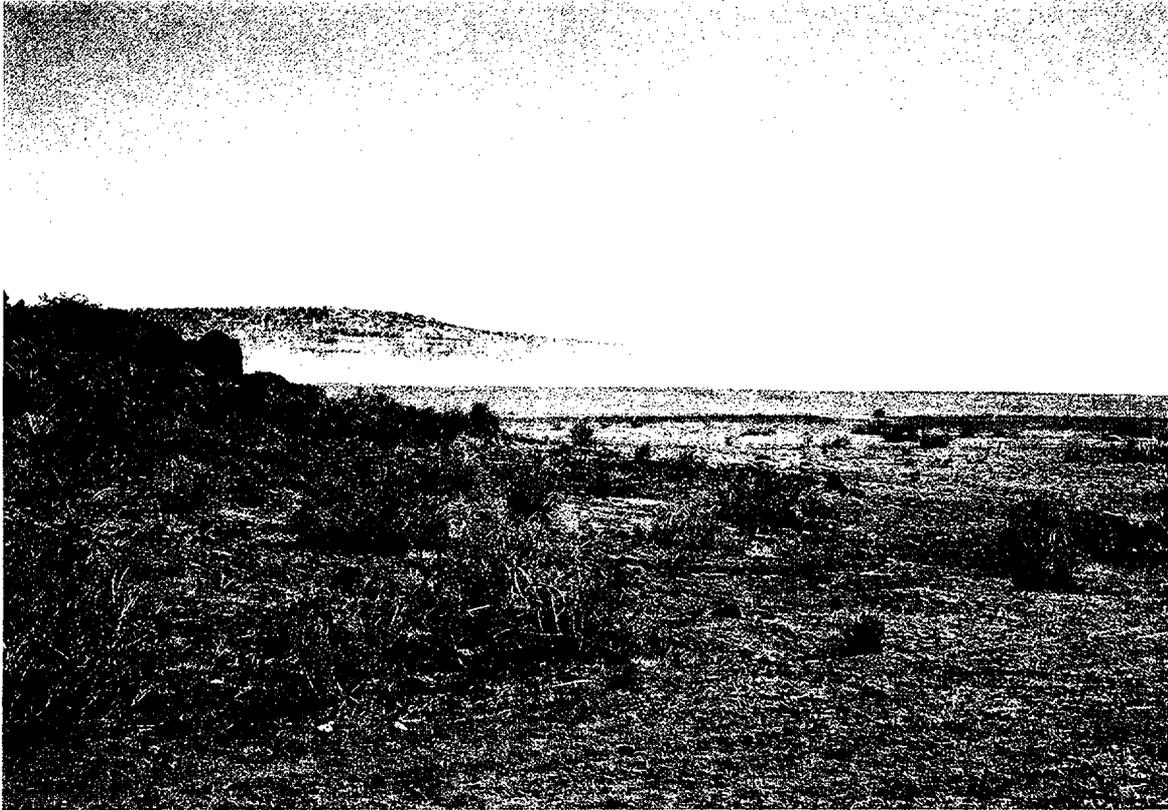
High winds occurring during the inspection were blowing a significant amount of sand and causing dust clouds (PL-1 and PL-2). Consequently the features shown in some of the photographs included in this report are less distinct than they would be under better weather conditions.

BLU 5/2003. PL-1. Blowing sand and dust, view north from north end of main tailings pile.

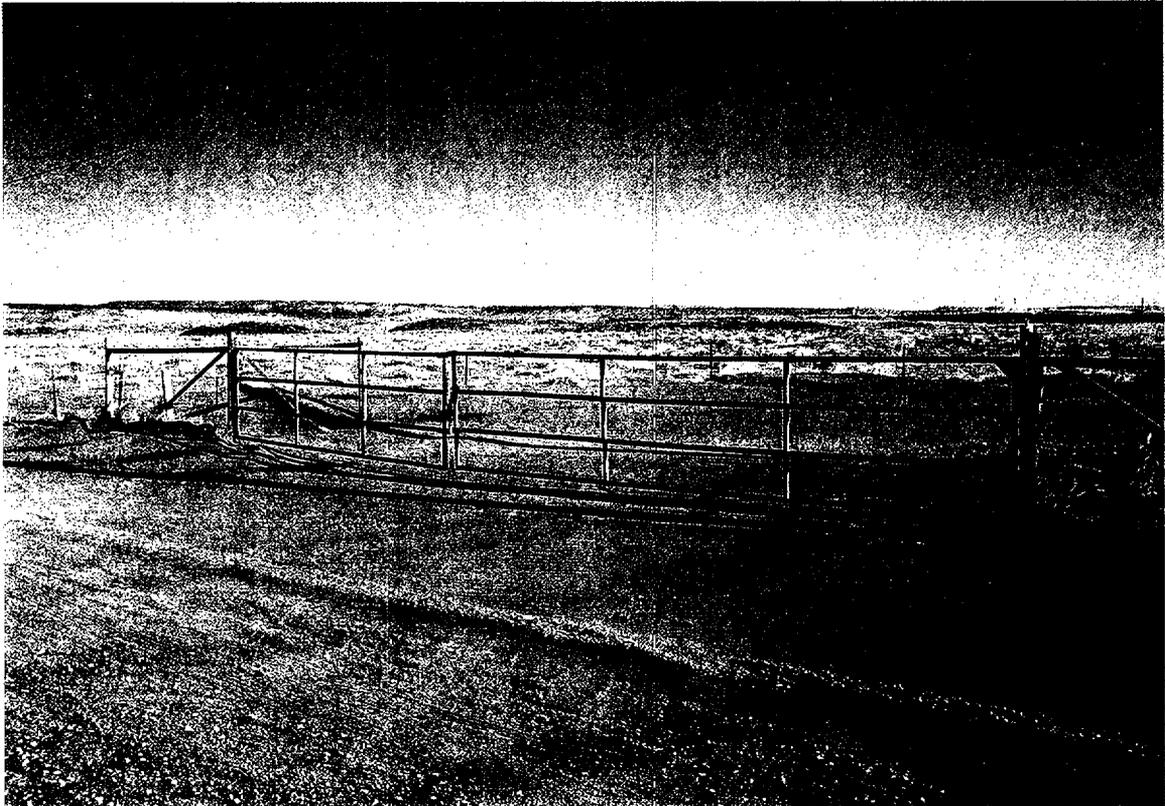
The entrance gate (at County Road 334) is a steel, double-swing stock gate. A chain and padlocks belonging to DOE and various utility companies that have rights-of-way across the site secure the gate. The access road leads from the entrance gate to the access gate. The access road is an all-weather road surfaced with crushed basalt and extends northward, along a narrow strip of DOE property, for approximately 1,700 feet to the site access gate. The access gate also is a steel, double-swing stock gate secured by padlocks keyed the same as the entrance gate. The entrance gate, access road, and access gate are in excellent condition. A significant amount of windblown sand had accumulated at the entrance gate (PL-3) and to open the gate, the inspectors had to force it through a small sand dune.

BLU 5/2003. PL-3. Entrance gate and windblown sand at County Road 334.

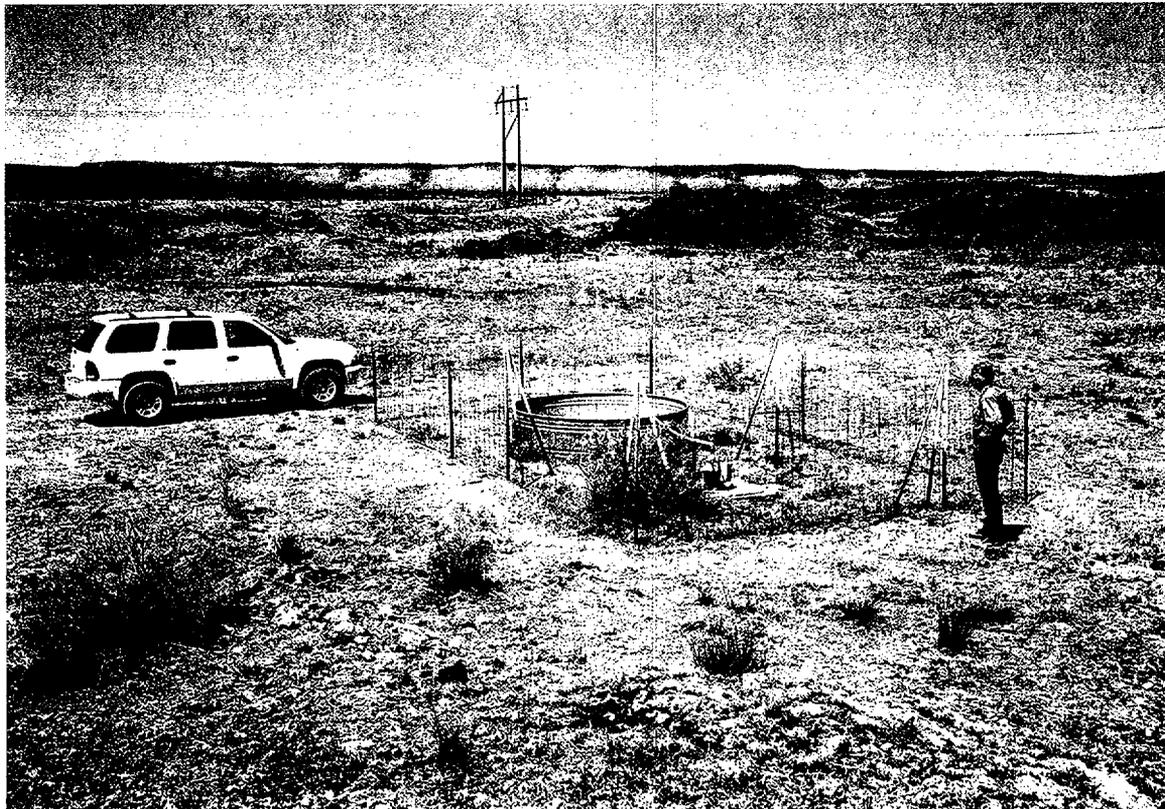
Wells previously had dedicated pumps, flow tubes, and stock tanks to contain purge water. Protective fencing placed around each well in 2001 to mitigate livestock damage was in good condition (PL-4). Tanks were missing from E(M) and Y2(M). Surface support equipment for the monitor wells (wiring and PVC pipes) is weathered and in poor condition but does not impact sampling activities.

BLU 5/2003. PL-4. Monitor well L(SG) and protective fencing.

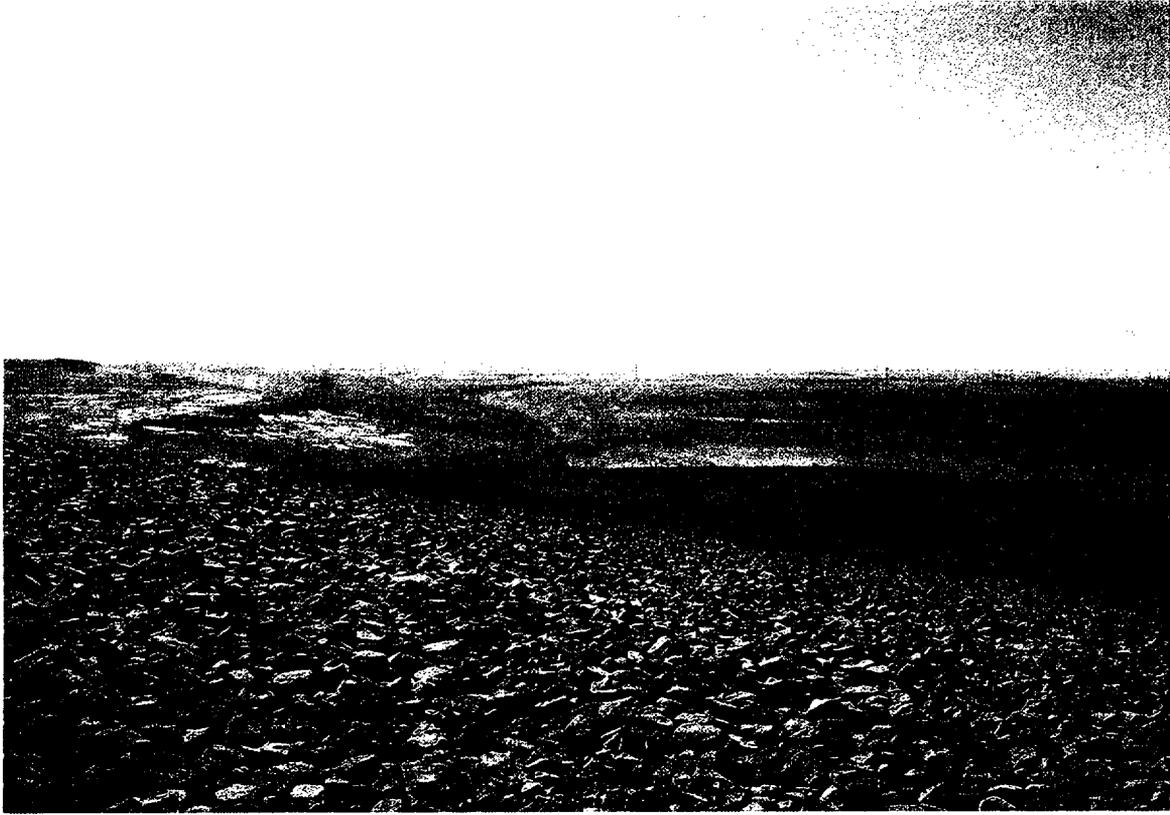
BLU 5/2003. PL-9. South bench tailings area.

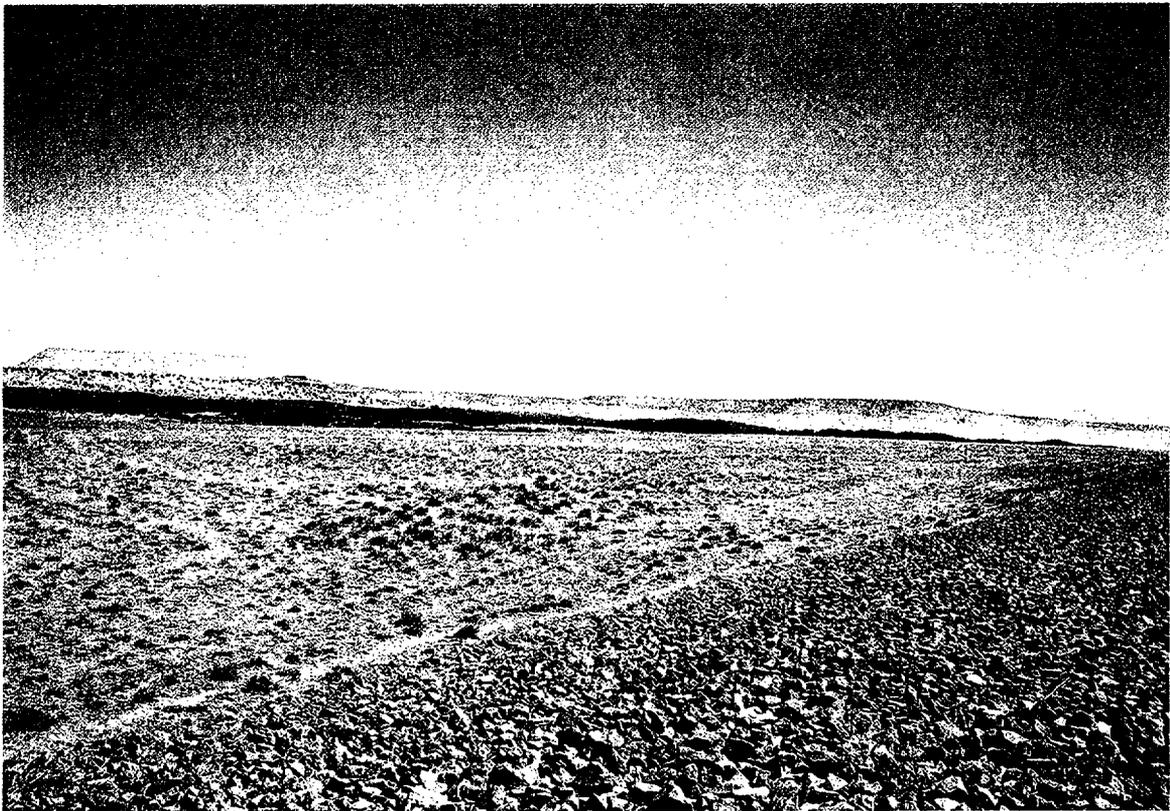
BLU 5/2003. PL-10. Cover over acid tailings.

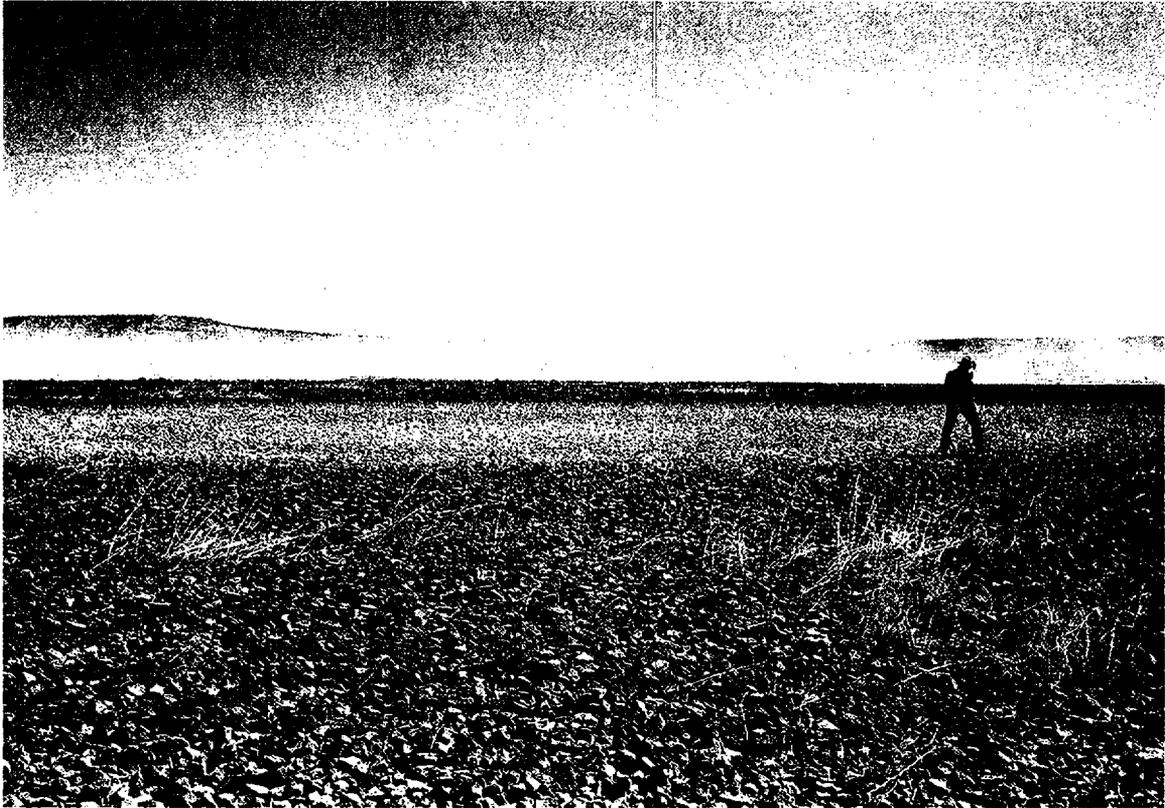
The low spots are the result of settlement or an artifact of construction. Slimes from the settling ponds were placed in the northern part of the main tailings disposal cell and areas containing slimes are more likely to settle than areas containing drier waste materials. However, a grade of less than 0.5 percent is hard to achieve over an area as large as the north end of the main tailings disposal cell. Either mechanism could account for the depressions. One small depression that was observed for the first time during this inspection has a distinctly bowl-like shape (PL-11). This depression is most likely the result of settlement.

BLU 5/2003. PL-11. Bowl shaped depression on north edge of main tailings pile.

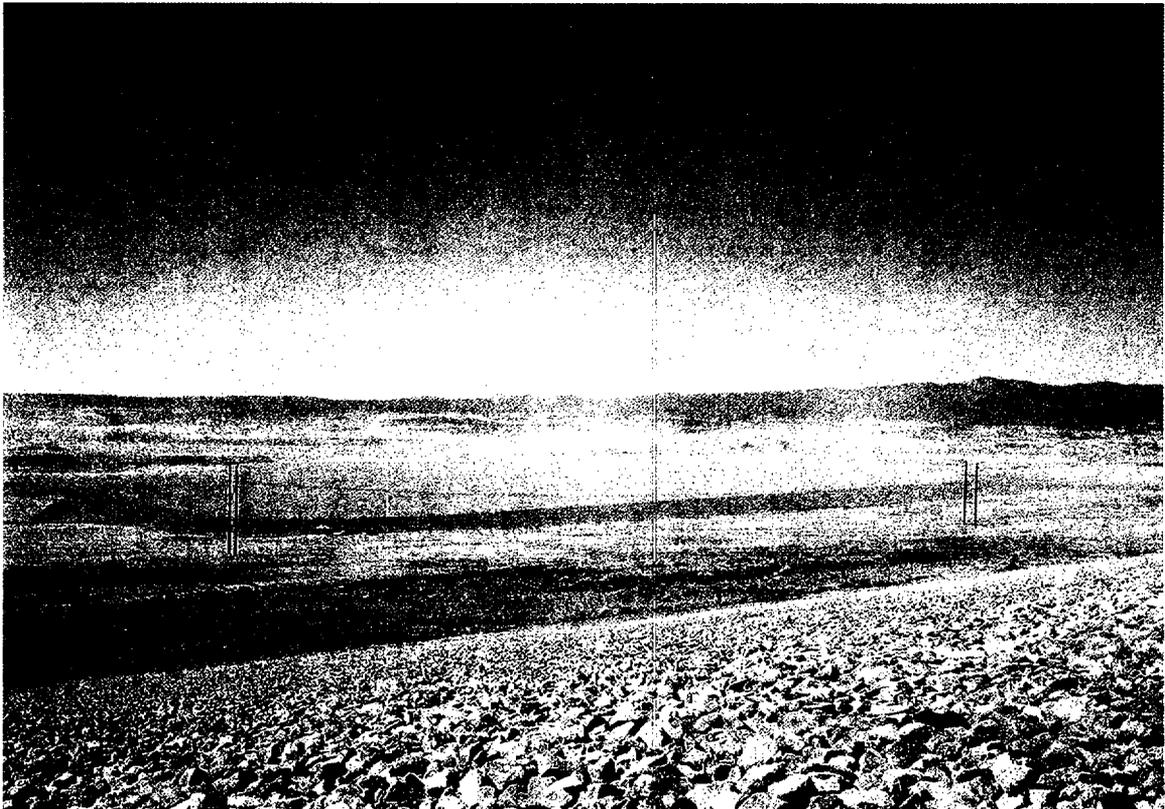
The top and side slopes of the carbonate tailings disposal cell are covered by basalt riprap (PL-12). The top, for the most part, slopes gently eastward. The small northwest and southeast extensions slope in their respective directions. The carbonate tailings disposal cell and its extensions are in excellent condition.

BLU 5/2003. PL-12. Carbonate tailings pile.

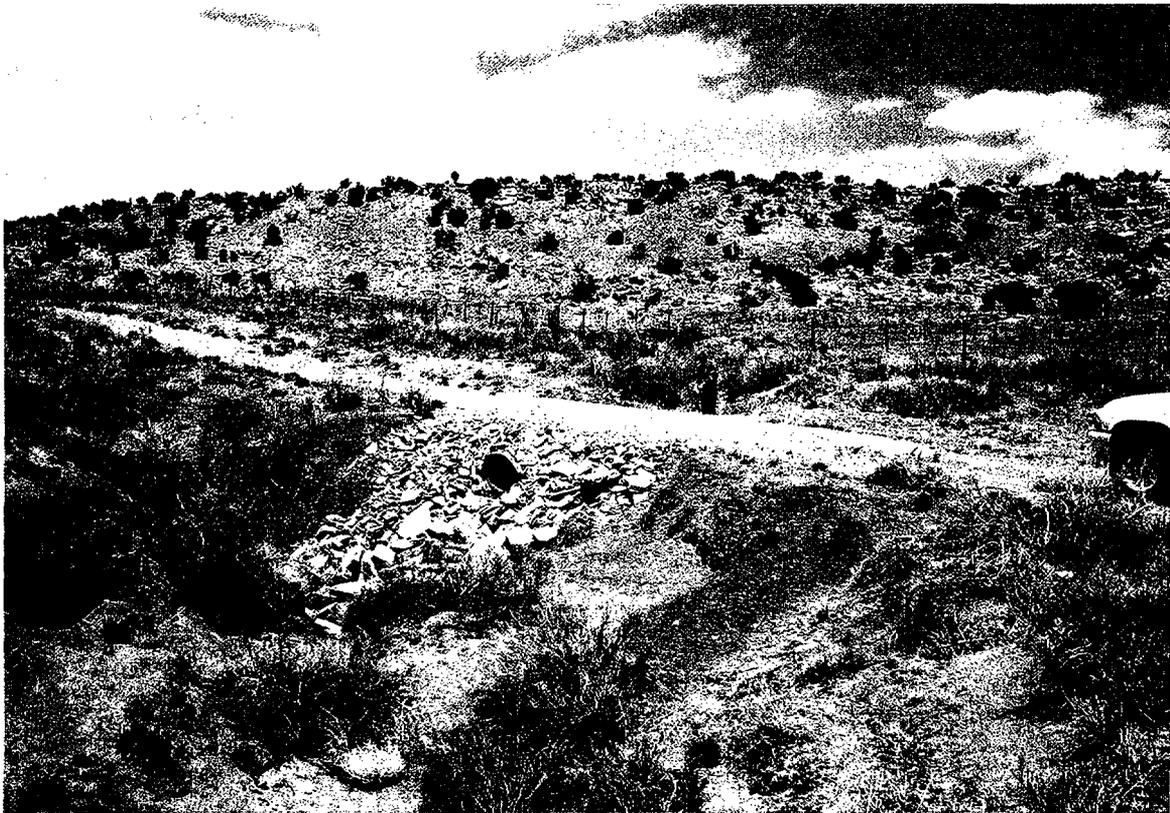
The perimeter road consists of a dirt track covered at places with crushed basalt. The road runs along the site boundary in much of the southern and most of the northern and eastern parts of the site. Most of the road is in good to excellent condition, but will require periodic maintenance. In 2001, a culvert was installed where the road was washing out south of boundary monument BM-16. The repair was inspected and remains in excellent condition (PL-13).

BLU 5/2003. PL-13. Culvert near BM-16, installed in 2001.

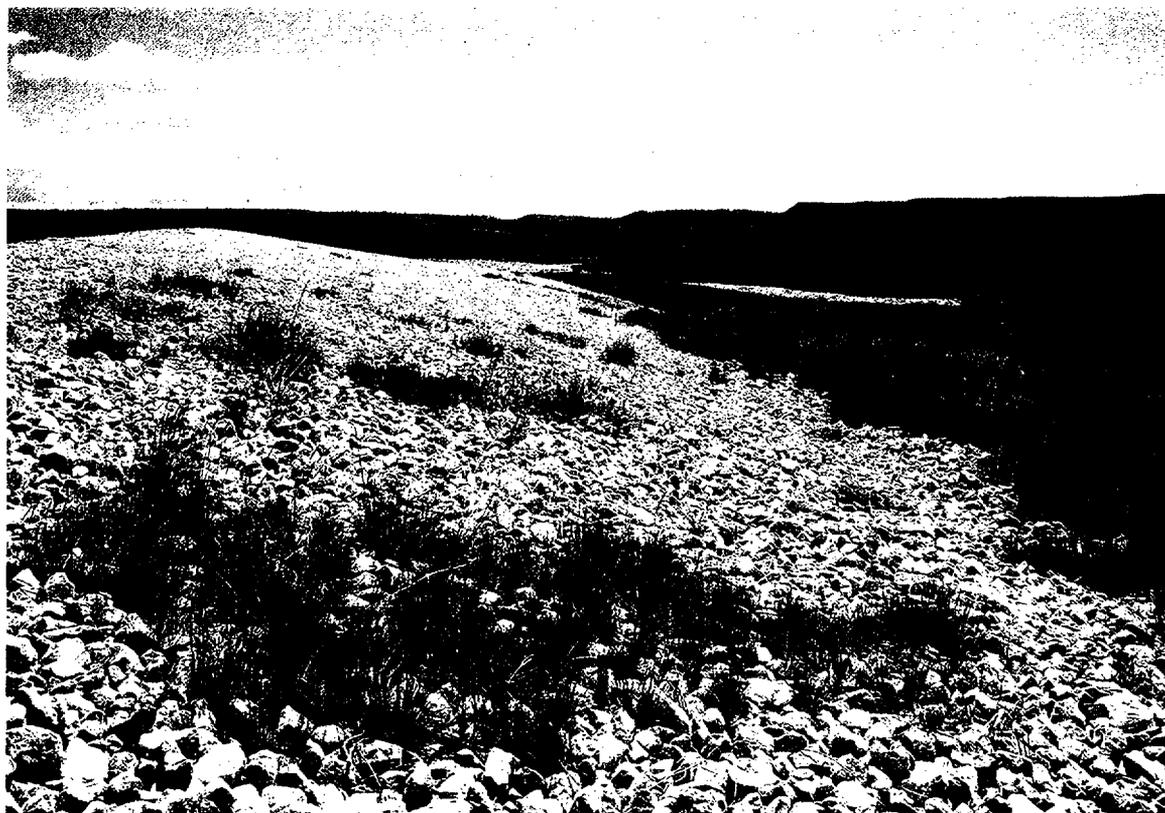
The tailings dam face, the steepest slope on site, is covered with riprap. The slope is stable and the riprap shows no signs of degradation. Scattered plants, mostly grass, grow in the riprap (PL-2). These plants do not pose an immediate threat to stability or function of this structure. The plant density has not increased over the last few years. Plant density in the riprap dam face will continue to be evaluated during future inspections.

EDG 6/2003. PL-2. Embankment face.

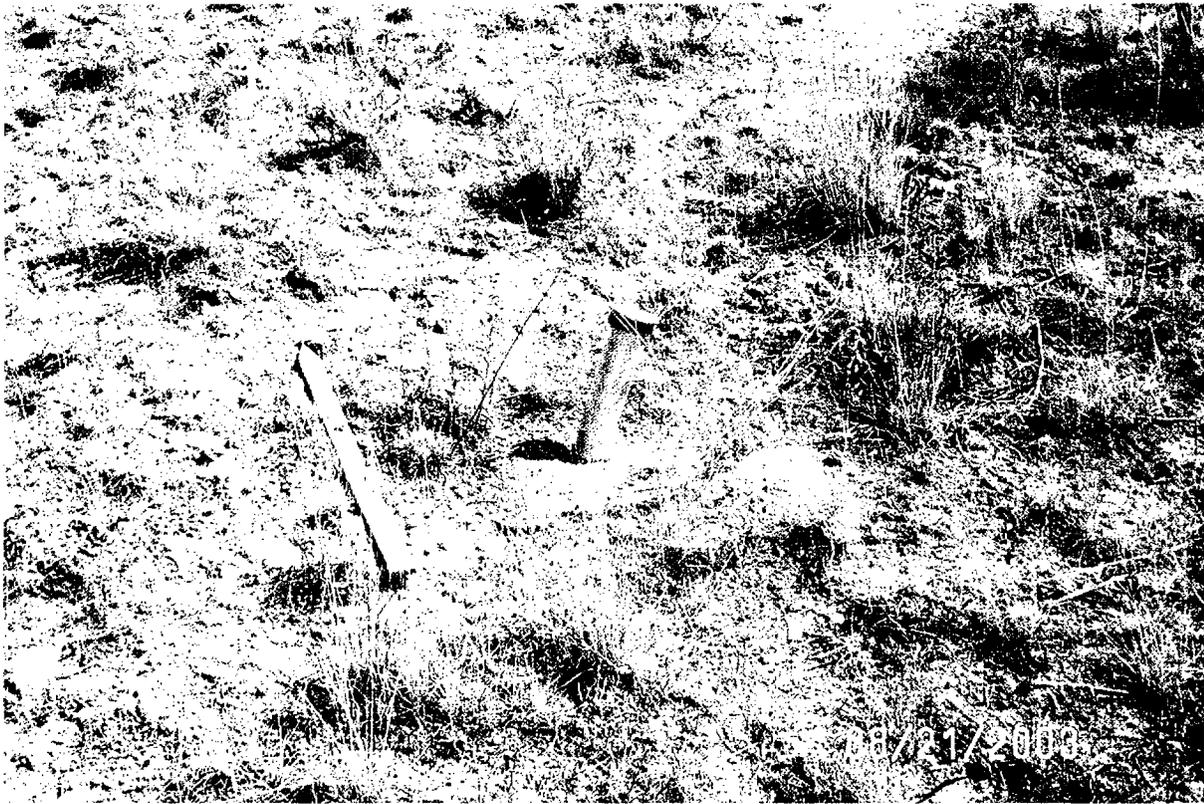
Six boundary monuments designated BM-1, BM-2, BM-3, BM-3A, BM-4, and BM-5 define the site boundary. Inspectors noted that BM-3A had been bent (PL-1); all other monuments were in excellent condition.

SHE 8/2003. PL-1. Boundary monument 3A, bent.

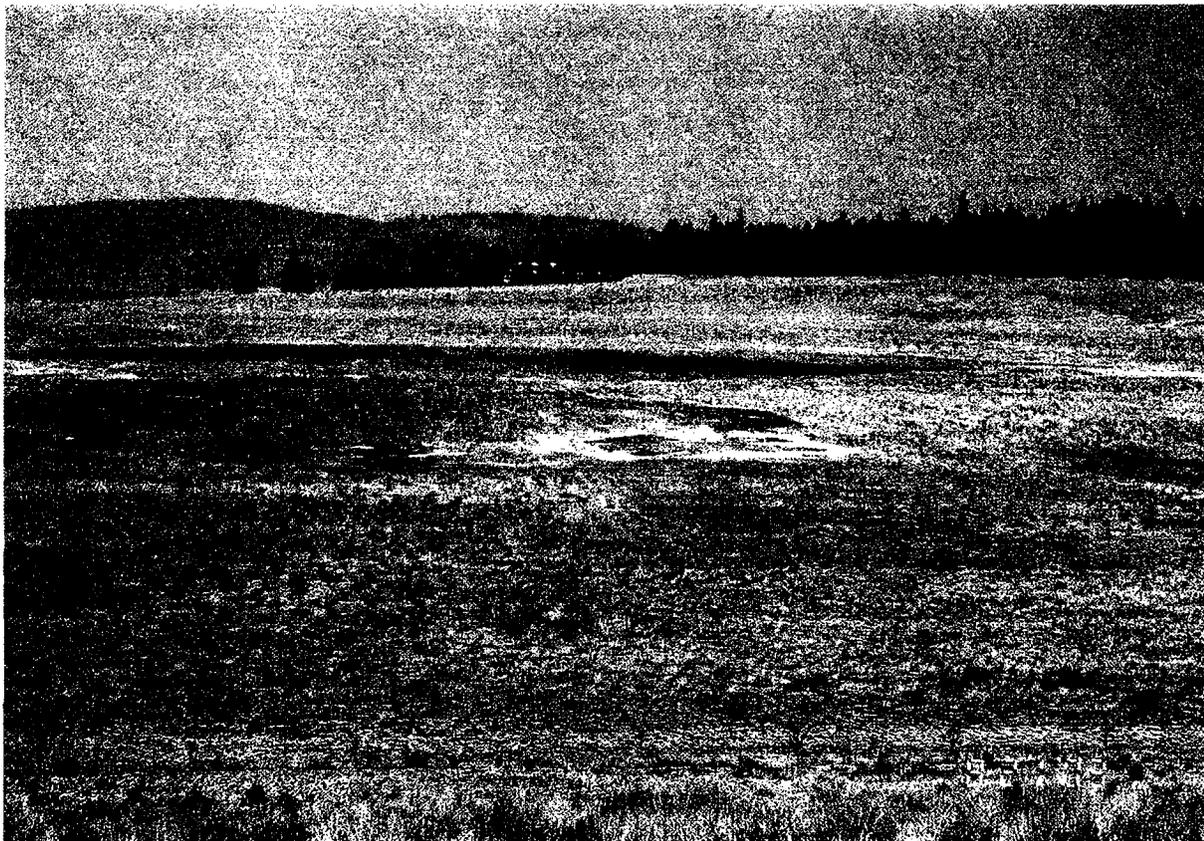
Inspectors noted an additional settlement area east of the existing pond area (PL-2). This low-lying area, 3 to 5 acres in size, contains riparian vegetation and shows indications of having saturated soils during certain times of the year. There was no water in this settled area at the time of the inspection.

SHE 8/2003. PL-2. Additional settlement area on top of tailings impoundment; pond area (dark green) is in background.

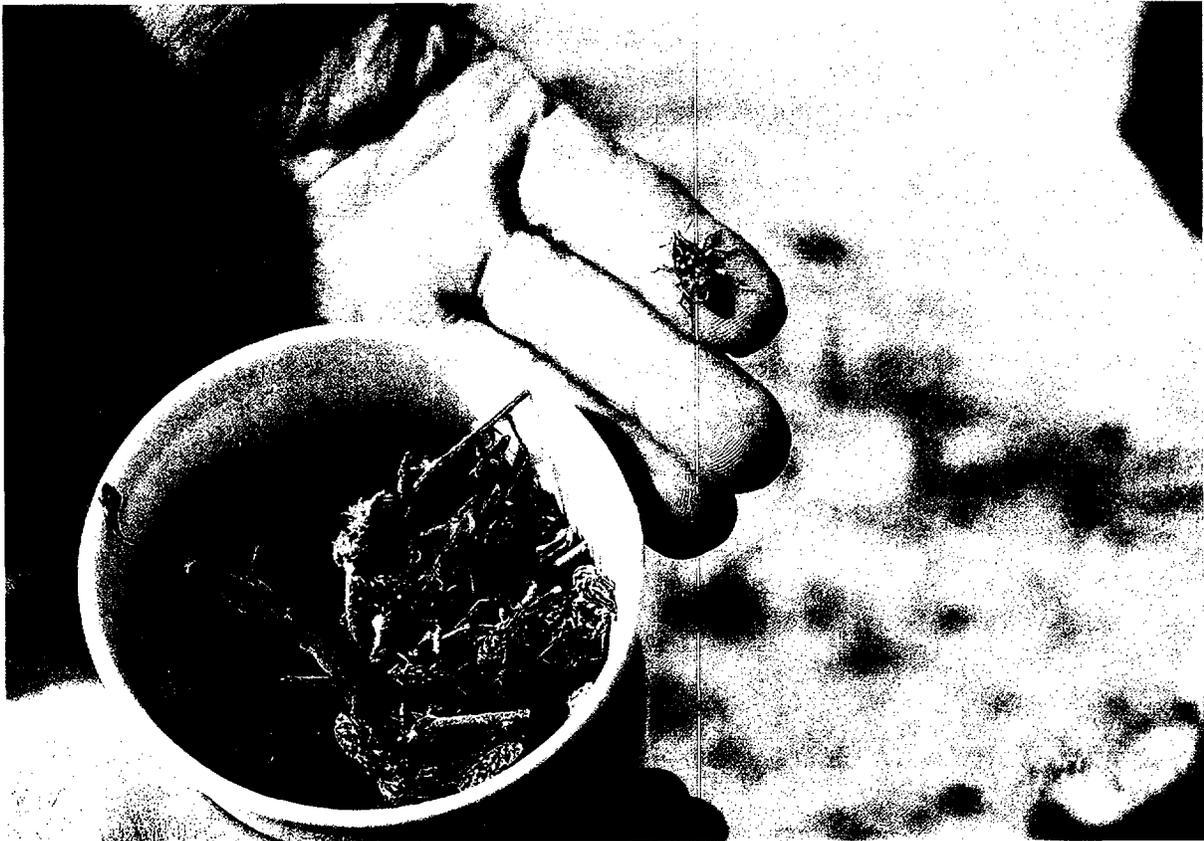
SHE 8/2003. PL-3. Knapweed root weevil (Cyphocleonus achates).

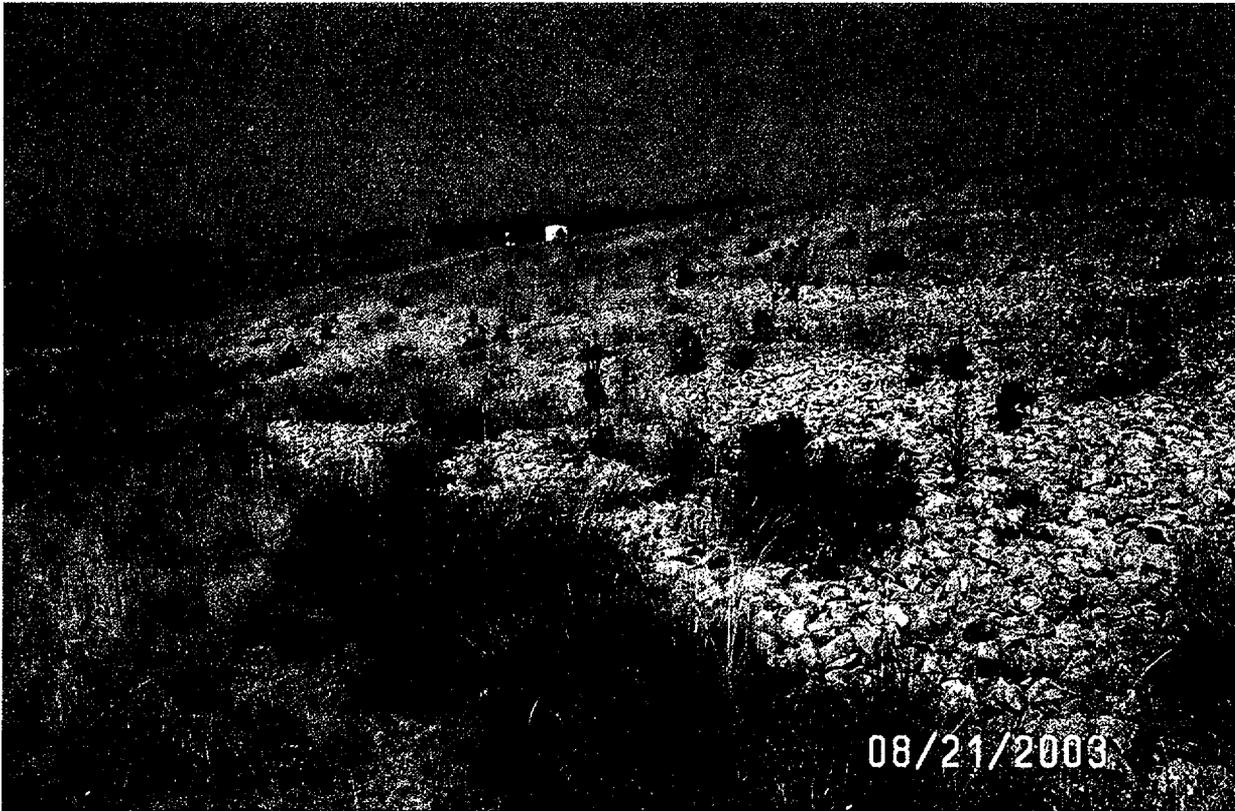
The tailings embankment on this site, classified as a dam, necessitates a dam safety inspection to assure continued compliance with the Federal Dam Safety Act. The impoundment dam face was inspected in accordance with the attached Dam Inspection Checklist and photographed (PL-4 and PL-5). No evidence of seepage, slumping, erosion, or instability was observed. Ponderosa pines, some as tall as 24 inches, were observed on the face.

SHE 8/2003. PL-5. Embankment face showing vegetation encroachment.

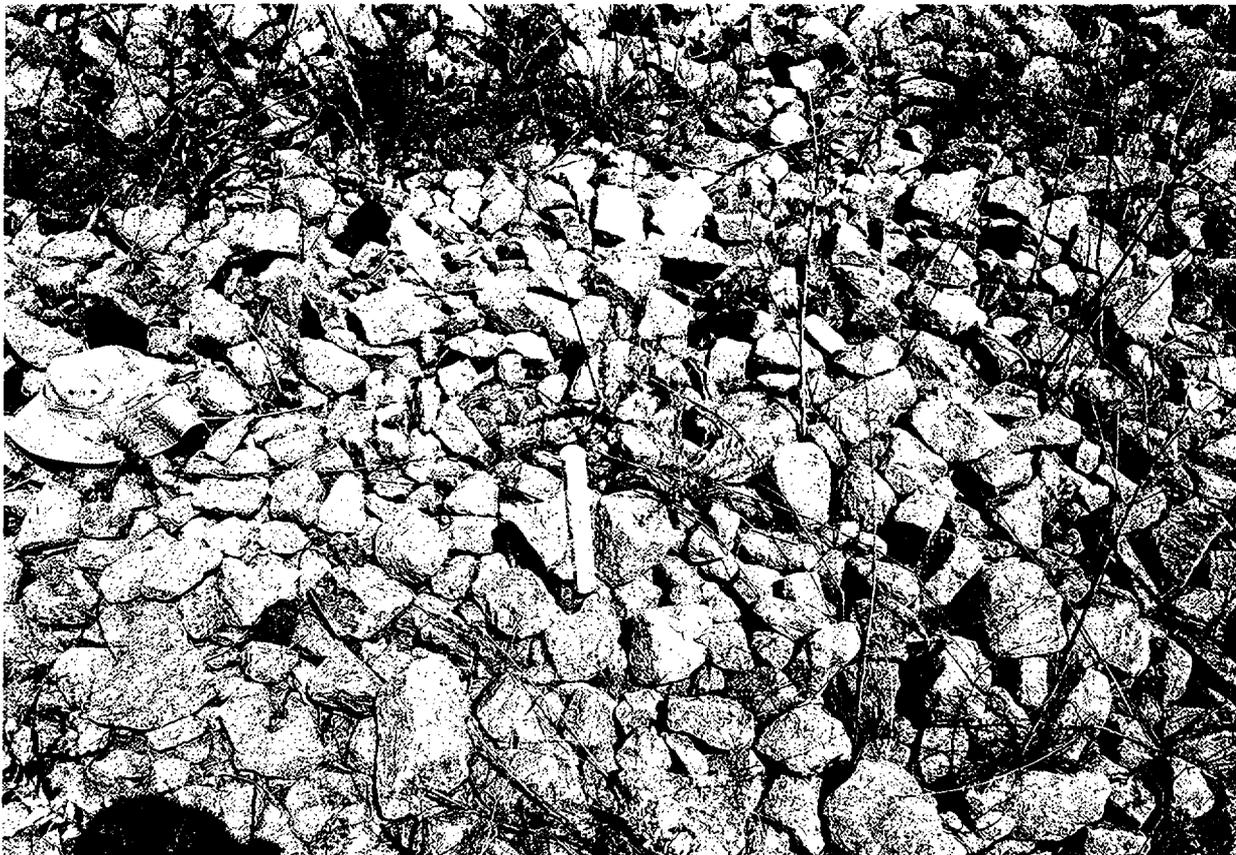
SHE 8/2003. PL-6. Rock Plot 1.

with a sleeve of PVC pipe or a section of PVC pipe at the center of each plot and obtained location information using global positioning system equipment. Baseline photographs were taken of each plot (facing a northerly direction) (PL-6 through PL-9). Photography should be repeated during future inspections for comparison to baseline rock quality. Future inspectors may recommend changes to the plot inspection frequency or cessation of monitoring.

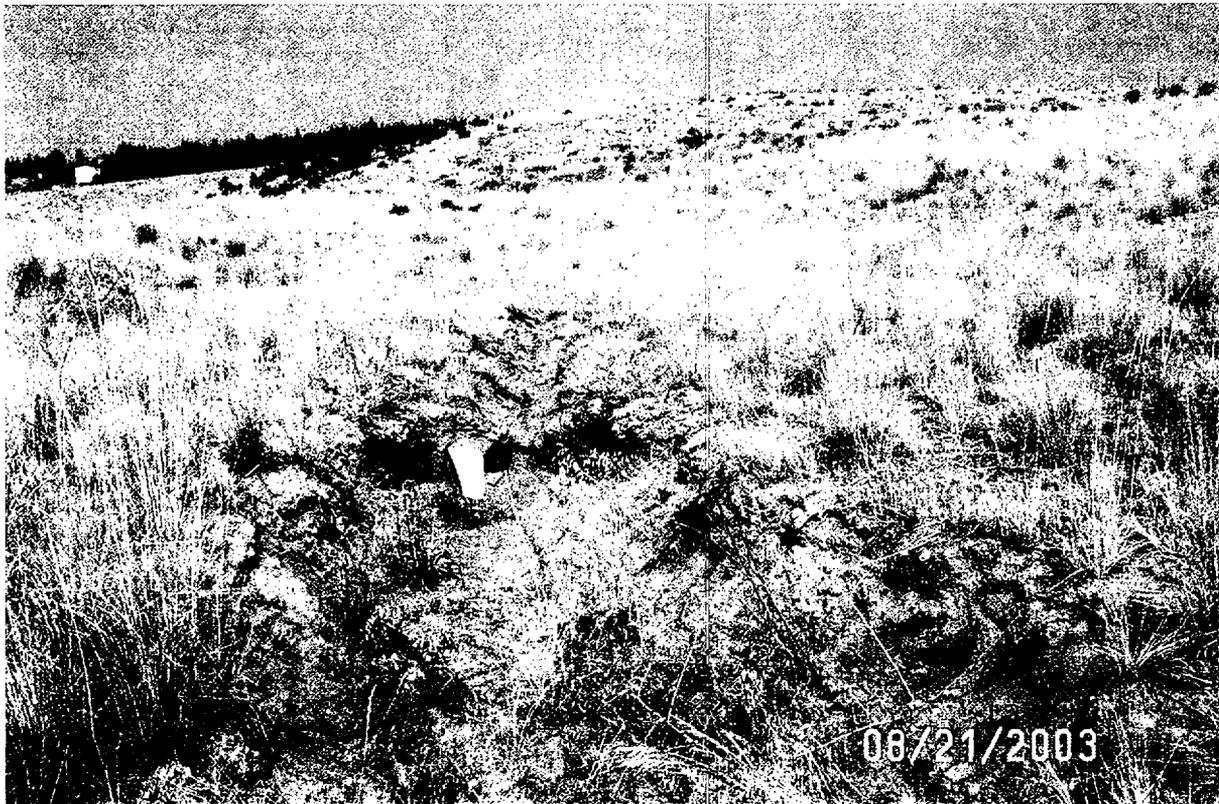
Adjacent to the eastern end of the dam face is a steep slope that is underlain by rock and covered with soil. Numerous rills and gullies noted during previous annual inspections were inspected on this slope (PL-10 through PL-13). No new rills were identified, and the size of existing rills had not increased since the 2001 and 2002 inspections. Although these erosional features do not threaten site integrity, they should be inspected annually to ensure the slope remains stable and sediment is not transported offsite.

SHE 8/2003. PL-11. Gully and headcut below riprap-armored portion of swale east of embankment face.

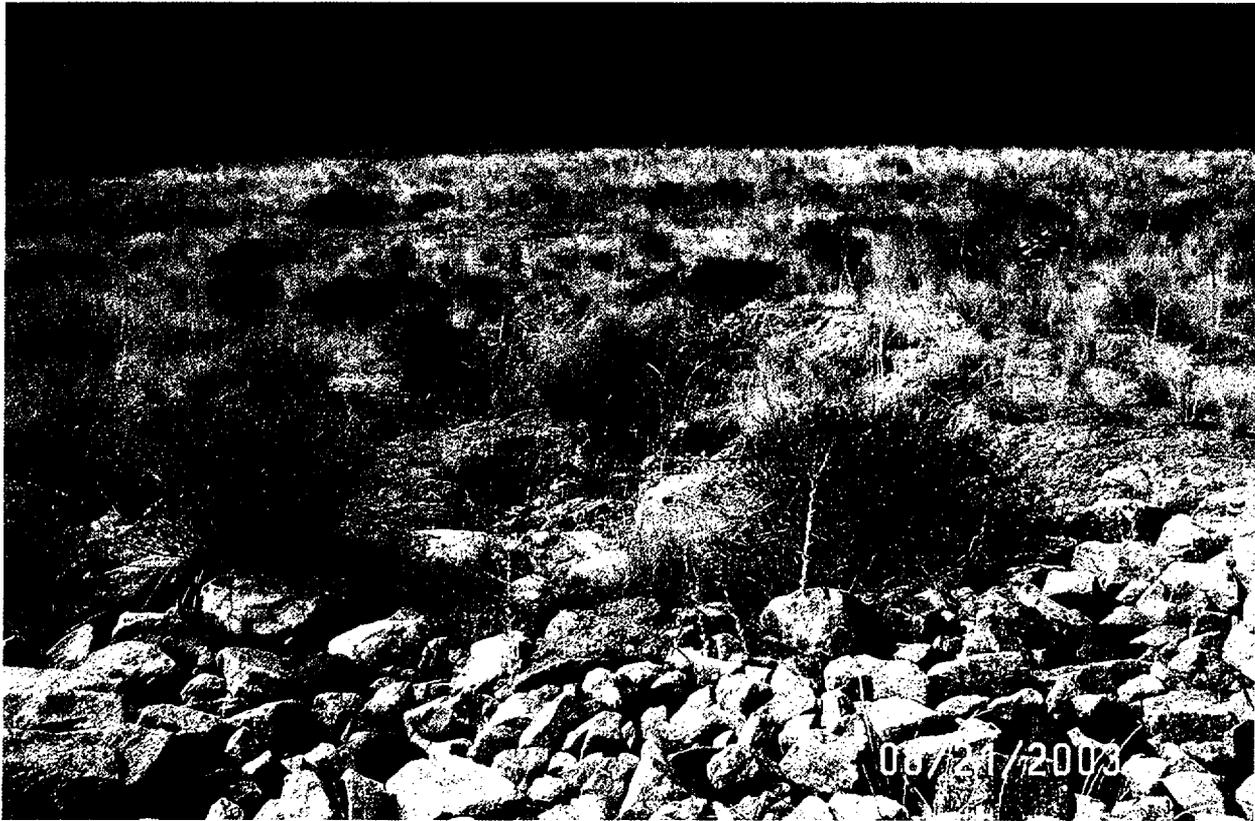
SHE 8/2003. PL-13. Gully below riprap-armored portion of swale east of embankment face.
