# A Hydrologic Assessment of the September 14, 1974, Flood in Eldorado Canyon, Nevada

By PATRICK A. GLANCY and LYNN HARMSSEN

GEOLOGICAL SURVEY PROFESSIONAL PAPER 930

*A presentation of hydrologic data and interpretations,  
eyewitness accounts of destruction,  
and documentation of flooding*

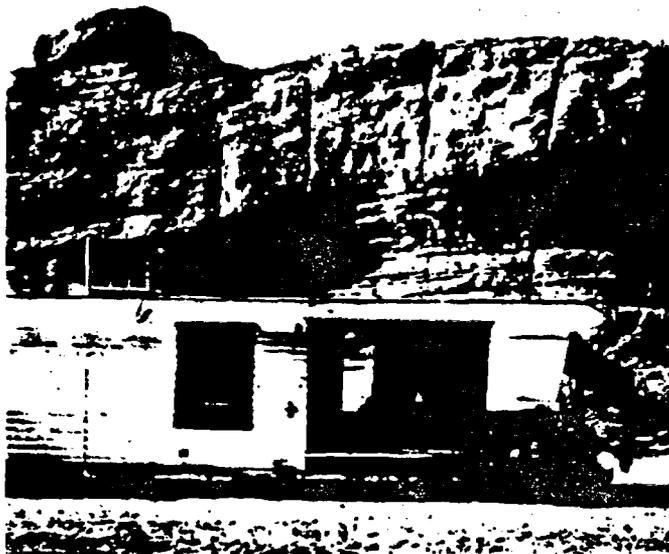
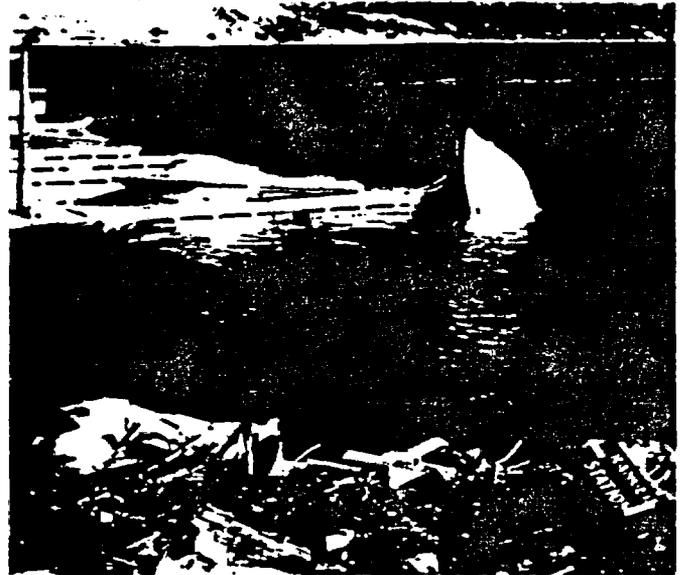
docks, the general location of a number of other specific cultural features, and qualitatively describes the nature of the damage sustained. Several photographs of damage to structures and vehicles near the canyon mouth are shown in figure 1. Figure 16 shows an overall view of the heavily damaged trailer park area. When viewing the damage shown in figures 1 and 16, keep in mind that the vehicles and structures receiving the greatest damage are not visible because they were either totally demolished or buried in Lake Mohave. Therefore, the photographs give a somewhat conservative view of the effects of the flood.

FIGURE 1.—Flood-damaged trailer, truck, and boats.

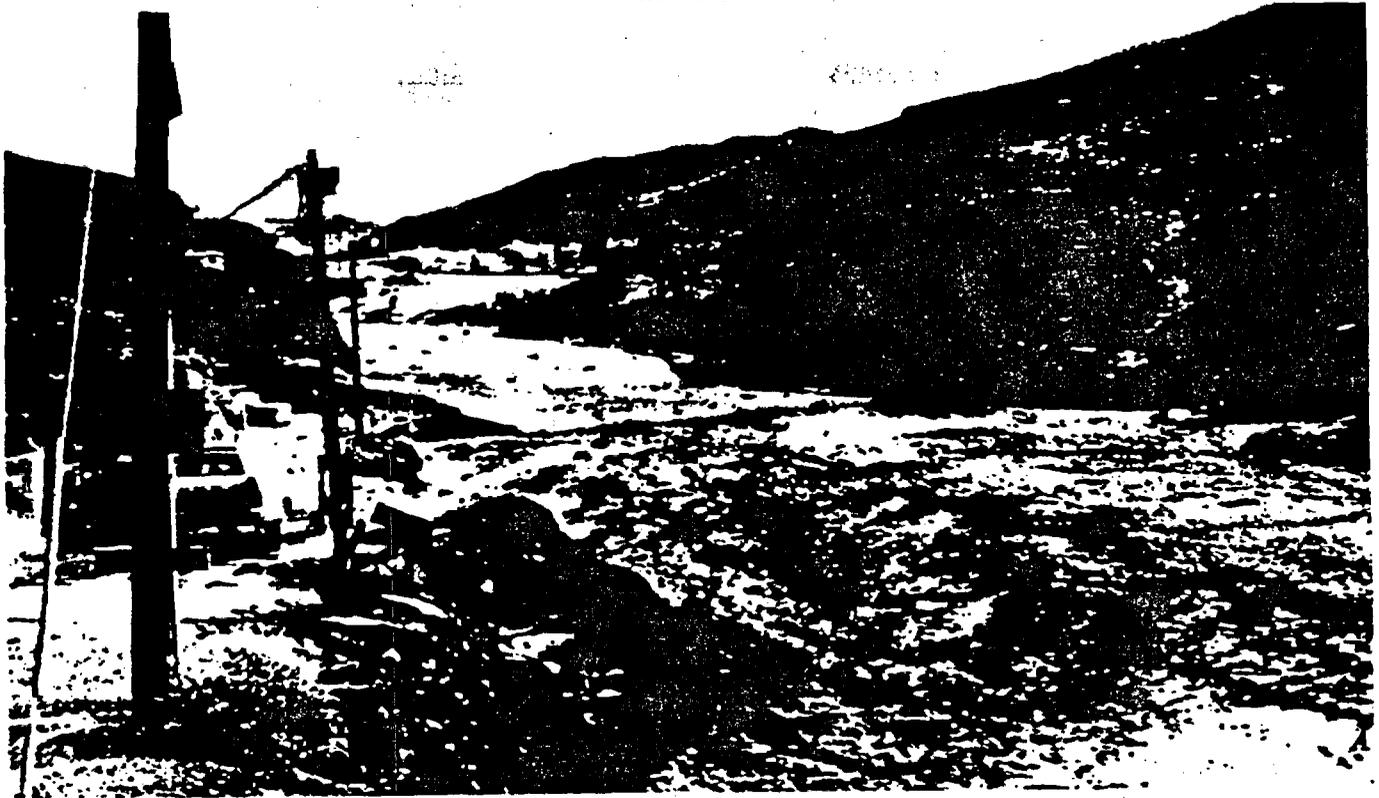
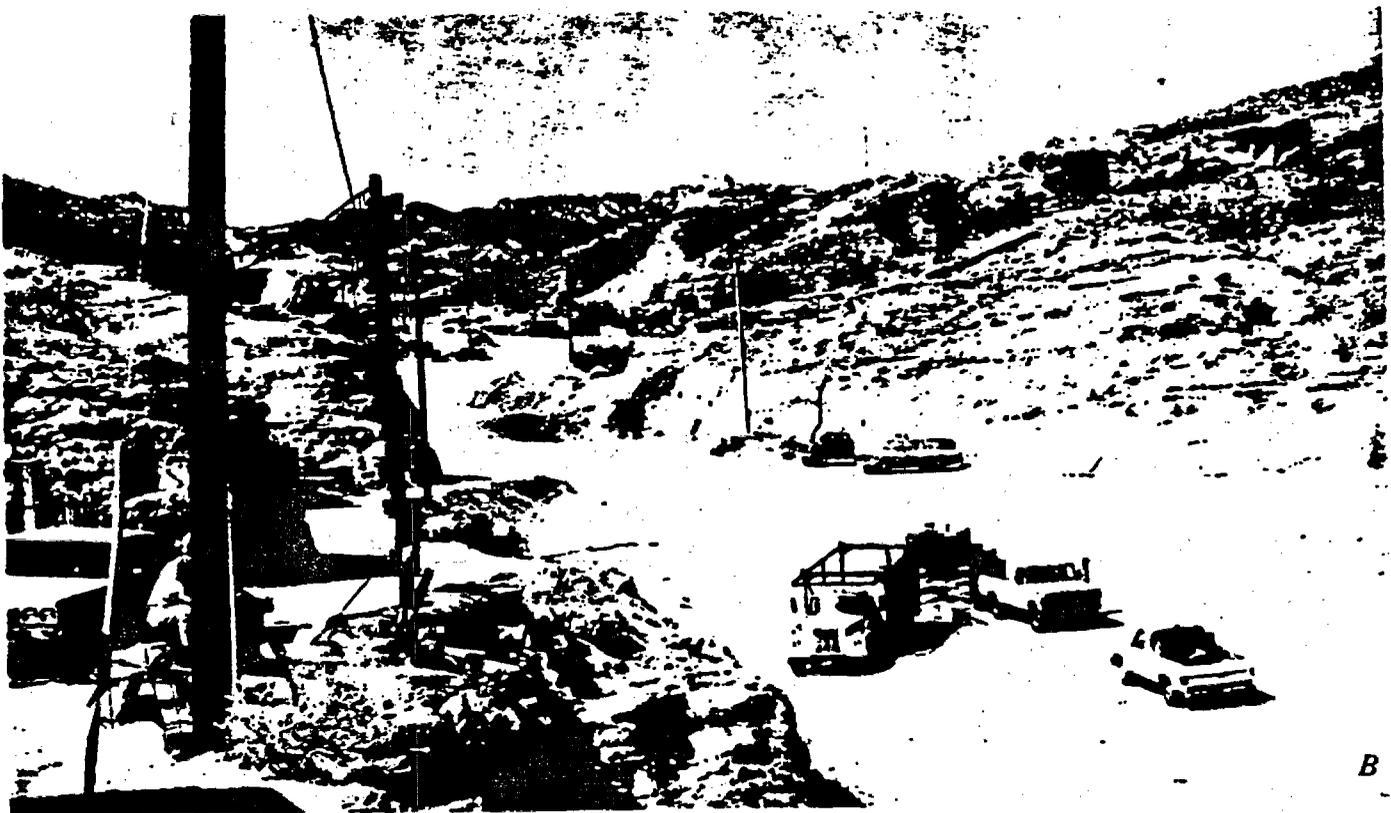
FIGURE 7.—Mouth of Eldorado Canyon. *A*. On September 14, 1974, probably during the late recession of flooding (photograph by Kenneth E. Beales, Las Vegas, Nevada). *B*. On October 1 during excavation of flood sediment deposits.

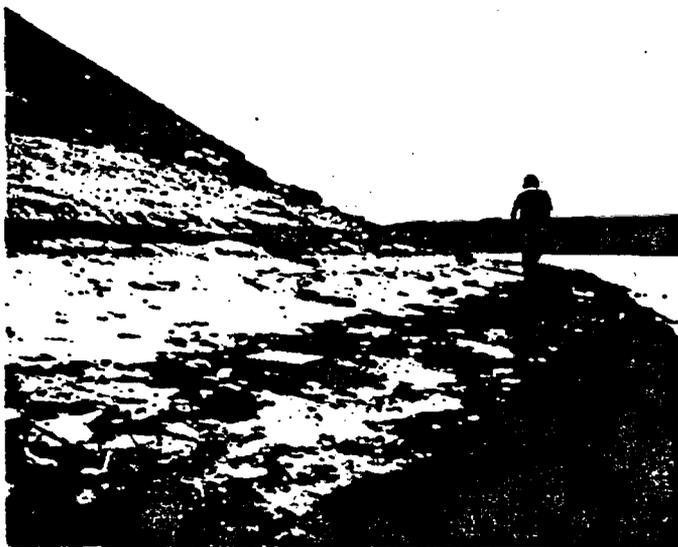
J. P. Monis and P. A. Glancy, U.S. Geological Survey, reconnoitered the east shore of Lake Mohave on September 19, 1974, for evidence of wave action caused by the flood surges entering the lake. Figure 8 shows the best noted evidence of possible flood wave action, at the base of a large sand dune across Lake Mohave about half a mile east and slightly south of the Eldorado Canyon mouth. The dune and its location relative to Eldorado Canyon are shown in the upper right part of figure 15. The horizontal cut in the sand above the flood debris (fig. 8), that was deposited before the lake was purposely drawn down to aid search-and-rescue operations, suggests a maximum wave height of about 1½ ft. However, the horizontal cut may have originated from a higher pre-flood lake stand. In any event, no known evidence was observed of flood wave action greater than about 1½ ft.

FIGURE 8.—Wave-cut bench (above debris line) along east shore of Lake Mohave, possibly caused by flood surges entering the lake.

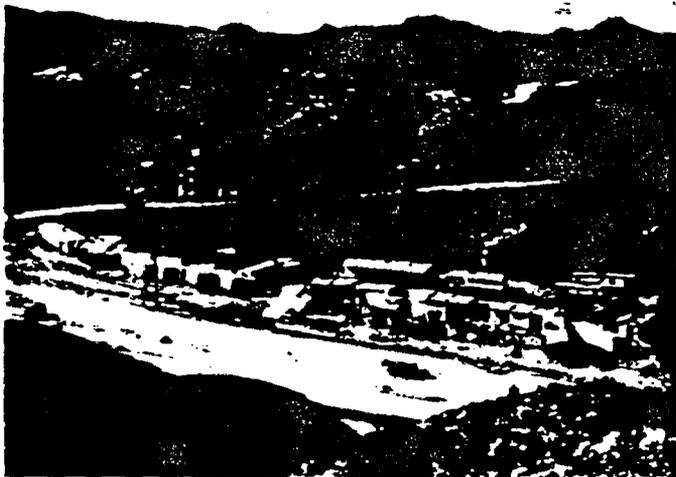
FIGURE 16.—Heavily damaged trailer park at Eldorado Canyon Resort. Afternoon, September 19, 1974.

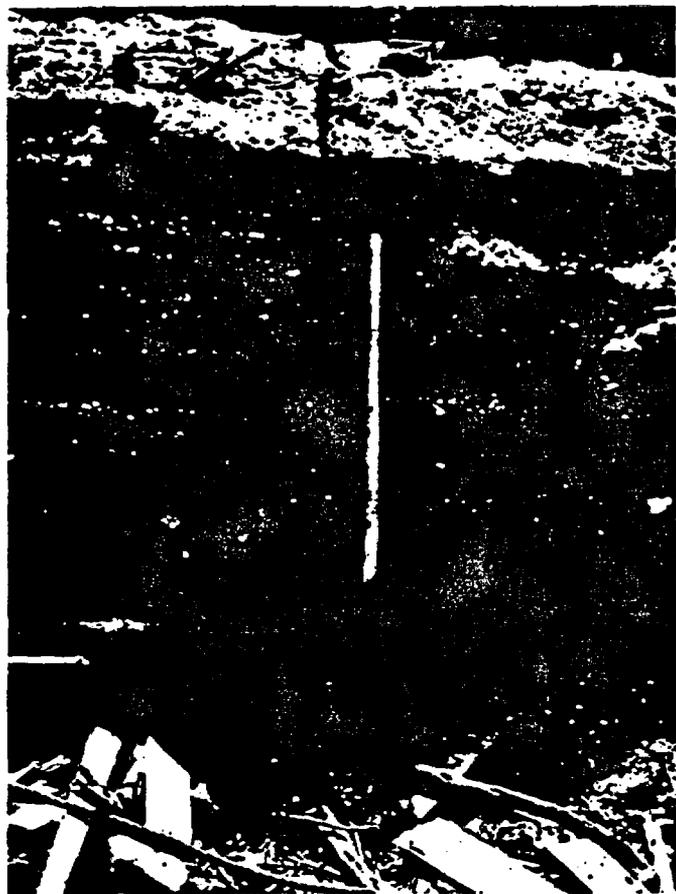
FIGURE 19.—Stratified sediment deposited at the mouth of Eldorado Canyon. Note alternating layers of mixed particle sizes with only a general impression of coarsest sediment in lowest strata.

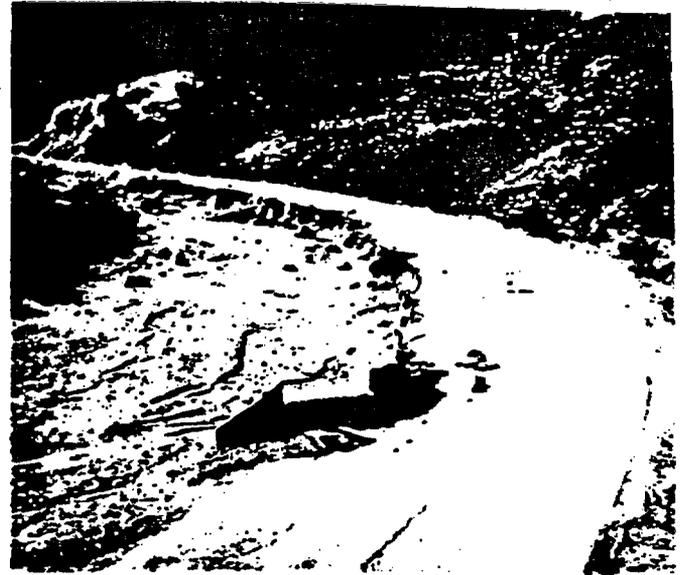
Severe lateral scour did occur in some places along major channels. Figure 27 shows examples of highway damage caused by this type of erosion.

FIGURE 27.—Highway damage in Techattacup Wash caused mainly by lateral channel scour.
