Subject: Beaver Valley Power Station, Unit No. 1 and No. 2
BV-1 Docket No. 50-334, License No. DPR-66
BV-2 Docket No. 50-412, License No. NPF-73
NRC Bulletin 2003-02
BV-2 Lower Head Inspection 60-Day Report

Evaluation Report for 2R10

RPV Lower Head Penetrations

(Ref: NRC Bulletin 2003-02)

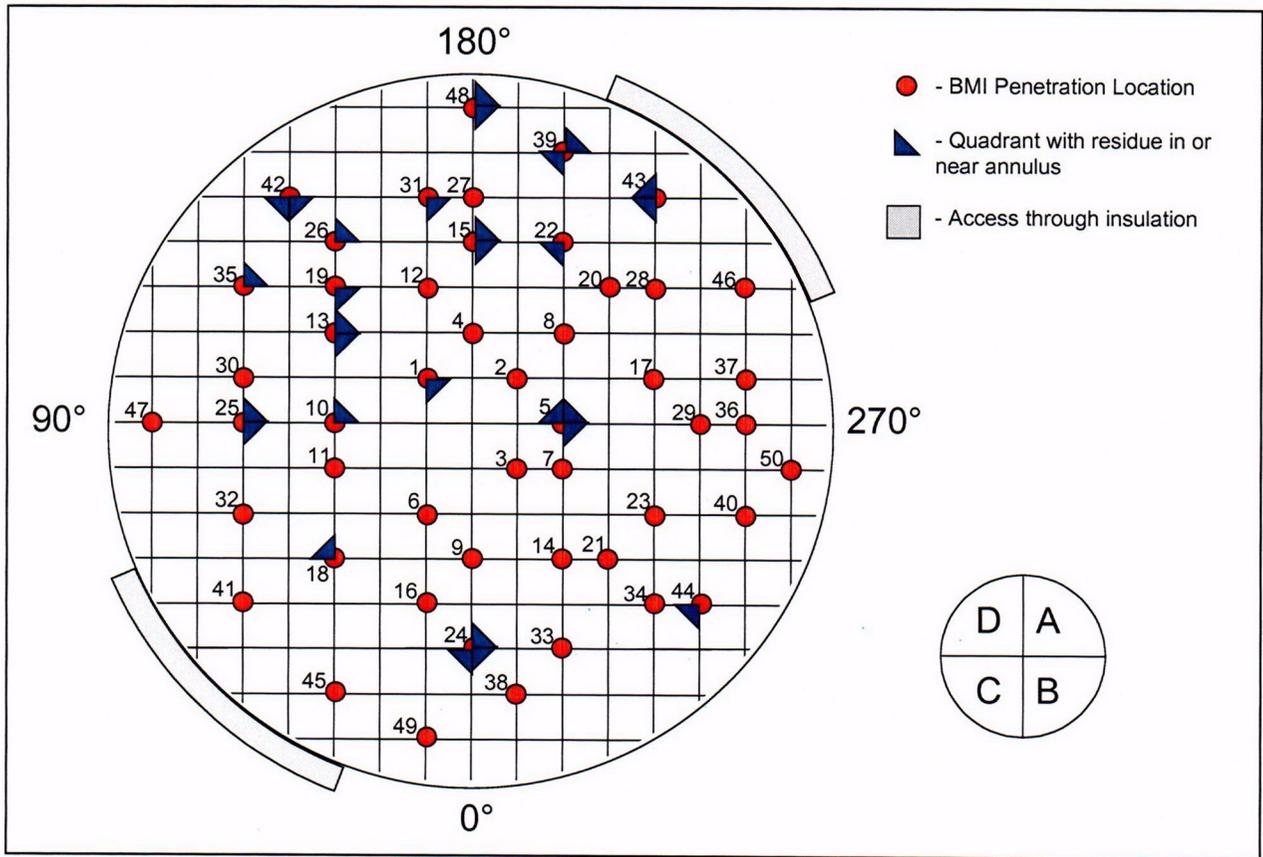
Figure 1: Locations of residue observed in or near penetration annulus.

As shown in Figure 1 of this response, residue was observed in or near the annulus on the uphill, downhill, and sidehill orientations. The residue observed on the boss around many penetrations is randomly oriented in all directions. As shown in Figure 2, similar residue is observed on the vessel surface as well.

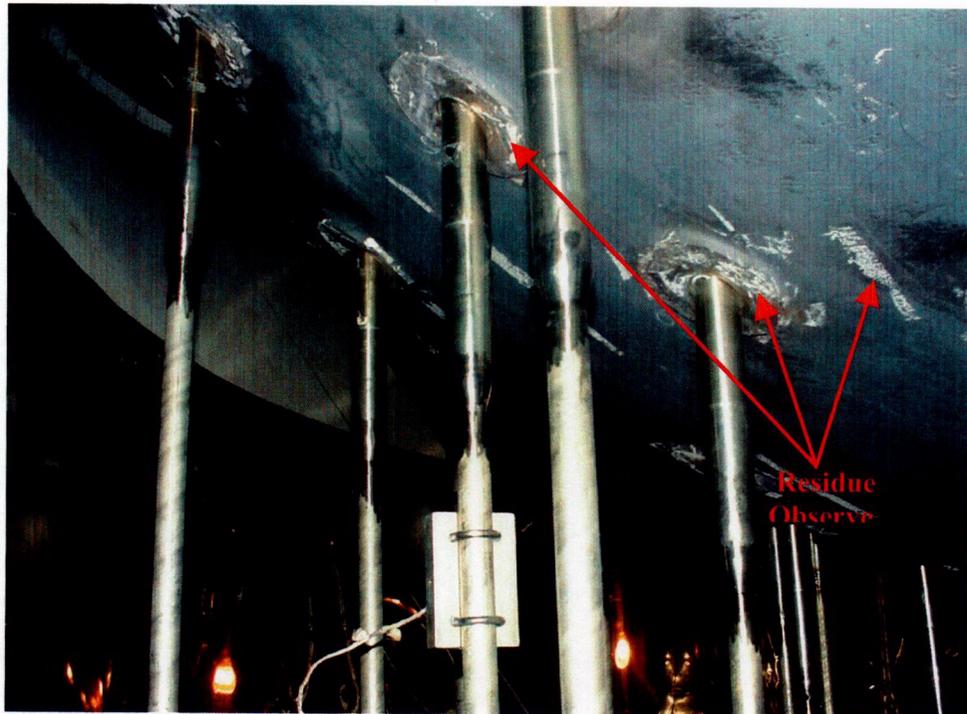
Figure 2: BVPS Unit 2 lower head observed during 2R10.

There is evidence of residue on or around virtually every nozzle as shown in Figure 2. However, only 18 penetrations showed residue in or near the annulus and were thus called out for further evaluation during the visual exam.

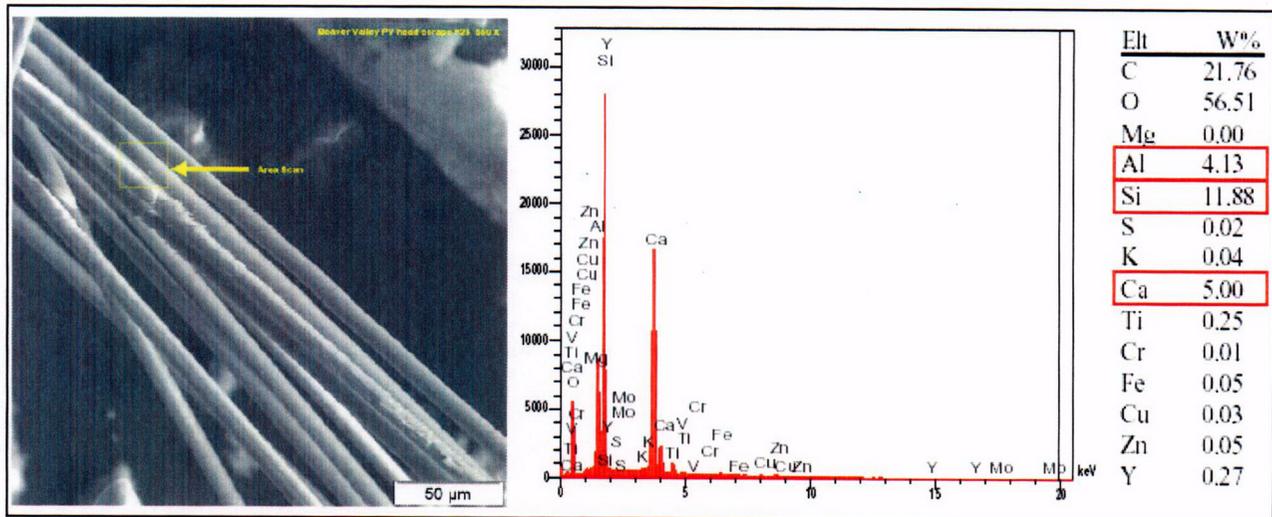
Figure 7: SEM-EDS analysis of fibers visible on particle scraped from the annulus of Penetration 25. Note the significant amounts Al, Si, and Ca present.

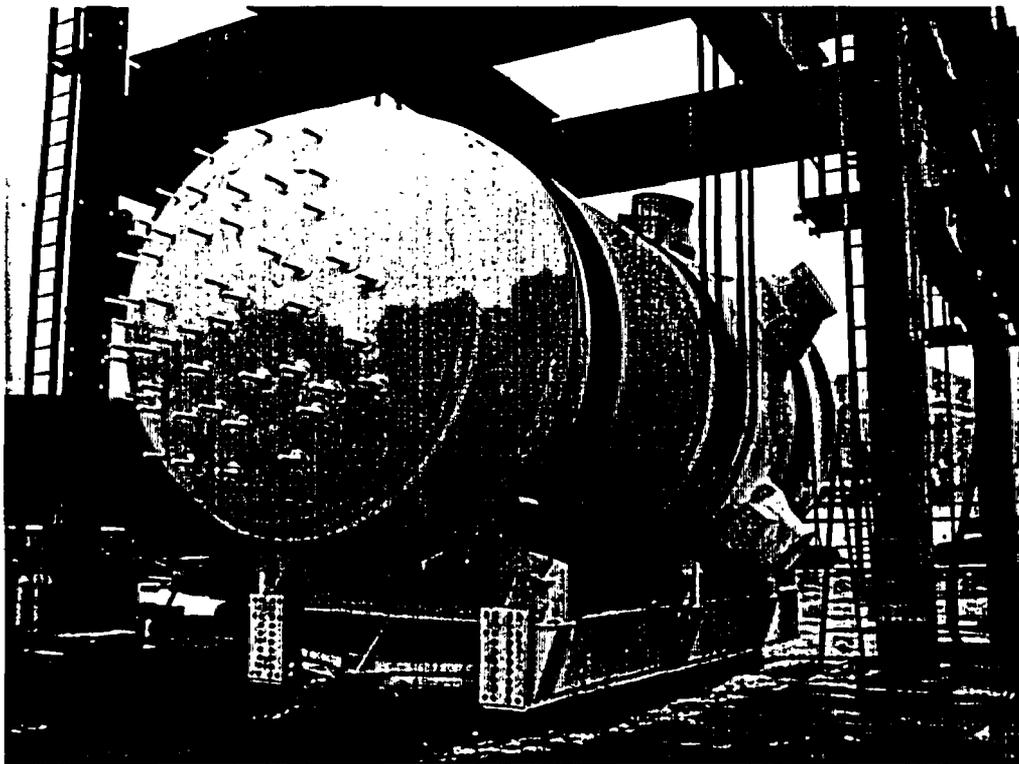
An image of the Beaver Valley Unit 2 pressure vessel prior to installation is shown in Figure 8. Note the bright appearance from the Spraylat protective coating on the outer surface in the black and white photograph.

Figure 8: BVPS Unit 2 reactor vessel with Spraylat coating applied.

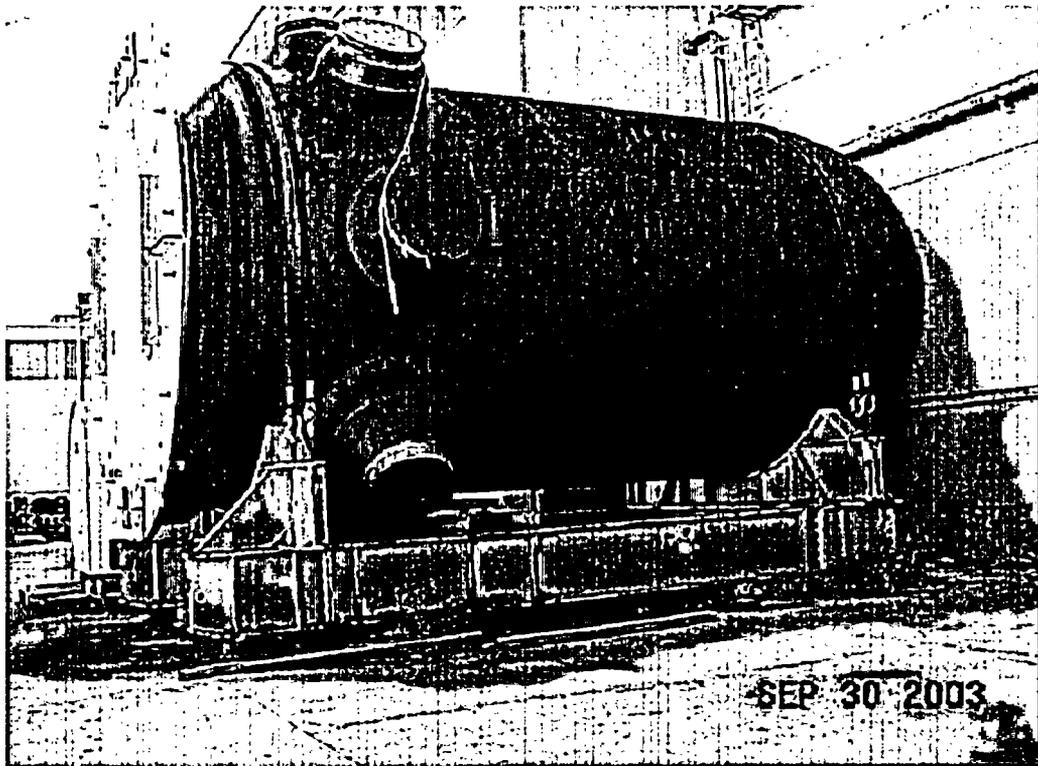
Figure 9: A Nuclear Reactor Pressure Vessel from a Cancelled Order (Note: This vessel has been stored outside at the Westinghouse-CE Chattanooga Site for over 20 years.)

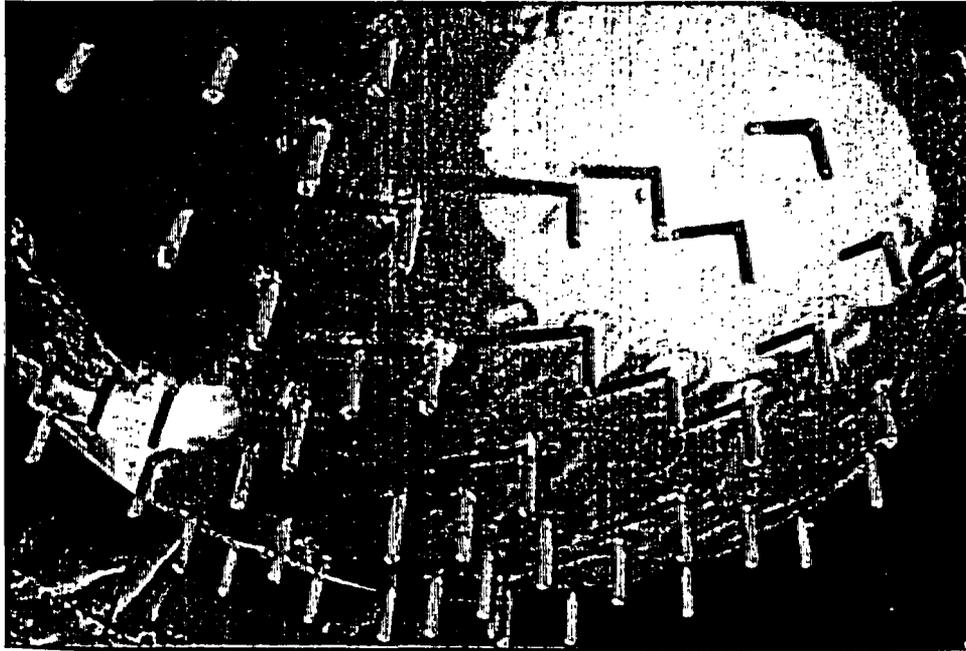
Figure 12: Bottom head of another CE vessel of similar vintage to BVPS Unit 2 with packaging of the BMI penetrations intact.
