Point Beach Nuclear Plant, Units 1 and 2
Dockets 50-266 and 50-301
License Nos. DPR-24 and DPR 27
Supplemental Response To NRC Bulletins 2001-01, 2002-01, And 2002-02 For
Reactor Vessel Head And Vessel Head Penetration Nozzle Inspection Findings

ENCLOSURE 1
**PBNP Unit 1 Reactor Pressure Vessel Head and Vessel Head Penetration Nozzle
Inspection Discussion**

Framatome ANP, NCR 602883, Revision 1 (and associated discussion)

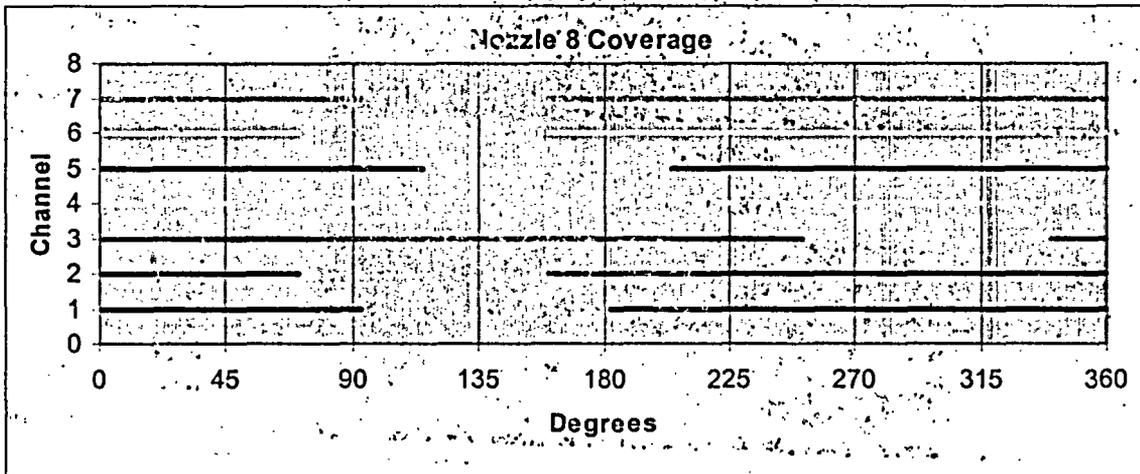
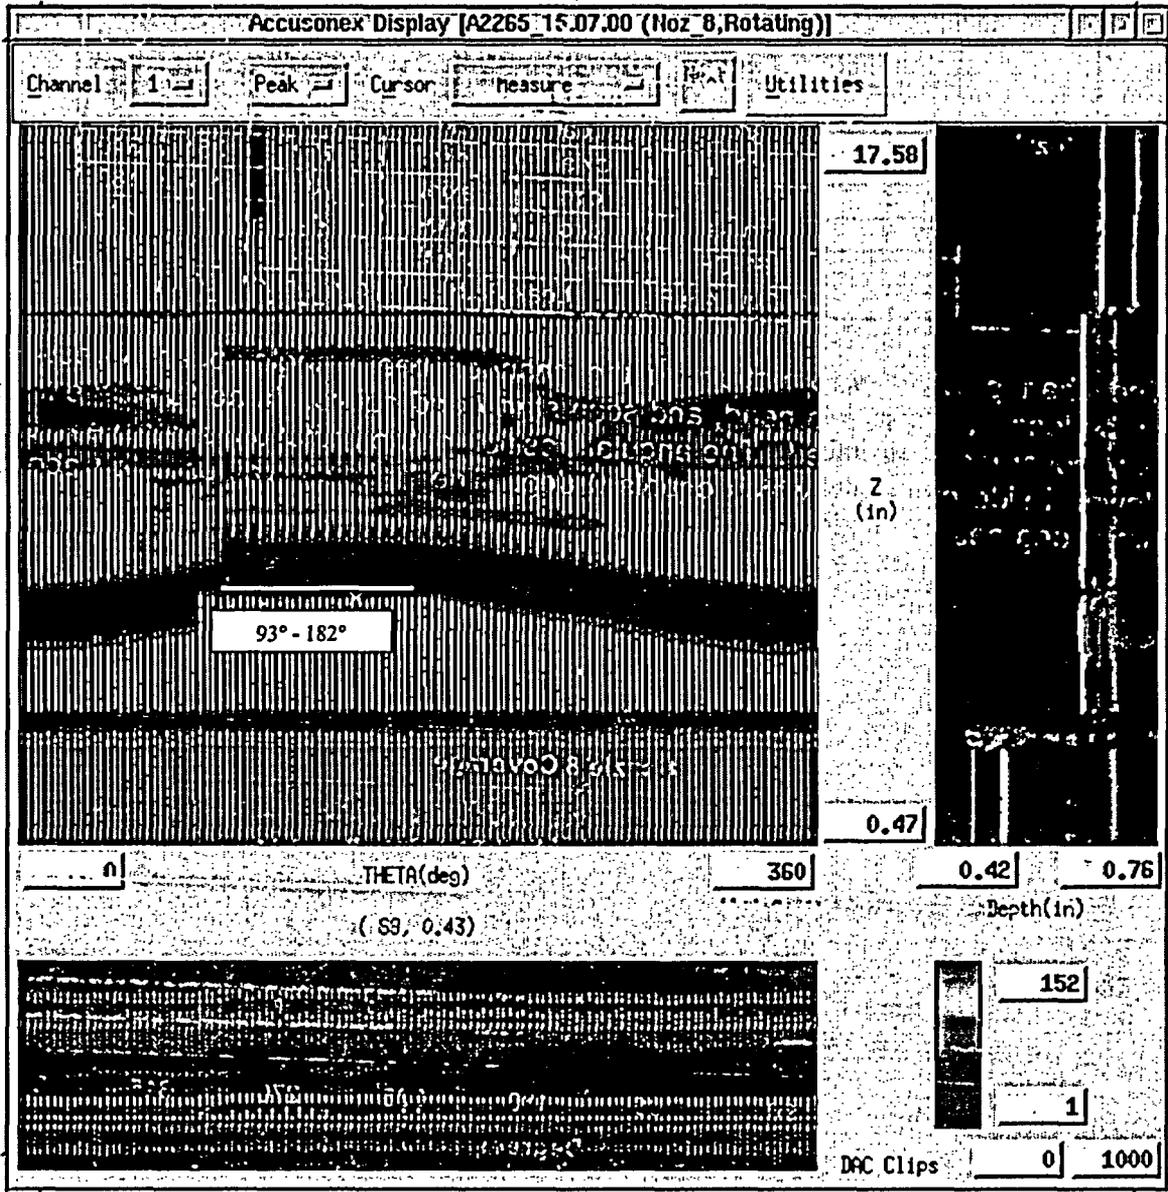
Nozzle 8	Area effected:			min.:	max:	Total:		
	Channel	Degree	Beam Direction	Defects	Probe Location	Limitation Start	Limitation End	
					93	182	89	
	1	0	normal	vol	0	93	182	
	2	30-L	axial	circ	338	71	160	
	3	60-S	axial	circ	158	251	340	
	4	45-LE	circ	axial	0	93	182	
	5	60-SE	circ	axial	22	115	204	
	6	60-SE	circ	axial	338	71	160	
	7	0, 30L, 45LE	Leak Path		combined	93	160

Horizontal line denotes the stall area.

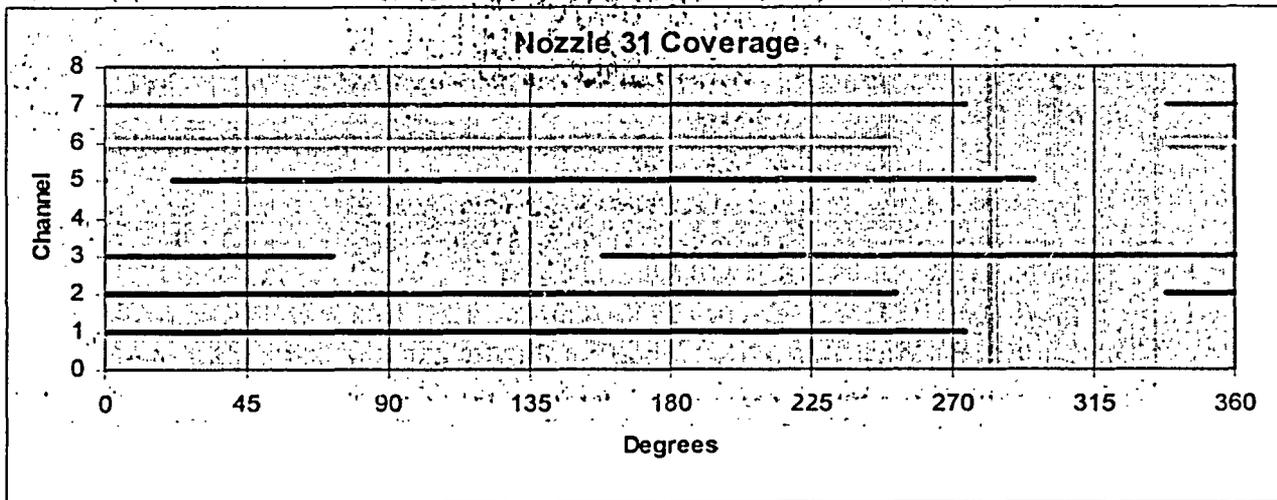
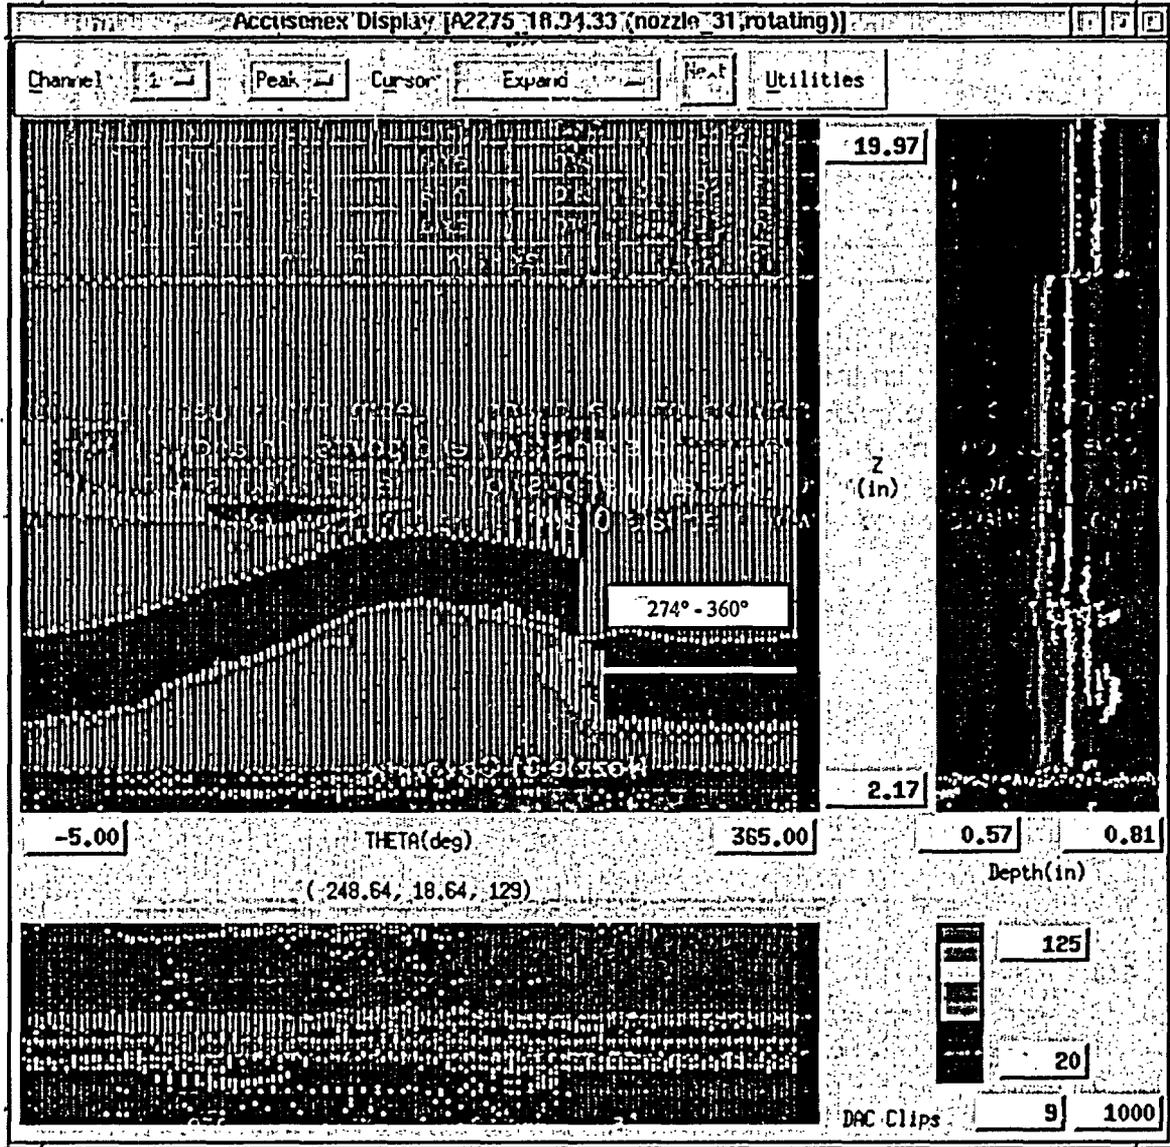
Nozzle 31	Area effected:			min.:	max:	Total:		
				274	360	86		
	Channel	Degree	Beam Direction	Defects	Probe Location	Limitation Start	End	
1	0	normal	vol	0	274	0		
2	30-L	axial	circ	338	252	338		
3	60-S	axial	circ	158	72	158		
4	45-LE	circ	axial	0	274	0		
5	60-SE	circ	axial	22	296	22		
6	60-SE	circ	axial	338	252	338		
7	0, 30L, 45LE	Leak Path		combined	274	338

Horizontal line denotes the stall area.

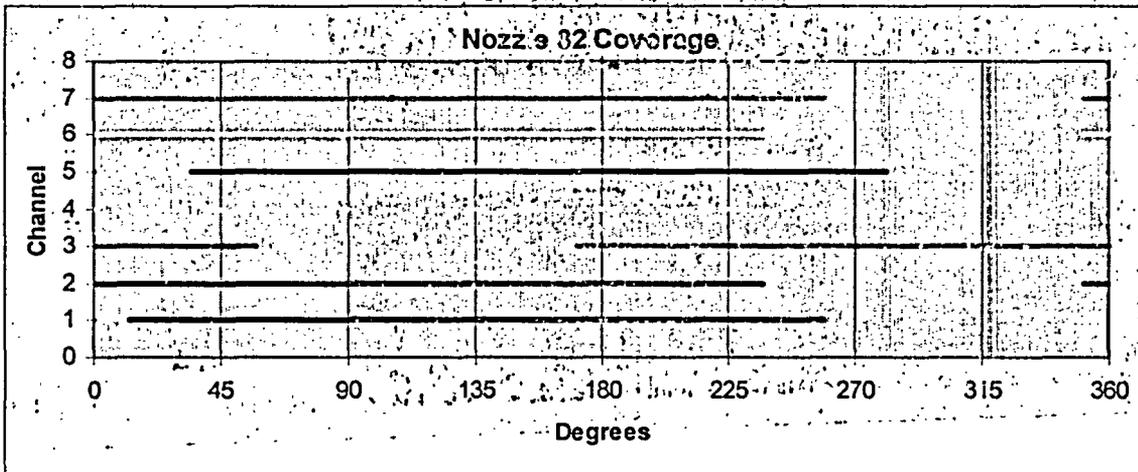
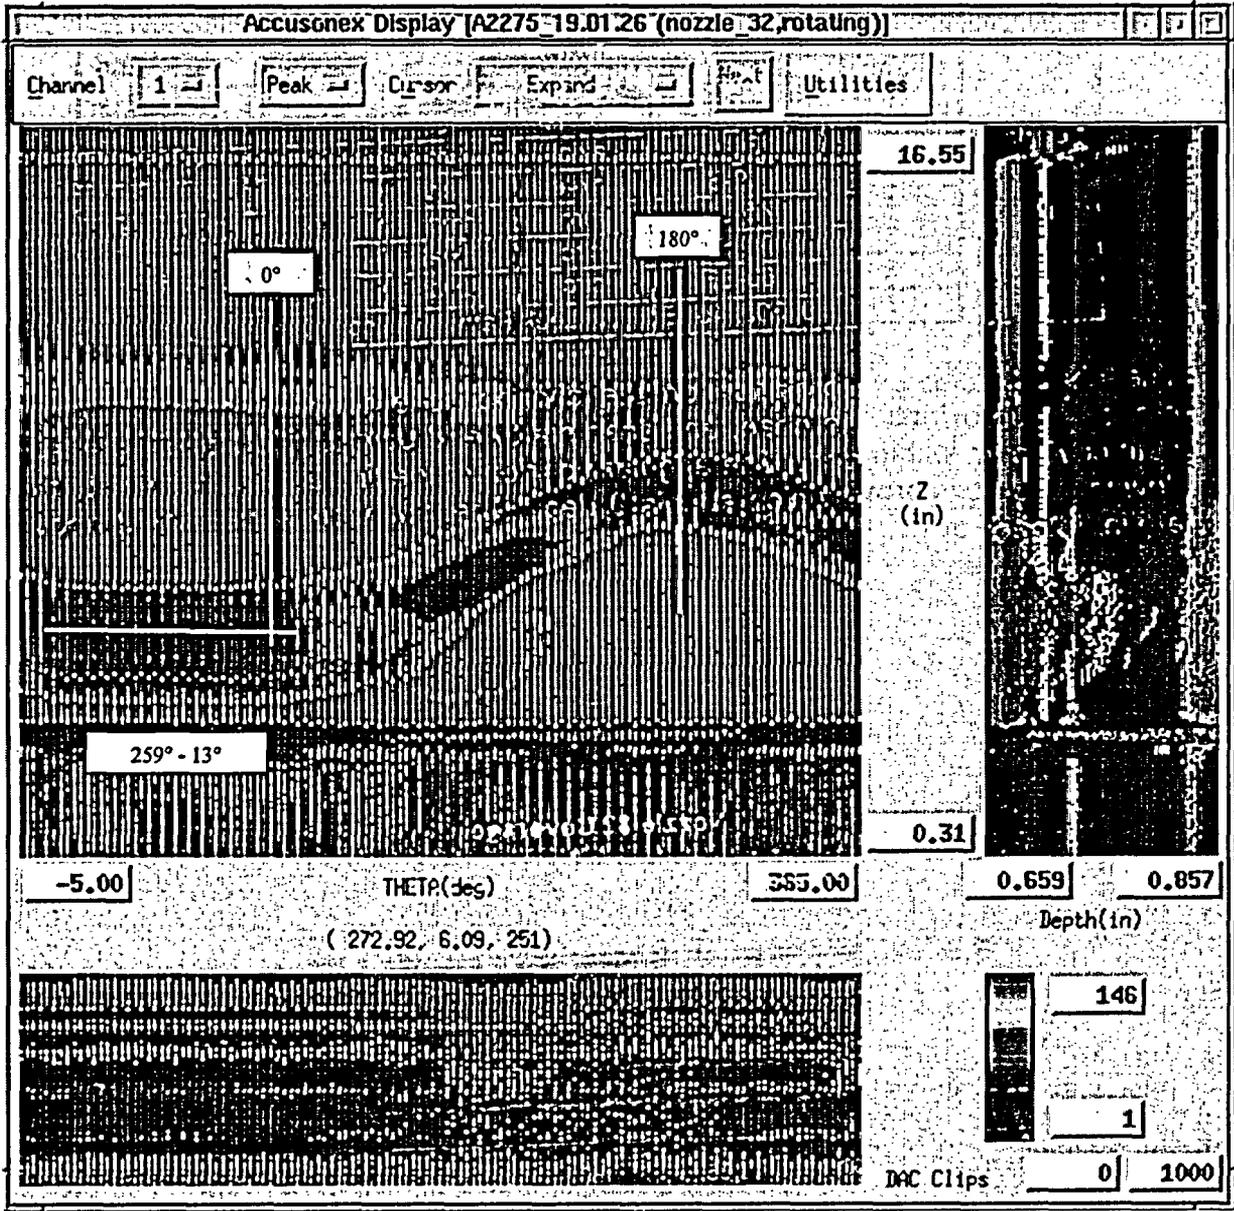
Channel	Degree	Beam Direction	Defects	Probe Location	Area effected:	
					min:	max:
						Total:
					259	127
					13	
Nozzle 32	1	0	normal	vol	0	259
	2	30-L	axial	circ	338	237
	3	60-S	axial	circ	158	57
	4	45-LE	circ	axial	0	259
	5	60-SE	circ	axial	22	281
	6	60-SE	circ	axial	338	237
	7	0, 30L, 45LE	Leak Path	combined		351

Horizontal line denotes the stall area.

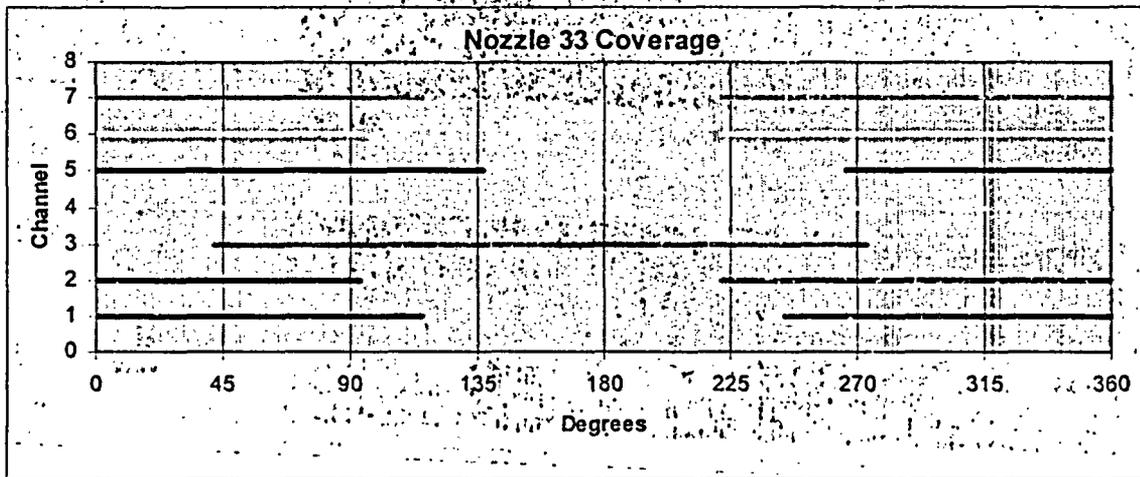
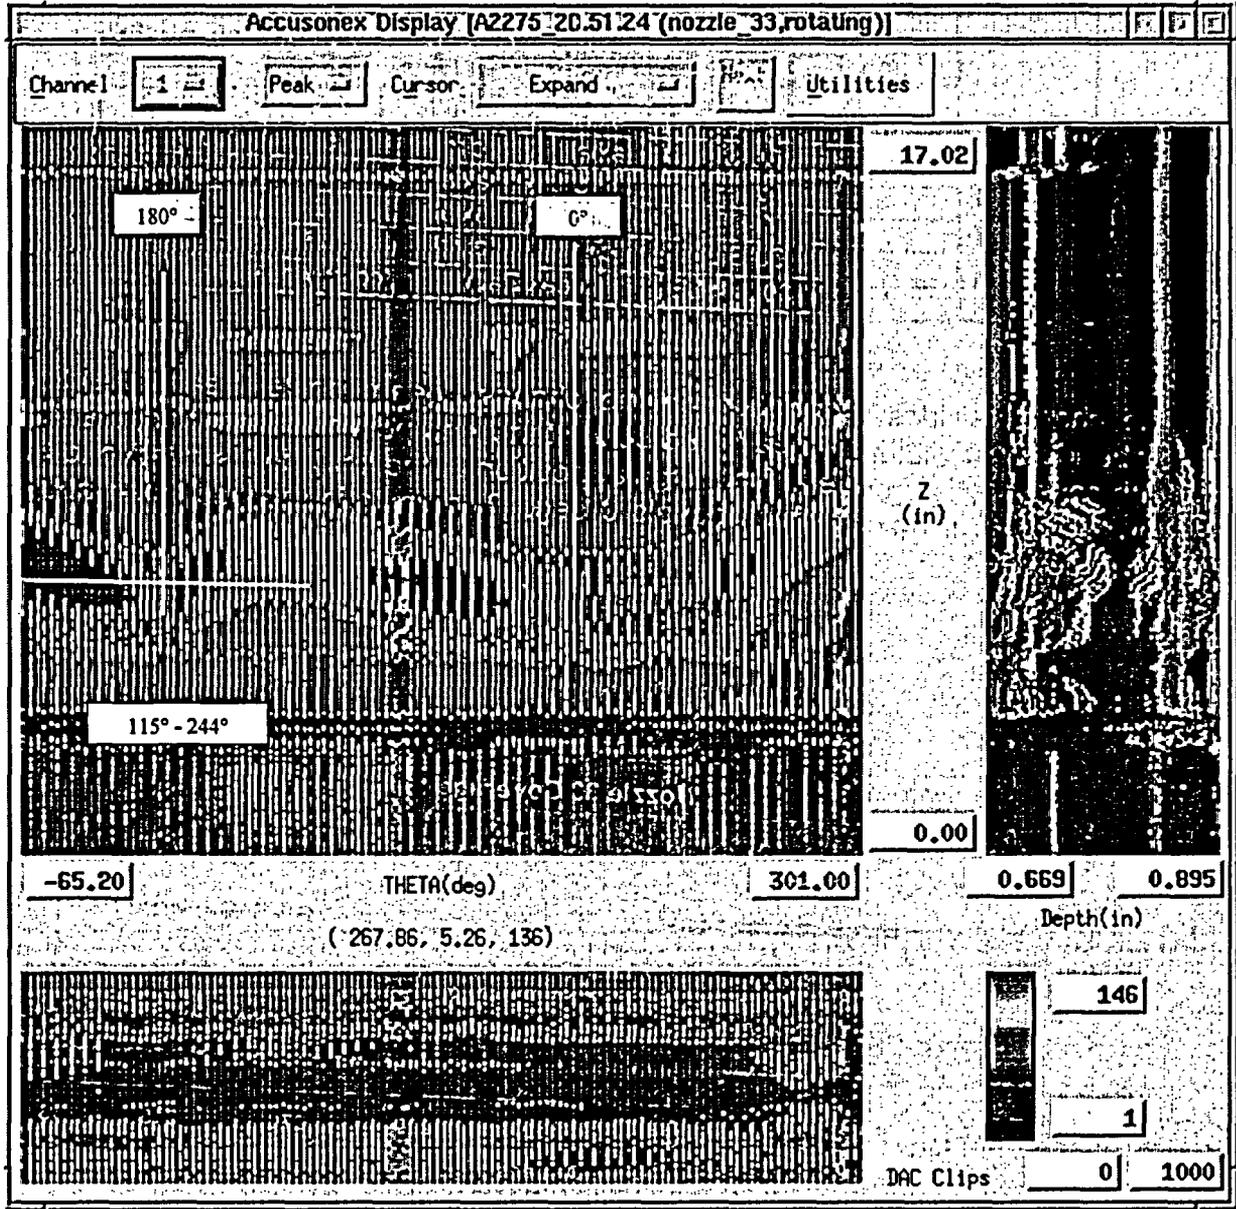
Nozzle 33	Area effected:			min.:	max:	Total:		
				115	244	129		
	Channel	Degree	Beam Direction	Defects	Probe Location	Limitation Start	Limitation End	
1	0	normal	vol	0	115	244		
2	30-L	axial	circ	338	93	222		
3	60-S	axial	circ	158	273	42		
4	45-LE	circ	axial	0	115	244		
5	60-SE	circ	axial	22	137	266		
6	60-SE	circ	axial	338	93	222		
7	0, 30L, 45LE	Leak Path		combined	115	222

Horizontal line denotes the stall area.

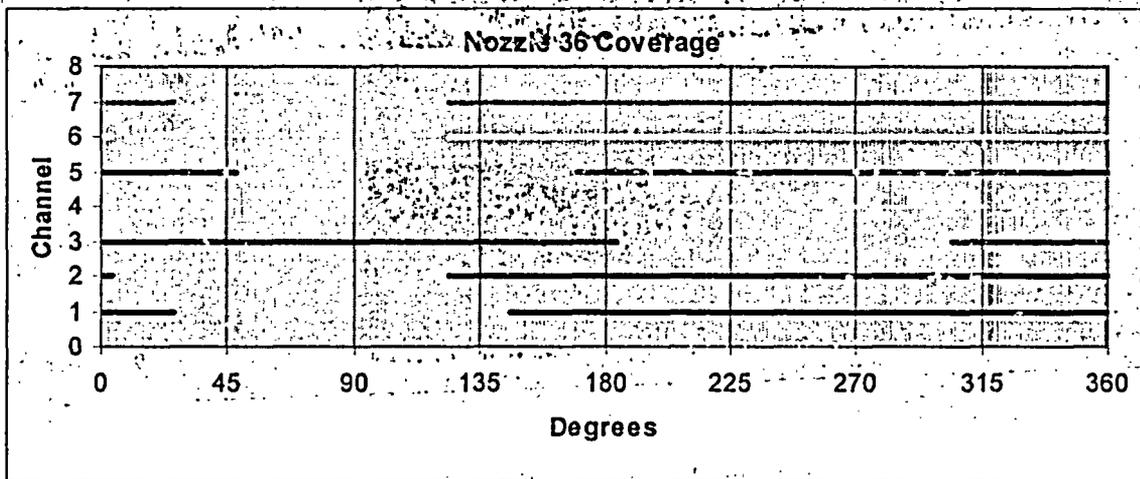
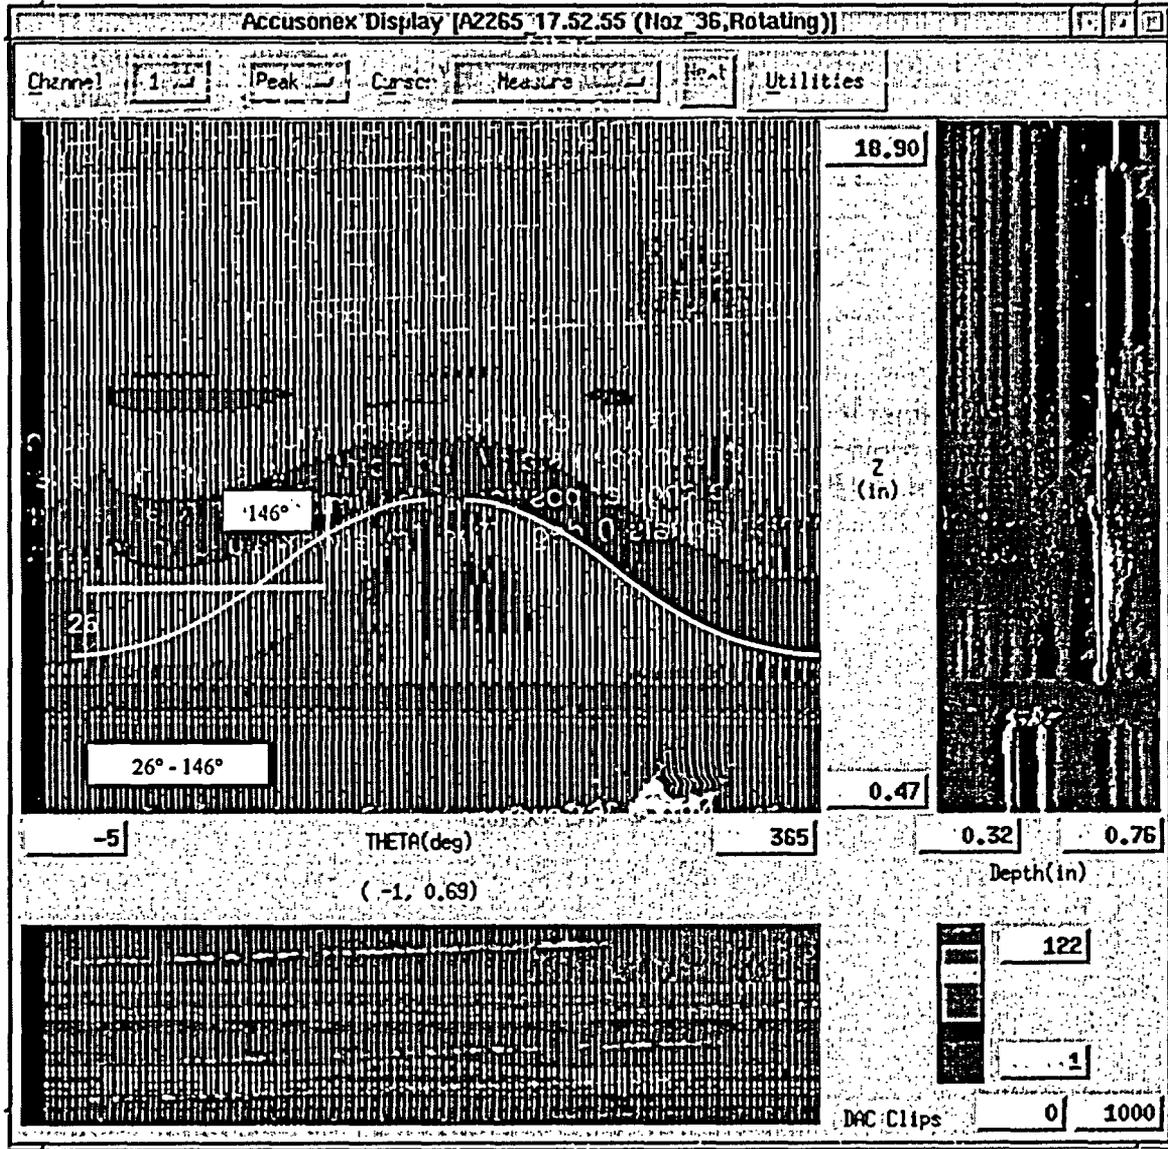
Channel	Degree	Beam Direction	Area effected:	min.:	max:	Total:	Limitation	
			Defects	Probe Location	Start	End		
				26	146	120		
Nozzle 36	1	0	normal	vol	0	26	146	
	2	30-L	axial	circ	338	4	124	
	3	60-S	axial	circ	158	184	304	
	4	45-LE	circ	axial	0	26	146	
	5	60-SE	circ	axial	22	48	168	
	6	60-SE	circ	axial	338	4	124	
	7	0, 30L, 45LE	Leak Path		combined	26	124

Horizontal line denotes the stall area.

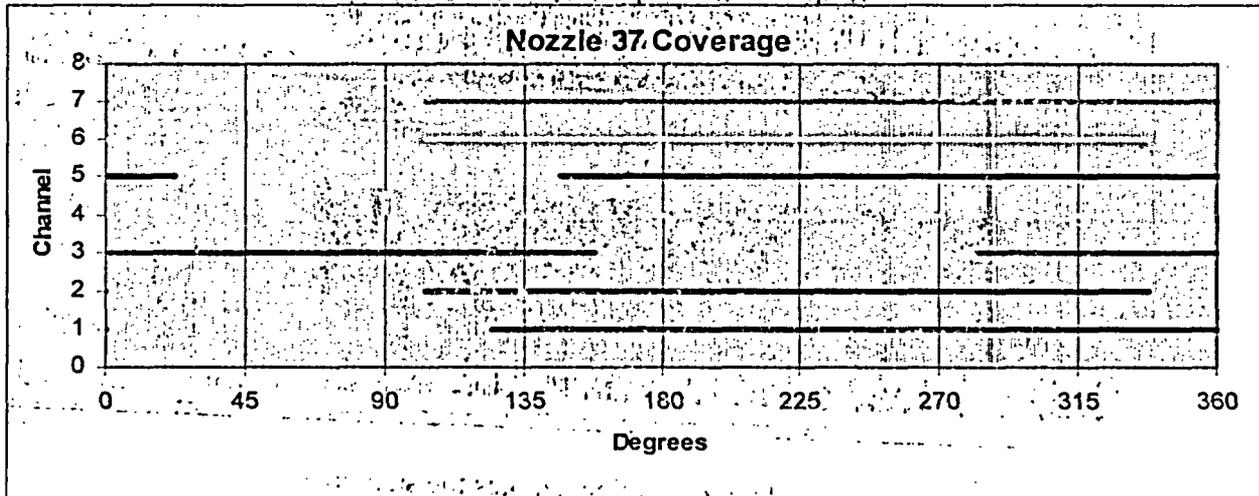
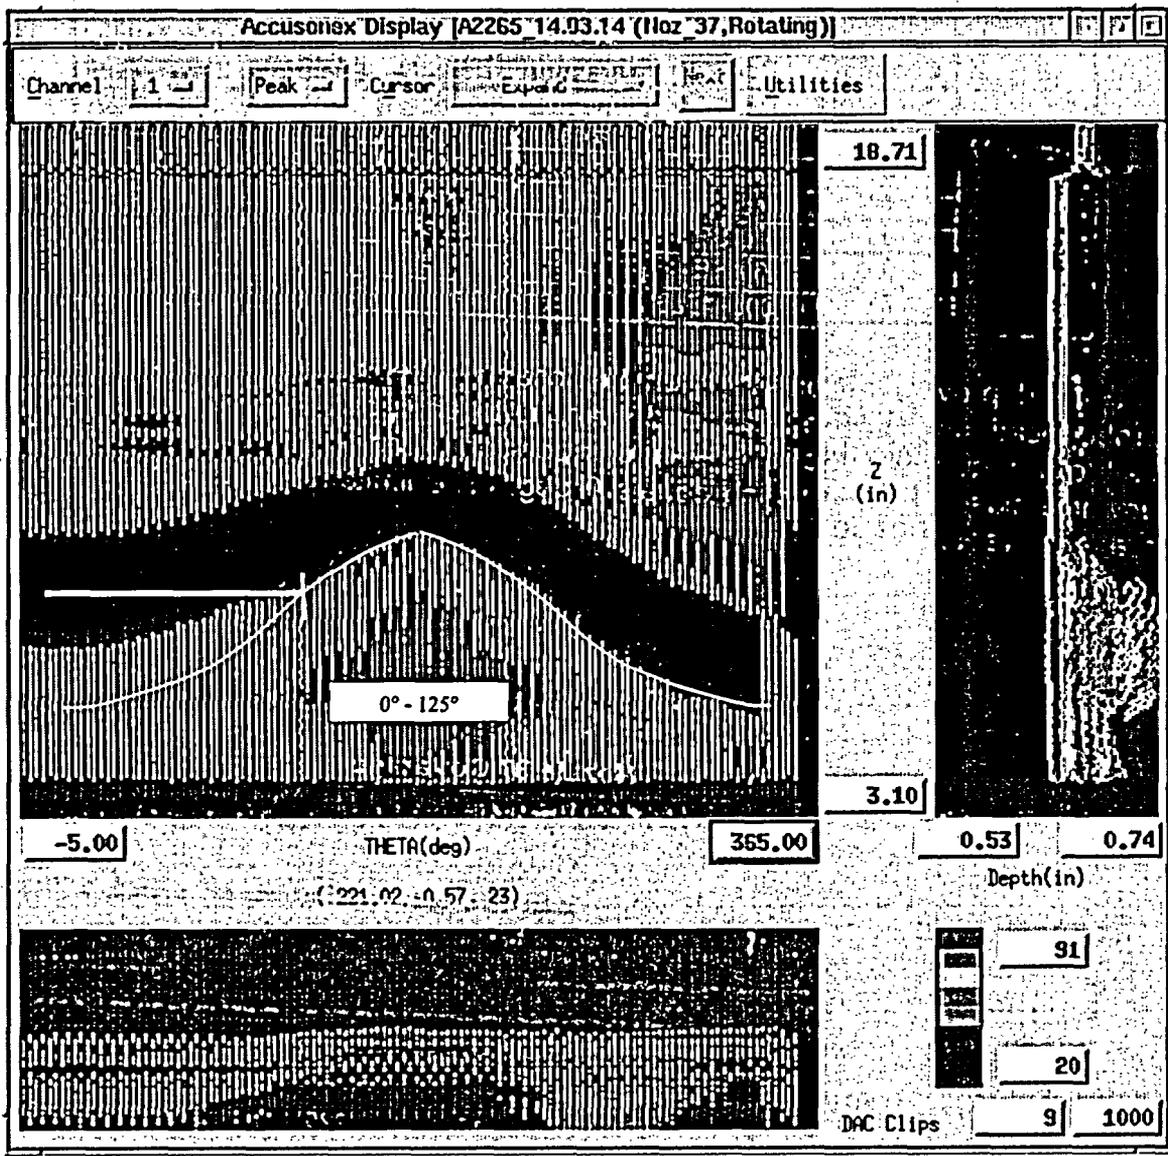
Nozzle 37	Area effected:		min.:	max:	Total:	Limitation	
			0	125	125	Start	End
	Channel	Degree	Beam Direction	Defects	Probe Location	Start	End
1	0	normal	vol	0	0	125	
2	30-L	axial	circ	338	338	103	
3	60-S	axial	circ	158	158	283	
4	45-LE	circ	axial	0	0	125	
5	60-SE	circ	axial	22	22	147	
6	60-SE	circ	axial	338	338	103	
7	0, 30L, 45LE	Leak Path		combined	0	103

Horizontal line denotes the stall area.

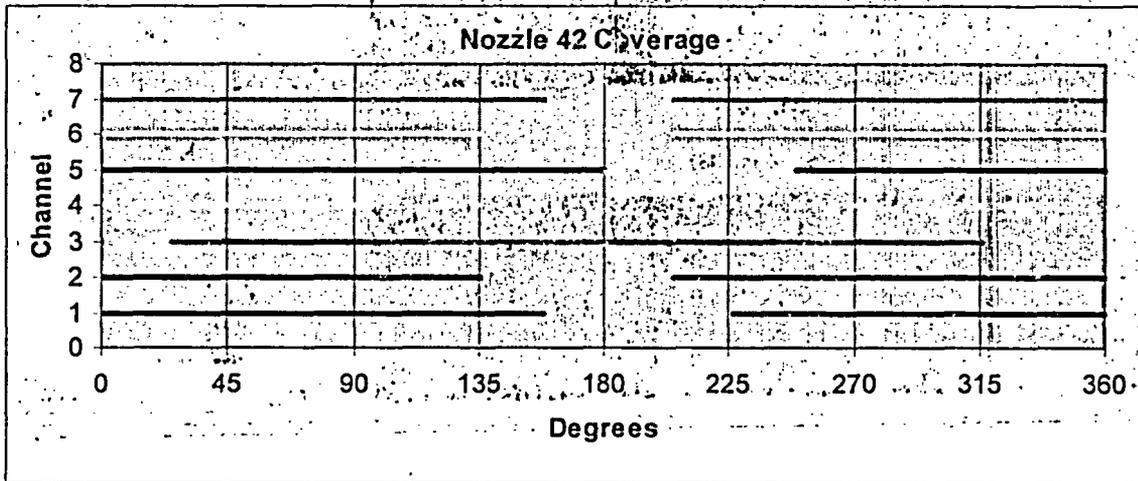
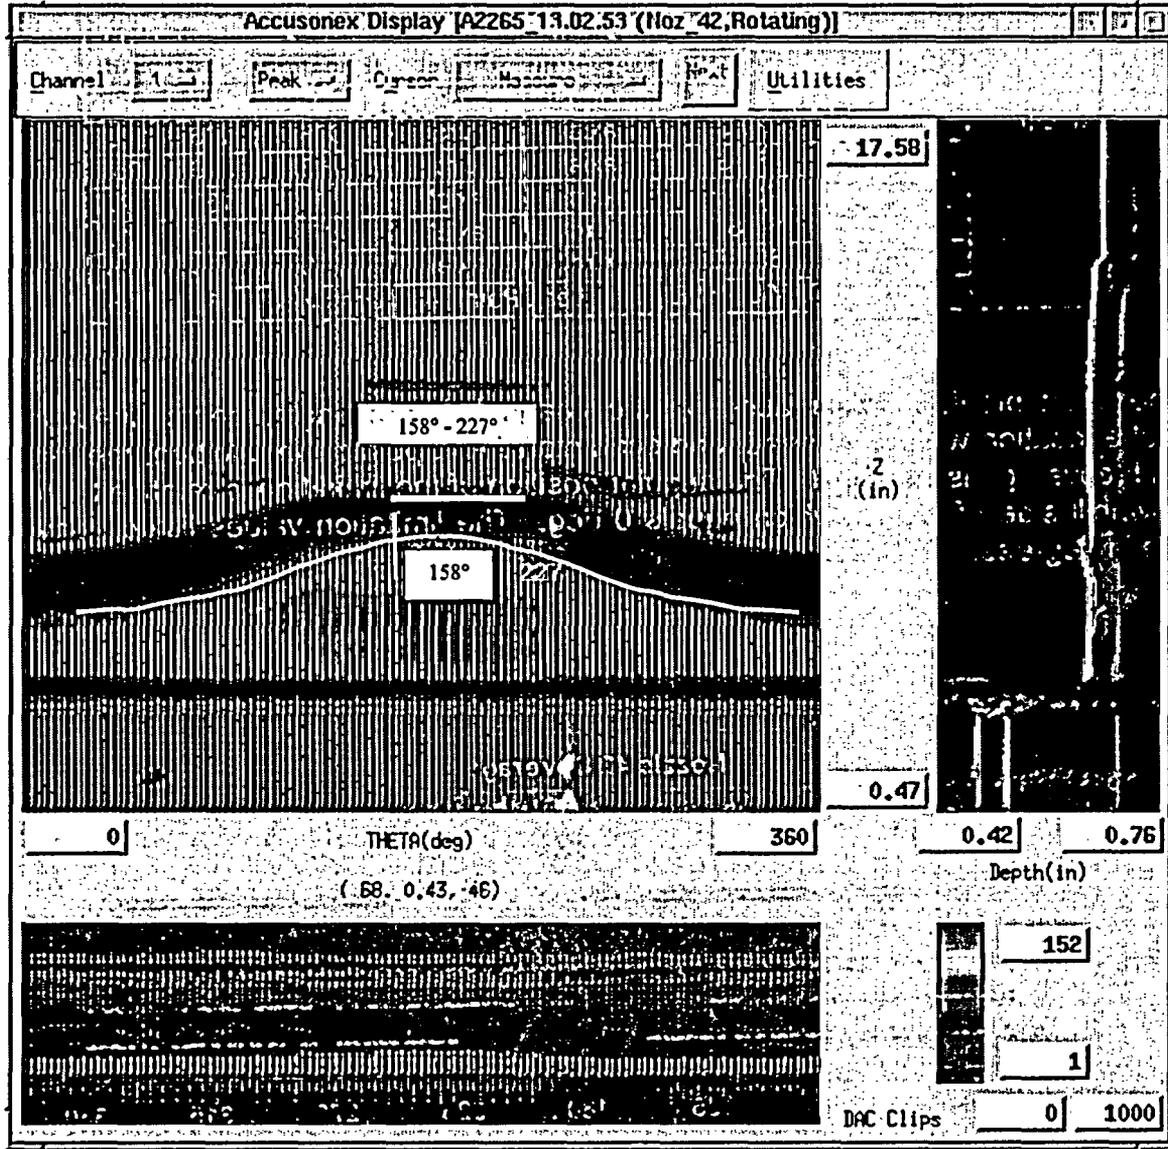
Nozzle 42	Area effected:		min:	max:	Total:	Limitation	
			158	227	69	Start	End
	Channel	Degree	Beam Direction	Defects	Probe Location		
1	0	normal	vol	0	158	227	
2	30-L	axial	circ	338	136	205	
3	60-S	axial	circ	158	316	25	
4	45-LE	circ	axial	0	158	227	
5	60-SE	circ	axial	22	180	249	
6	60-SE	circ	axial	338	136	205	
7	0, 30L, 45LE	Leak Path		combined	158	205

Horizontal line denotes the stall area.

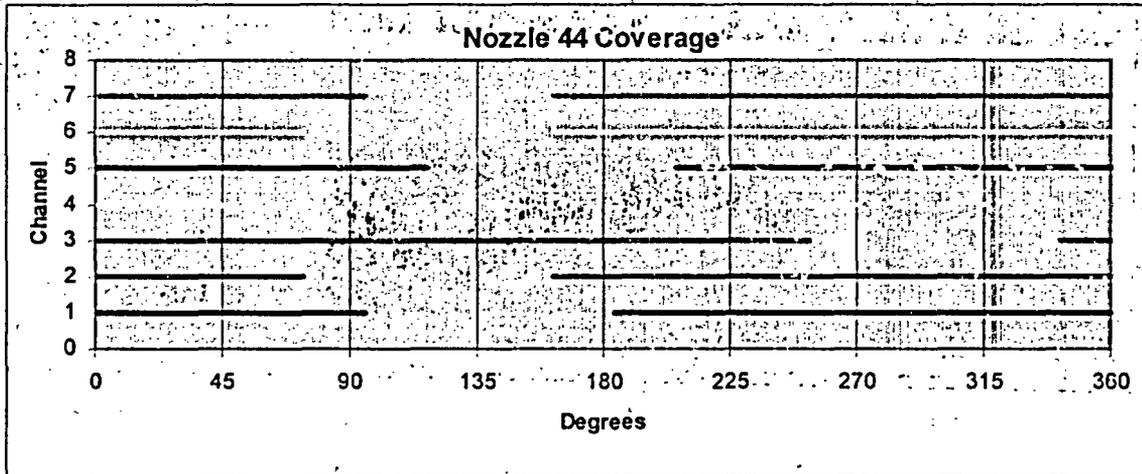
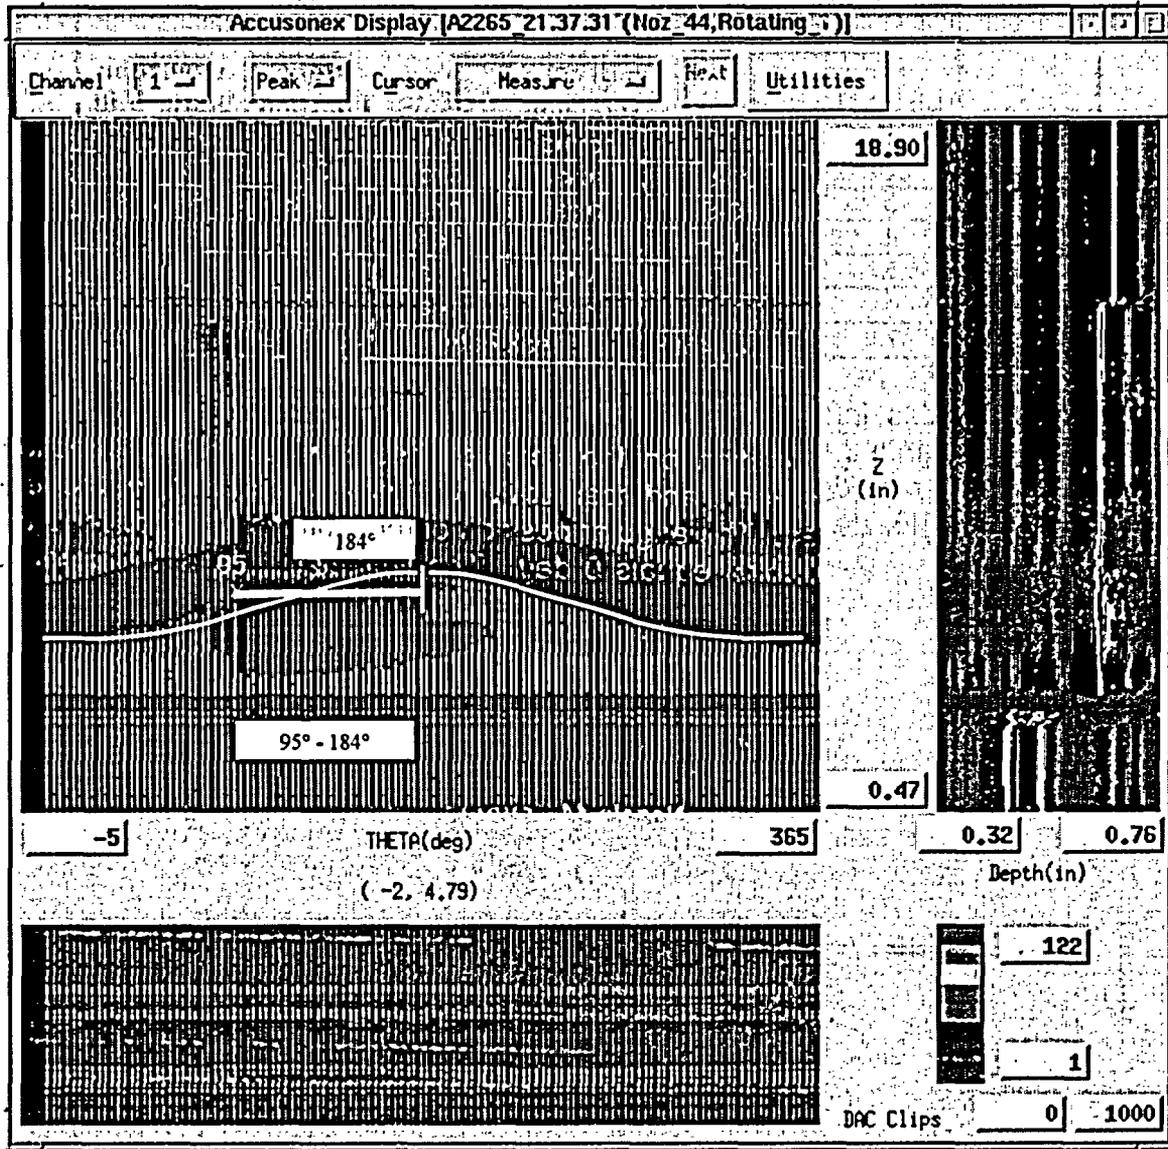
Nozzle 44	Area effected:		min.:	max:	Total:		
			95	184	89		
	Channel	Degree	Beam Direction	Defects	Probe Location	Limitation Start	End
1	0	normal	vol	0	95	184	
2	30-L	axial	circ	338	73	162	
3	60-S	axial	circ	158	253	342	
4	45-LE	circ	axial	0	95	184	
5	60-SE	circ	axial	22	117	206	
6	60-SE	circ	axial	338	73	162	
7	0, 30L, 45LE		Leak Path		combined	95	162

Horizontal line denotes the stall area.

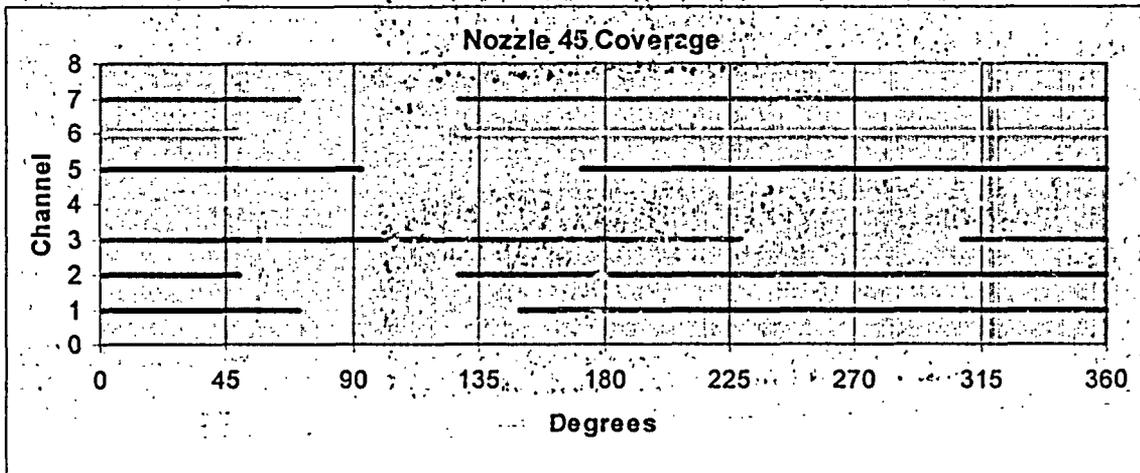
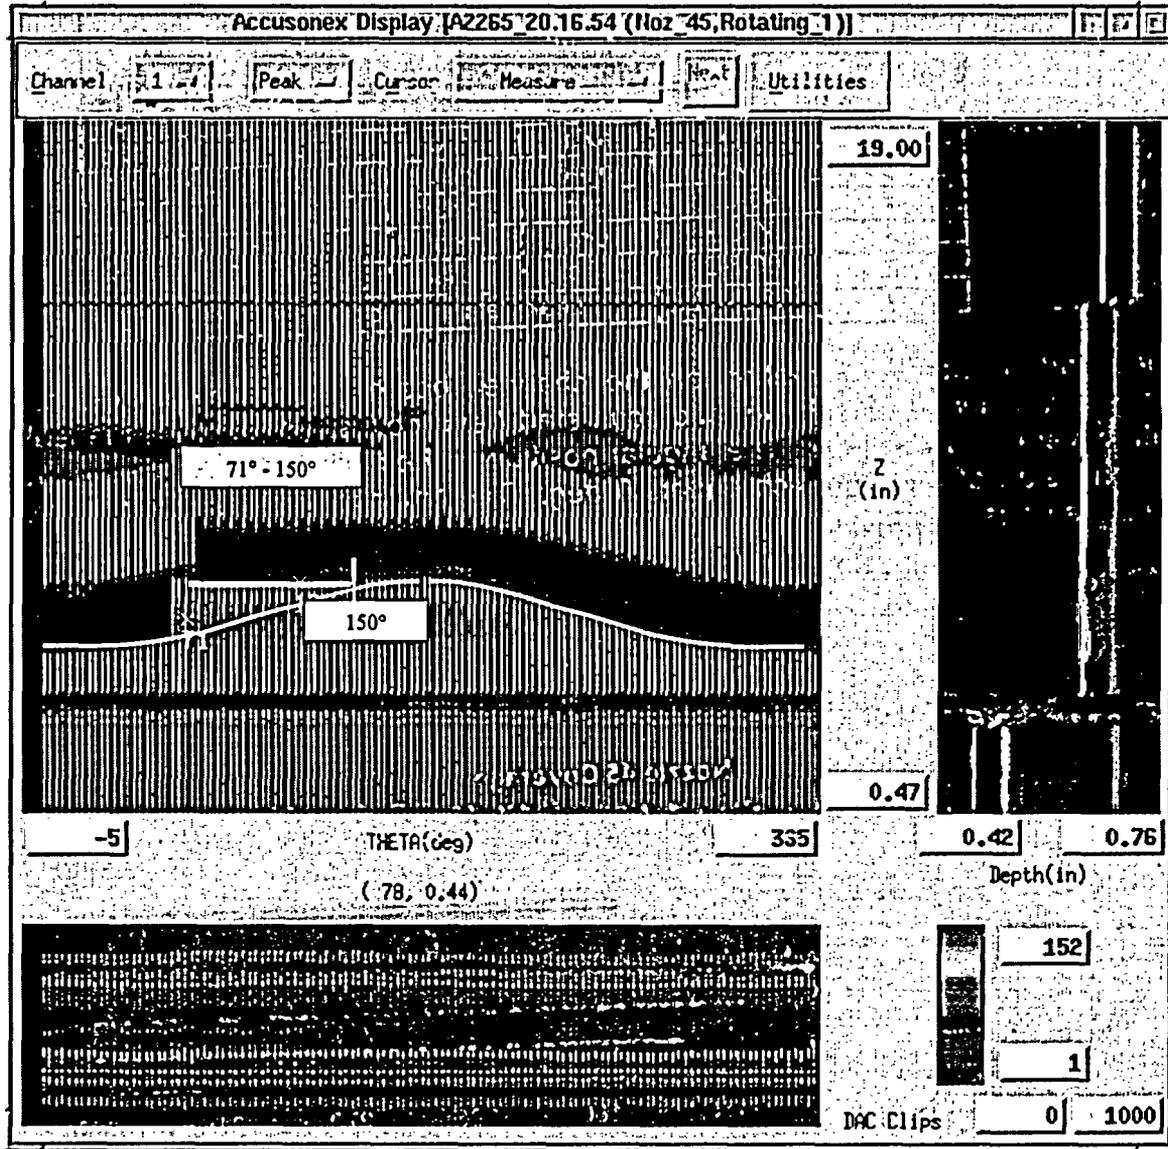
Nozzle 45	Area effected:		min.:	max:	Total:	Limitation	
			71	150	79	Start	End
	Channel	Degree	Beam Direction	Defects	Probe Location	Start	End
1	0	normal	vol	0	71	150	
2	30-L	axial	circ	338	49	128	
3	60-S	axial	circ	158	229	308	
4	45-LE	circ	axial	0	71	150	
5	60-SE	circ	axial	22	93	172	
6	60-SE	circ	axial	338	49	128	
7	0, 30L, 45LE	Leak Path		combined	71	128

Horizontal line denotes the stall area.

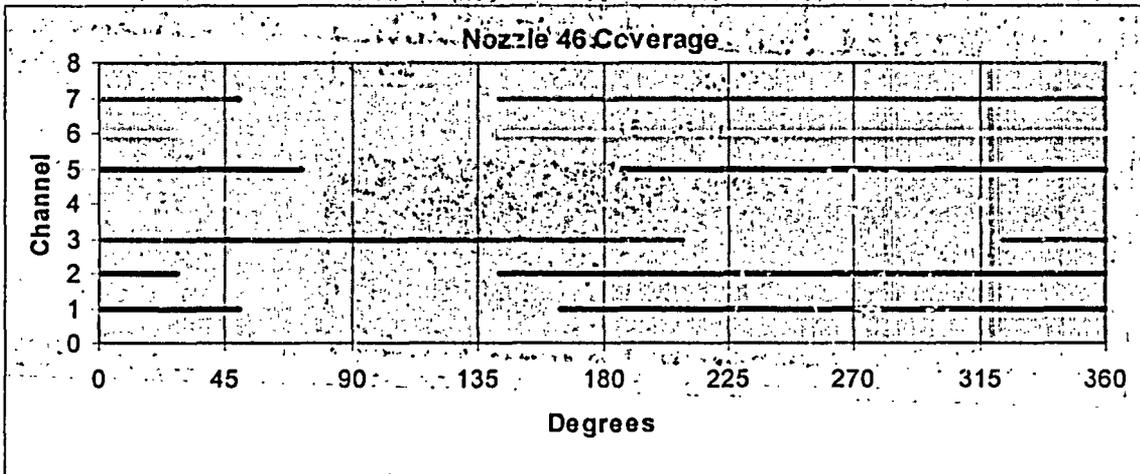
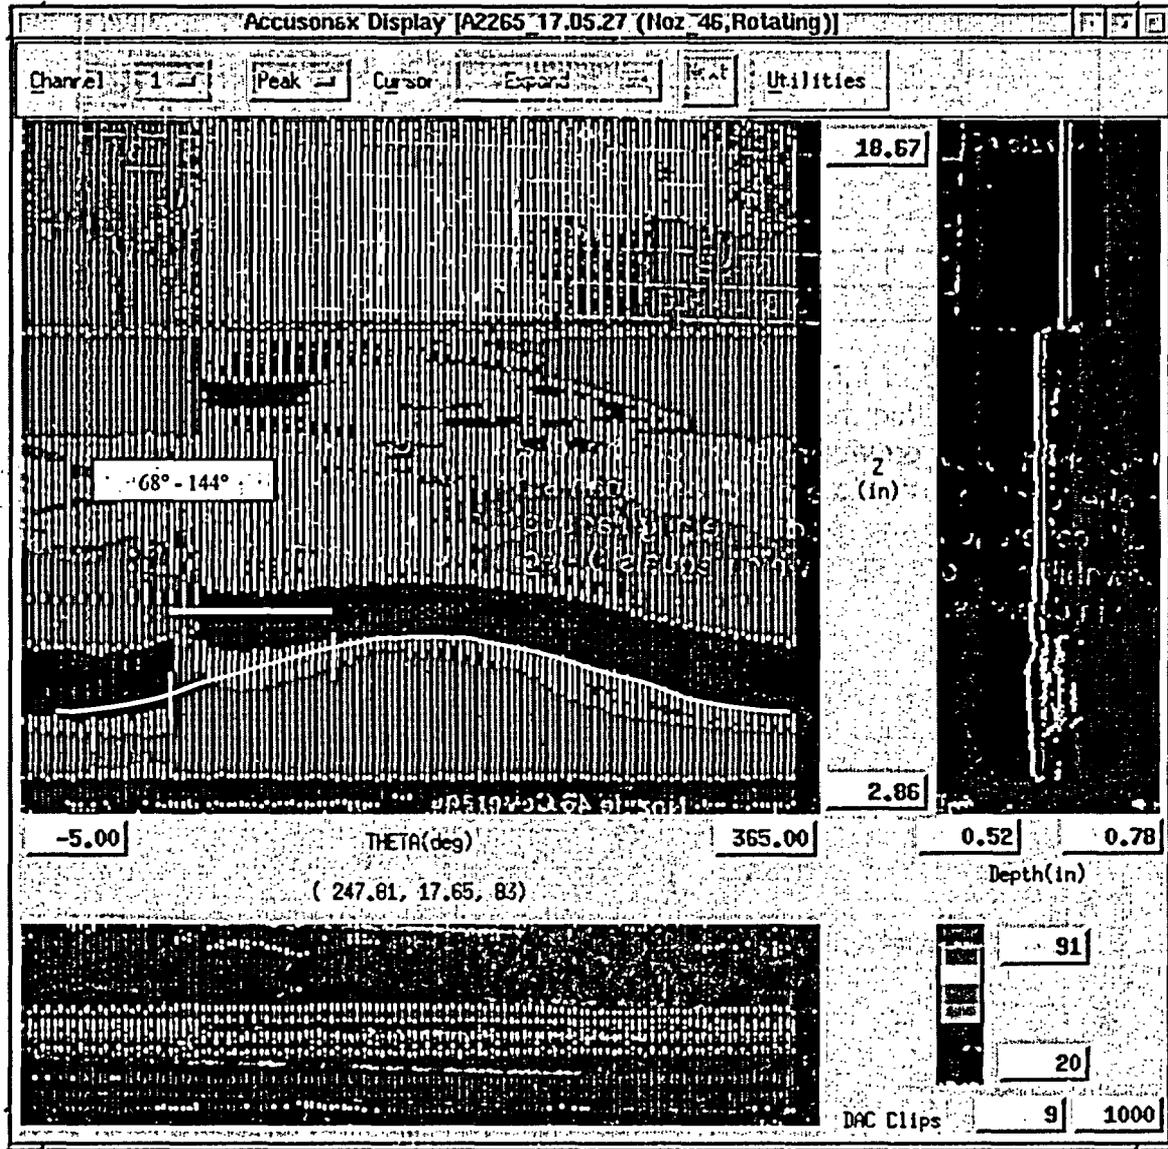
Nozzle 46	Area effected:			min.:	max:	Total:		
				68	144	76		
	Channel	Degree	Beam Direction	Defects	Probe Location	Limitation Start	Limitation End	
1	0	normal	vol	0	68	144		
2	30-L	axial	circ	338	46	122		
3	60-S	axial	circ	158	226	302		
4	45-LE	circ	axial	0	68	144		
5	60-SE	circ	axial	22	90	166		
6	60-SE	circ	axial	338	46	122		
7	0, 30L, 45LE	Leak Path		combined	68	122

Horizontal line denotes the stall area.

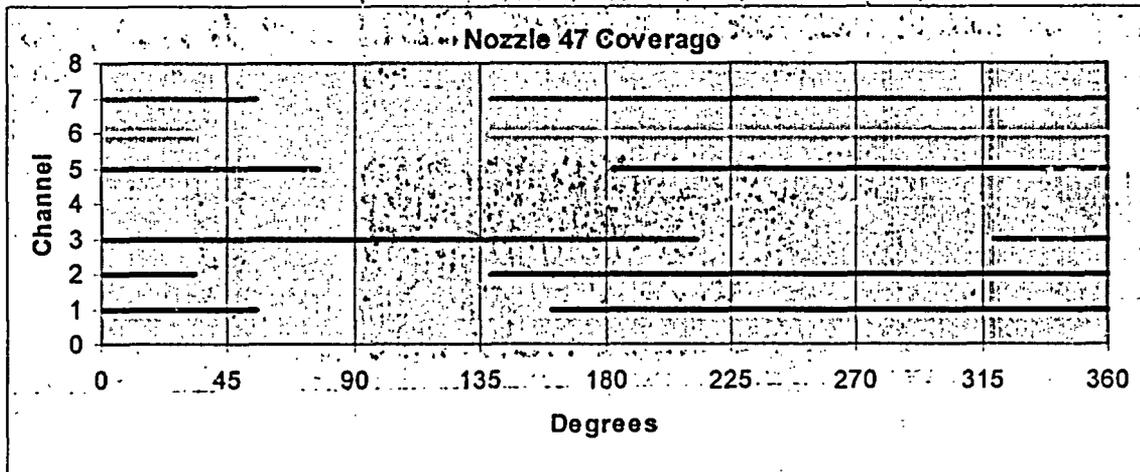
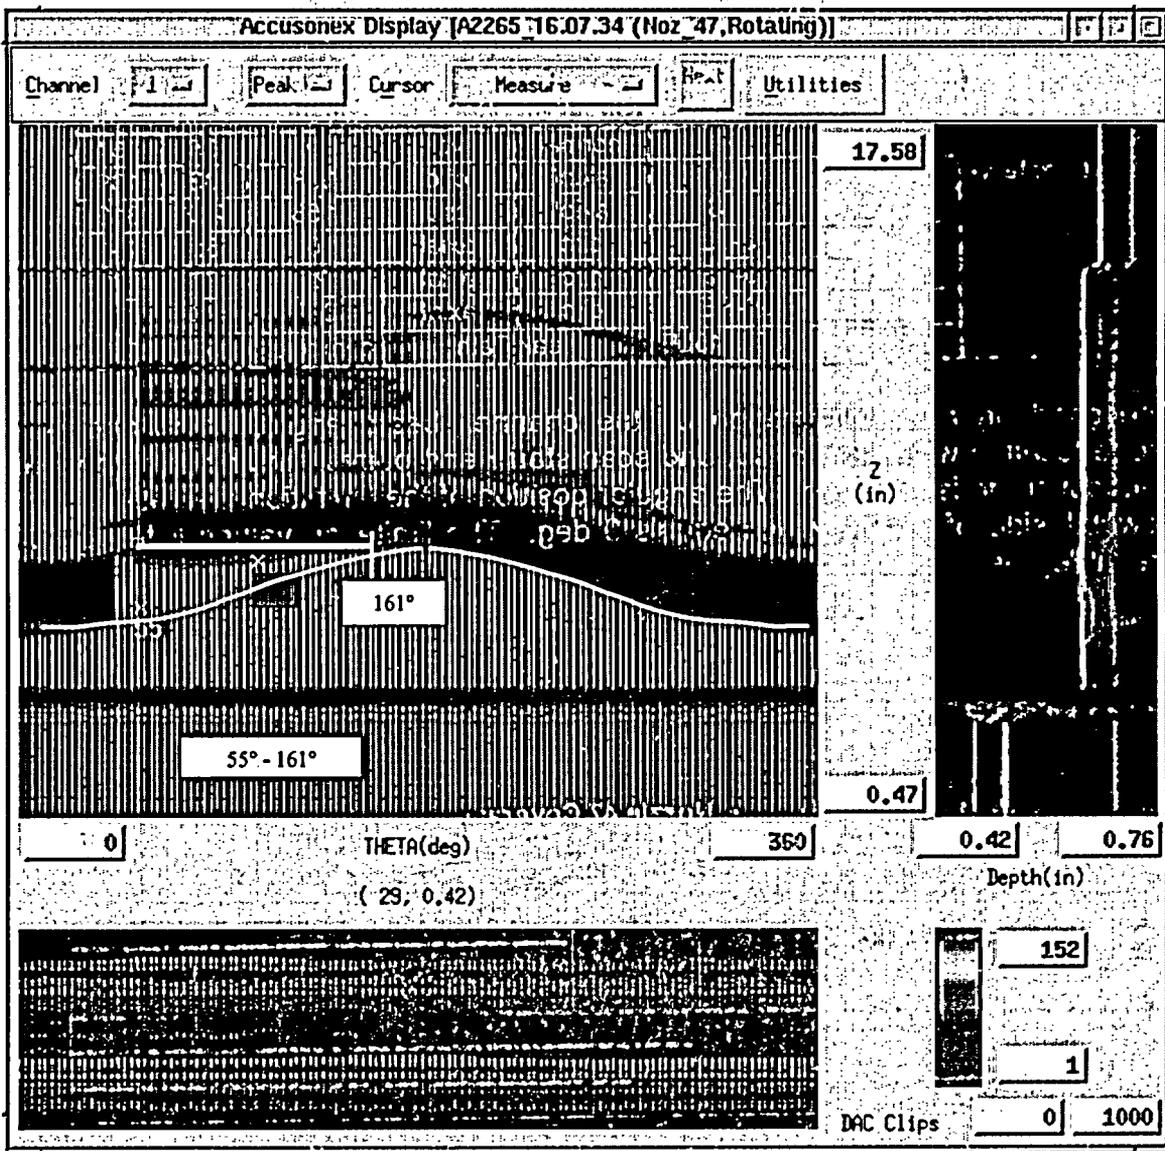
Nozzle 47	Area effected:			min.:	max:	Total:		
				55	161	106		
	Channel	Degree	Beam Direction	Defects	Probe Location	Limitation Start	Limitation End	
1	0	normal	vol	0	55	161		
2	30-L	axial	circ	338	33	139		
3	60-S	axial	circ	158	213	319		
4	45-LE	circ	axial	0	55	161		
5	60-SE	circ	axial	22	77	183		
6	60-SE	circ	axial	338	33	139		
7	0, 30L, 45LE	Leak Path		combined	55	139

Horizontal line denotes the stall area.
