## POST-IRRADIATION EXAMINATION RESULTS FROM THE BTF-105A LOCA/LOECC TEST

VALLIANT, P.J., IRISH, J.D. and CRAIG, S.T.

Fuel Safety Branch  
Reactor Safety Division  
AECL, Chalk River Laboratories  
Chalk River, Ontario, CANADA K0J 1J0

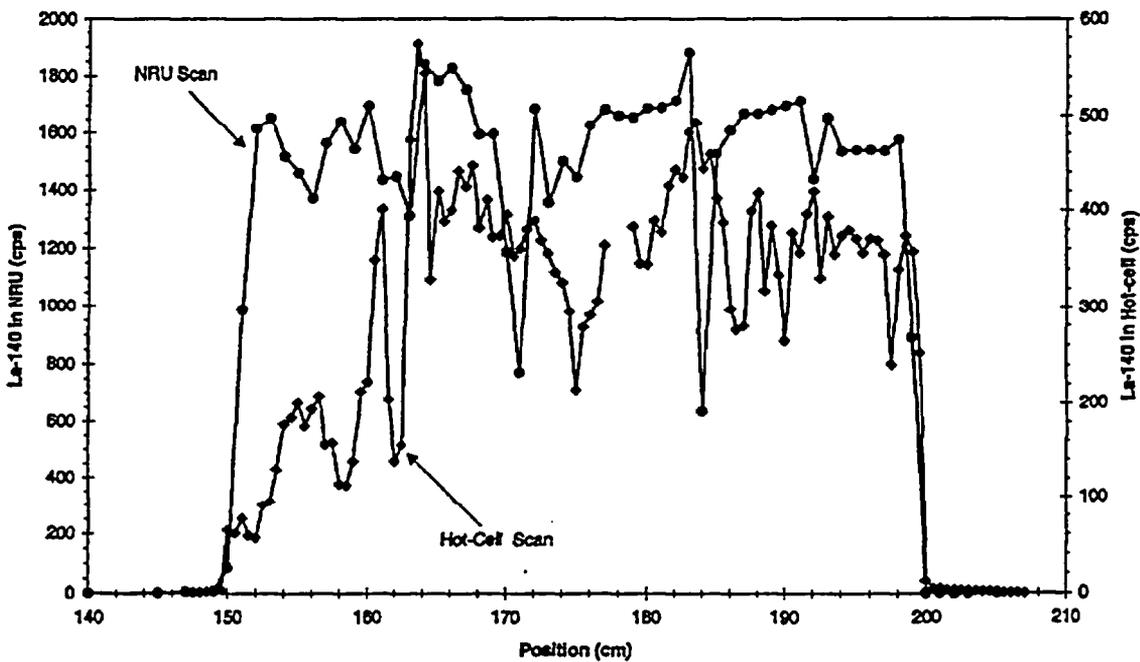
The fuel assembly was gamma scanned in a storage can in the NRU reactor building after the test. The scan revealed a relatively intact fuel element (Figure 5). A decision was made to transfer the assembly to the hot cells without epoxying the assembly. This allowed much more information to be gained about instrumentation and the condition of the thermal shroud than would have been possible if the stringer had been epoxyed initially. The ZIRCAR thermal insulation was cut longitudinally and the upper and lower halves were separated to expose the inner Zircaloy wall of the thermal shroud. In Figure 6 it can be seen that the inner Zircaloy wall is heavily oxidized and broken up at the elevation of the lower bearing pad of the fuel element. Evidence of steam ingress into the ZIRCAR insulation can be seen in the mating half of the thermal shroud where this ingress has discoloured the initially white ZIRCAR insulation. The insulation is mainly intact except for a through-wall crack that appears to line up with the zone of heaviest damage on the inner Zircaloy wall. It is possible, that the rapid injection of steam into the shroud following failure of the inner wall caused the through-wall crack in the insulation to form, which in turn, provided a path for the hot steam to heat the outer wall of the shroud directly. This would explain the rapid rise in temperature following shroud failure observed by a thermocouple located on the outside of the shroud [1]. This outer shroud thermocouple was located axially within a few millimetres of the observed crack in the insulation. A second gamma scan done in the hot cell showed some fuel relocation (Figure 5). A comparison of the two gamma scans indicates that most of the damage to the fuel element occurred during handling after the element was removed from the reactor. "Fuel powder" consisting of loose  $UO_2$  fuel

Figure 5: Comparison of La-140 Gamma Scans Performed in the NRU Storage Block and in the Hot Cells

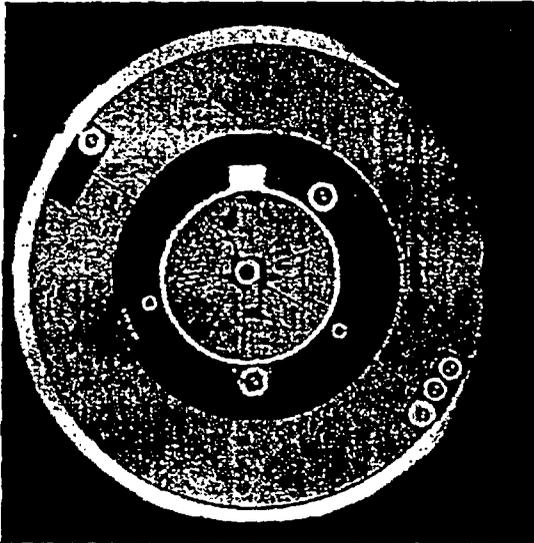
FS 30 2X  
Figure 8: Met 1 Upper Bearing Pad - TFC01

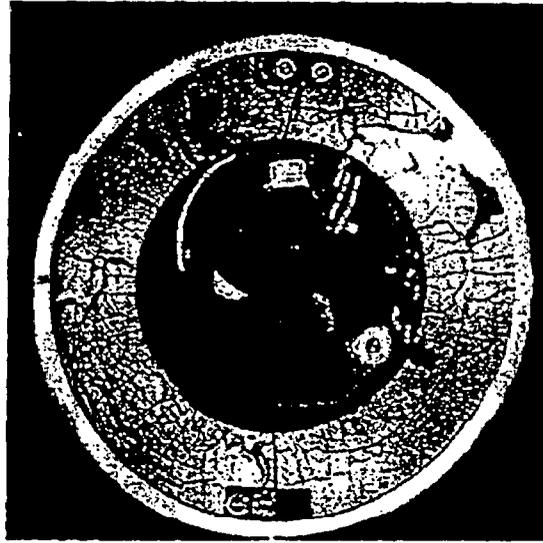
FS 25 2X  
Figure 9: Met 2 Middle Bearing Pad
