## POST-IRRADIATION EXAMINATION RESULTS FROM THE BTF-105A LOCA/LOECC TEST

VALLIANT, P.J., IRISH, J.D. and CRAIG, S.T.

Fuel Safety Branch  
Reactor Safety Division  
AECL, Chalk River Laboratories  
Chalk River, Ontario, CANADA K0J 1J0

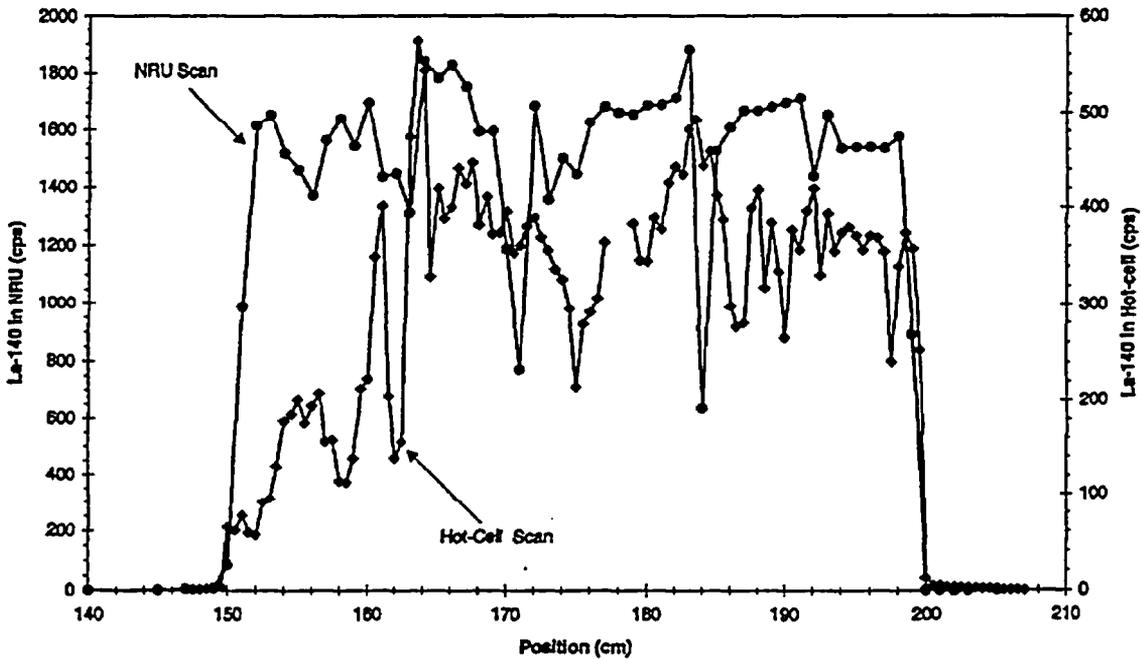
The fuel assembly was gamma scanned in a storage can in the NRU reactor building after the test. The scan revealed a relatively intact fuel element (Figure 5). A decision was made to transfer the assembly to the hot cells without epoxying the assembly. This allowed much more information to be gained about instrumentation and the condition of the thermal shroud than would have been possible if the stringer had been epoxyed initially. The ZIRCAR thermal insulation was cut longitudinally and the upper and lower halves were separated to expose the inner Zircaloy wall of the thermal shroud. In Figure 6 it can be seen that the inner Zircaloy wall is heavily oxidized and broken up at the elevation of the lower bearing pad of the fuel element. Evidence of steam ingress into the ZIRCAR insulation can be seen in the mating half of the thermal shroud where this ingress has discoloured the initially white ZIRCAR insulation. The insulation is mainly intact except for a through-wall crack that appears to line up with the zone of heaviest damage on the inner Zircaloy wall. It is possible, that the rapid injection of steam into the shroud following failure of the inner wall caused the through-wall crack in the insulation to form, which in turn, provided a path for the hot steam to heat the outer wall of the shroud directly. This would explain the rapid rise in temperature following shroud failure observed by a thermocouple located on the outside of the shroud [1]. This outer shroud thermocouple was located axially within a few millimetres of the observed crack in the insulation. A second gamma scan done in the hot cell showed some fuel relocation (Figure 5). A comparison of the two gamma scans indicates that most of the damage to the fuel element occurred during handling after the element was removed from the reactor. "Fuel powder" consisting of loose  $UO_2$  fuel

Figure 5: Comparison of La-140 Gamma Scans Performed in the NRU Storage Block and in the Hot Cells
