EPRI TR-104721
Project 2229-01
ESEERCO Project EP89-31
Final Report
December 1994

Evaluation of Fuel Rod Leakage Mechanisms—Summary Report

Joint EPRI/ESEERCO/Westinghouse Studies

Prepared by
Westinghouse Electric Corporation
Pittsburgh, Pennsylvania

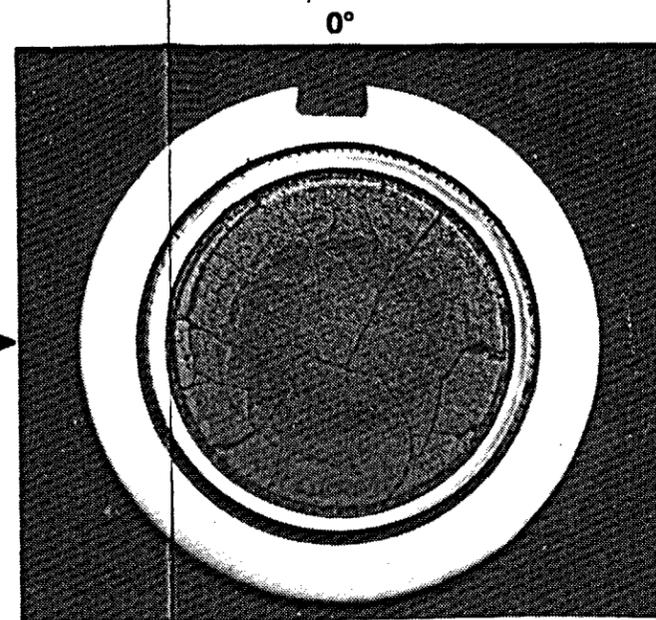
Pitted Oxide

Hydride Reorientation
and Cladding Thinning

Maximum Oxide - 210µm (at 310°)

Figure 3.3-6. O.D. Oxide Pitting Near Rod Fracture, Rod D79F/H12

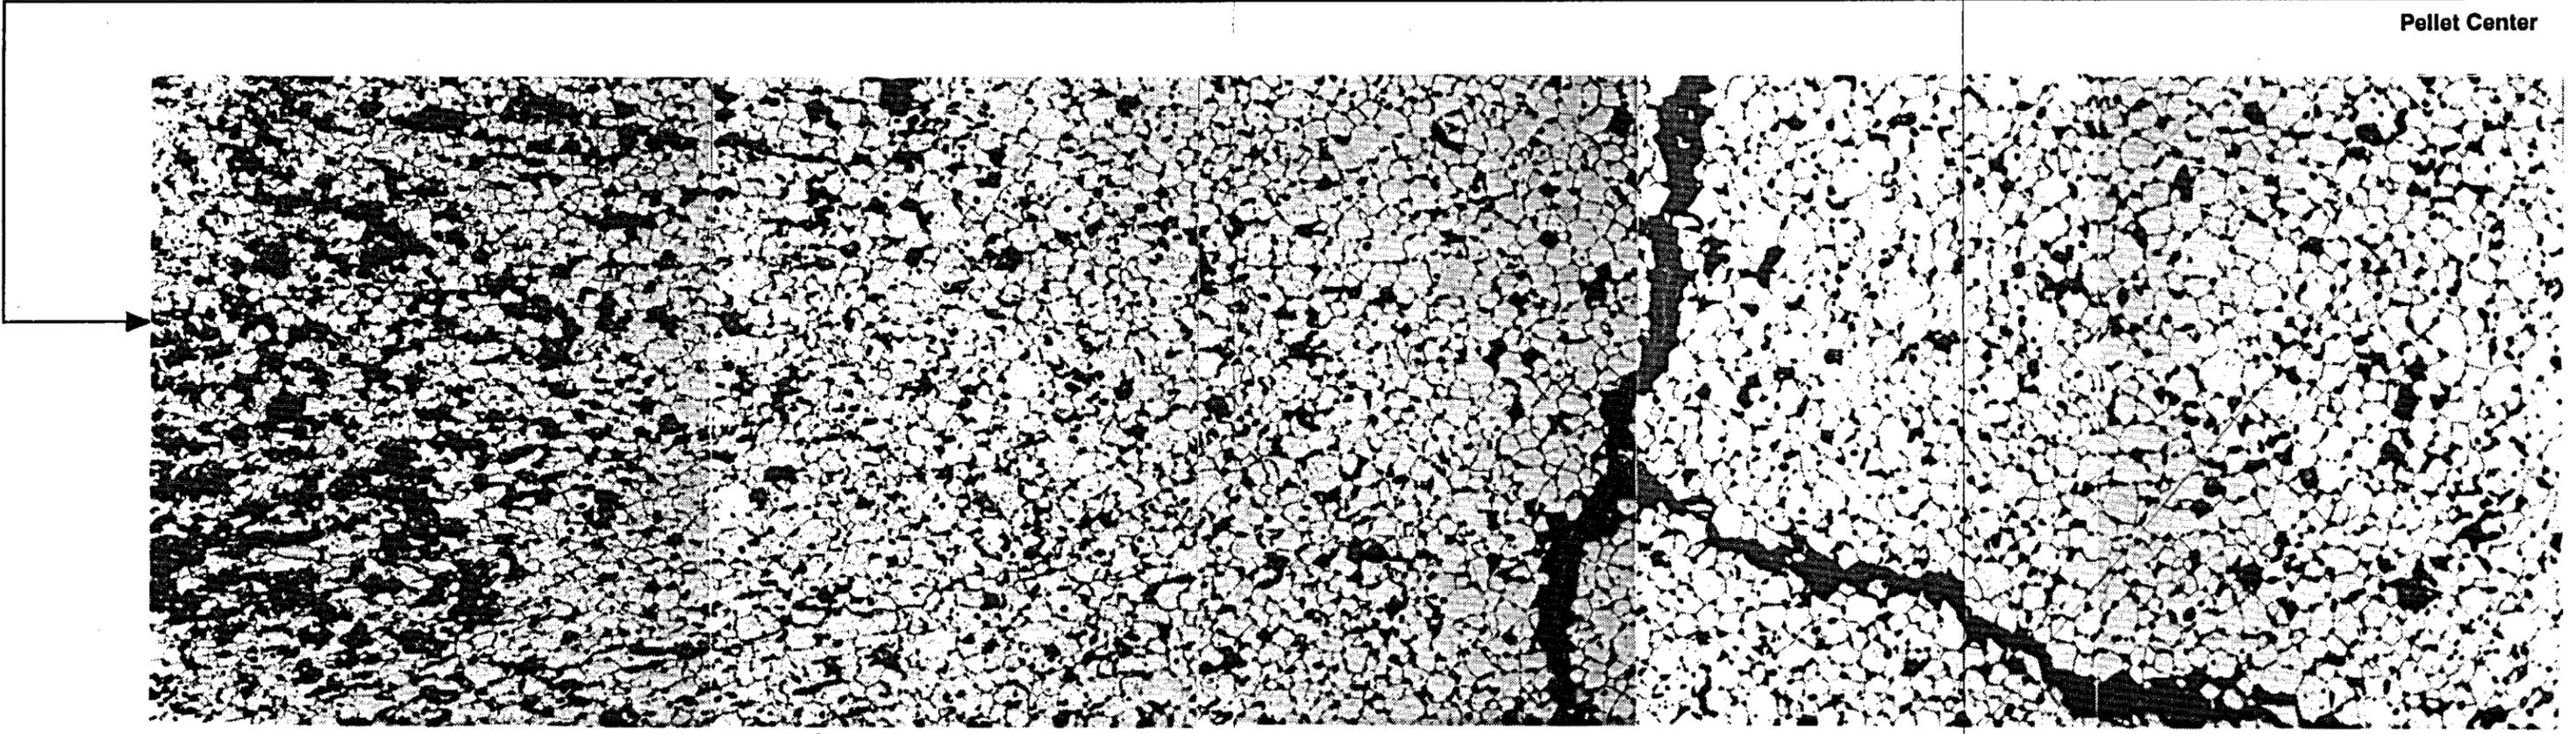
Figure 3.3-8. Fuel Structural Changes near Rod Fracture, Rod D79F/H12

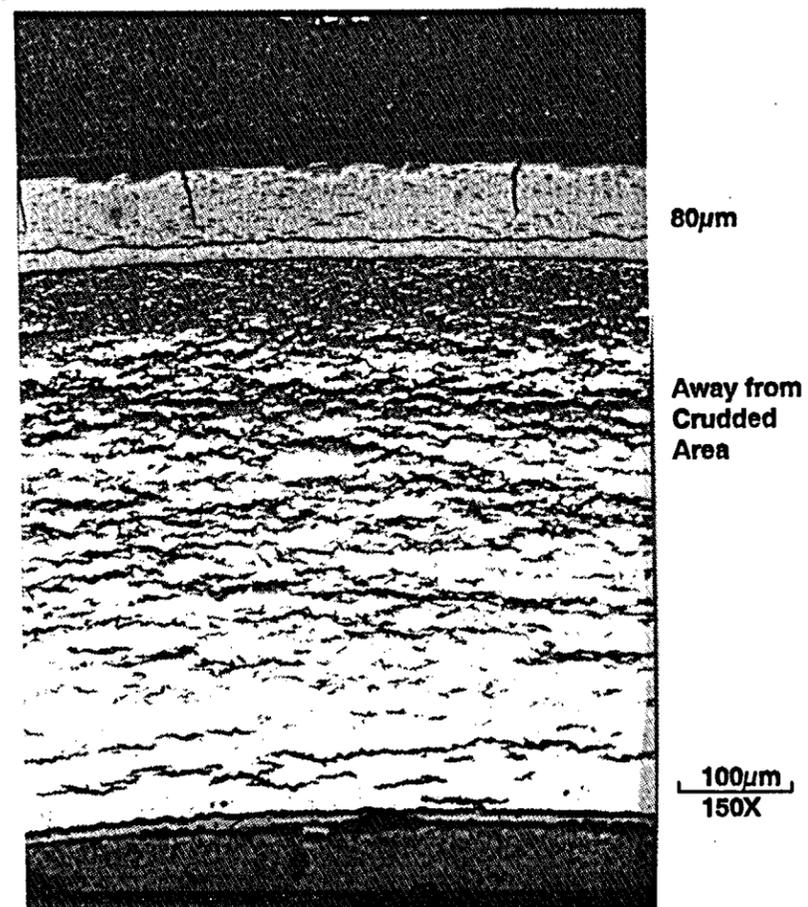
Figure 3.3-14. Increased Waterside Corrosion in the Crudded Region, V.C. Summer Vantage 5 Rod VV2/J05

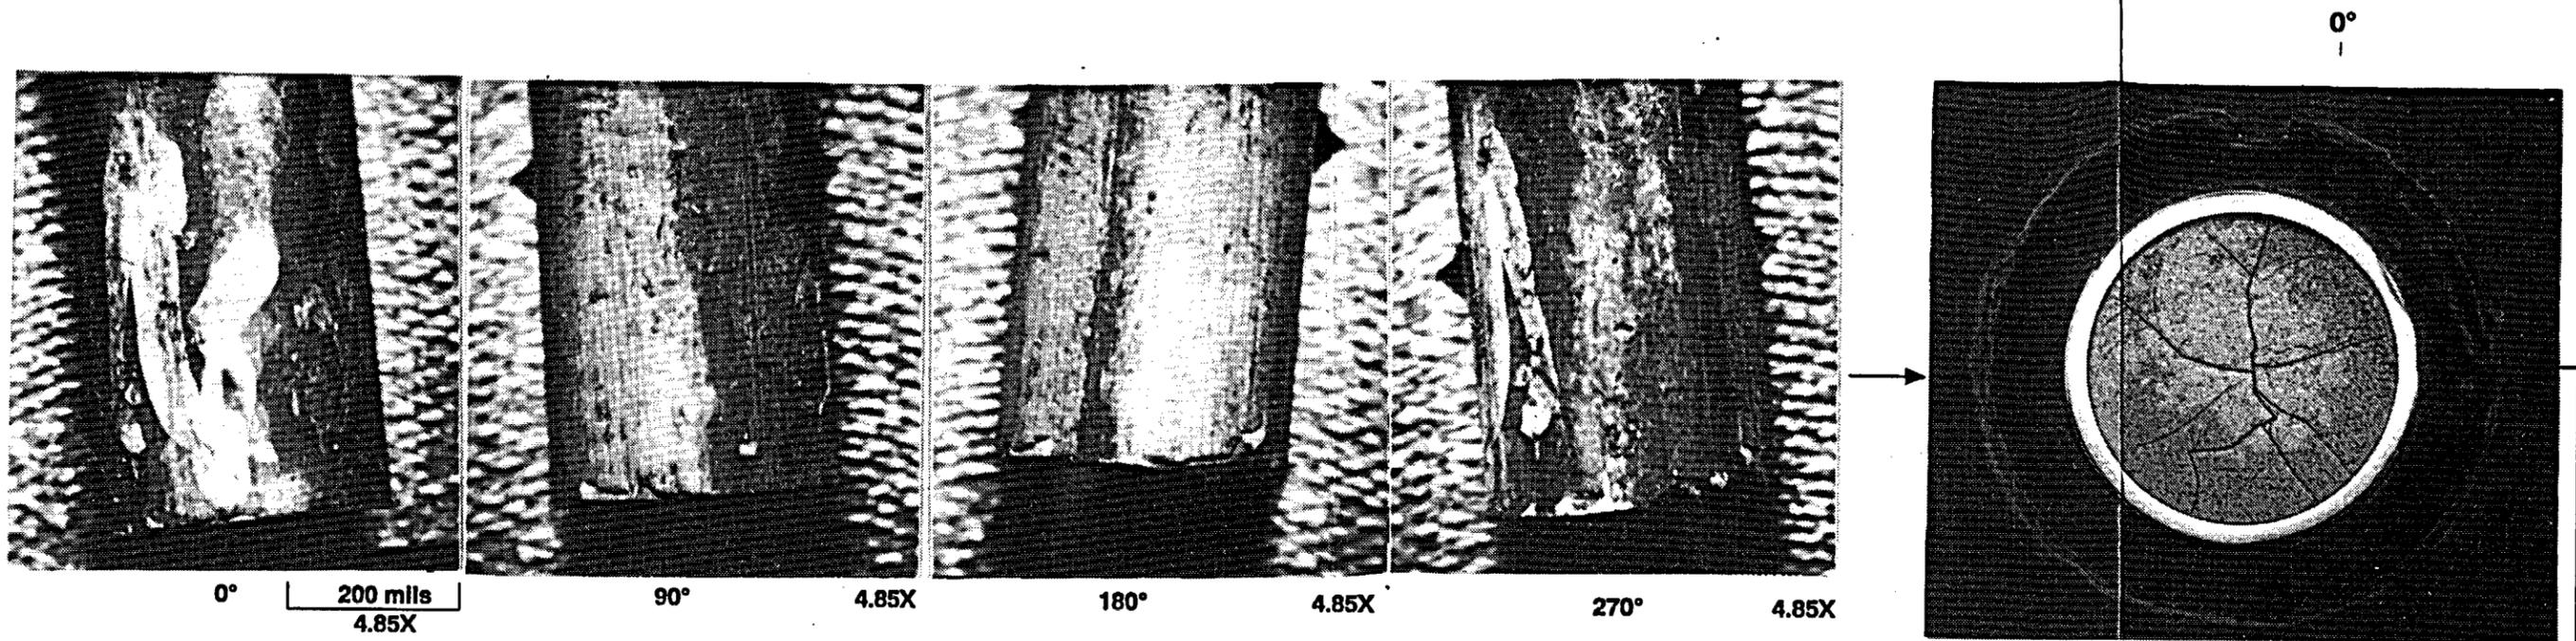
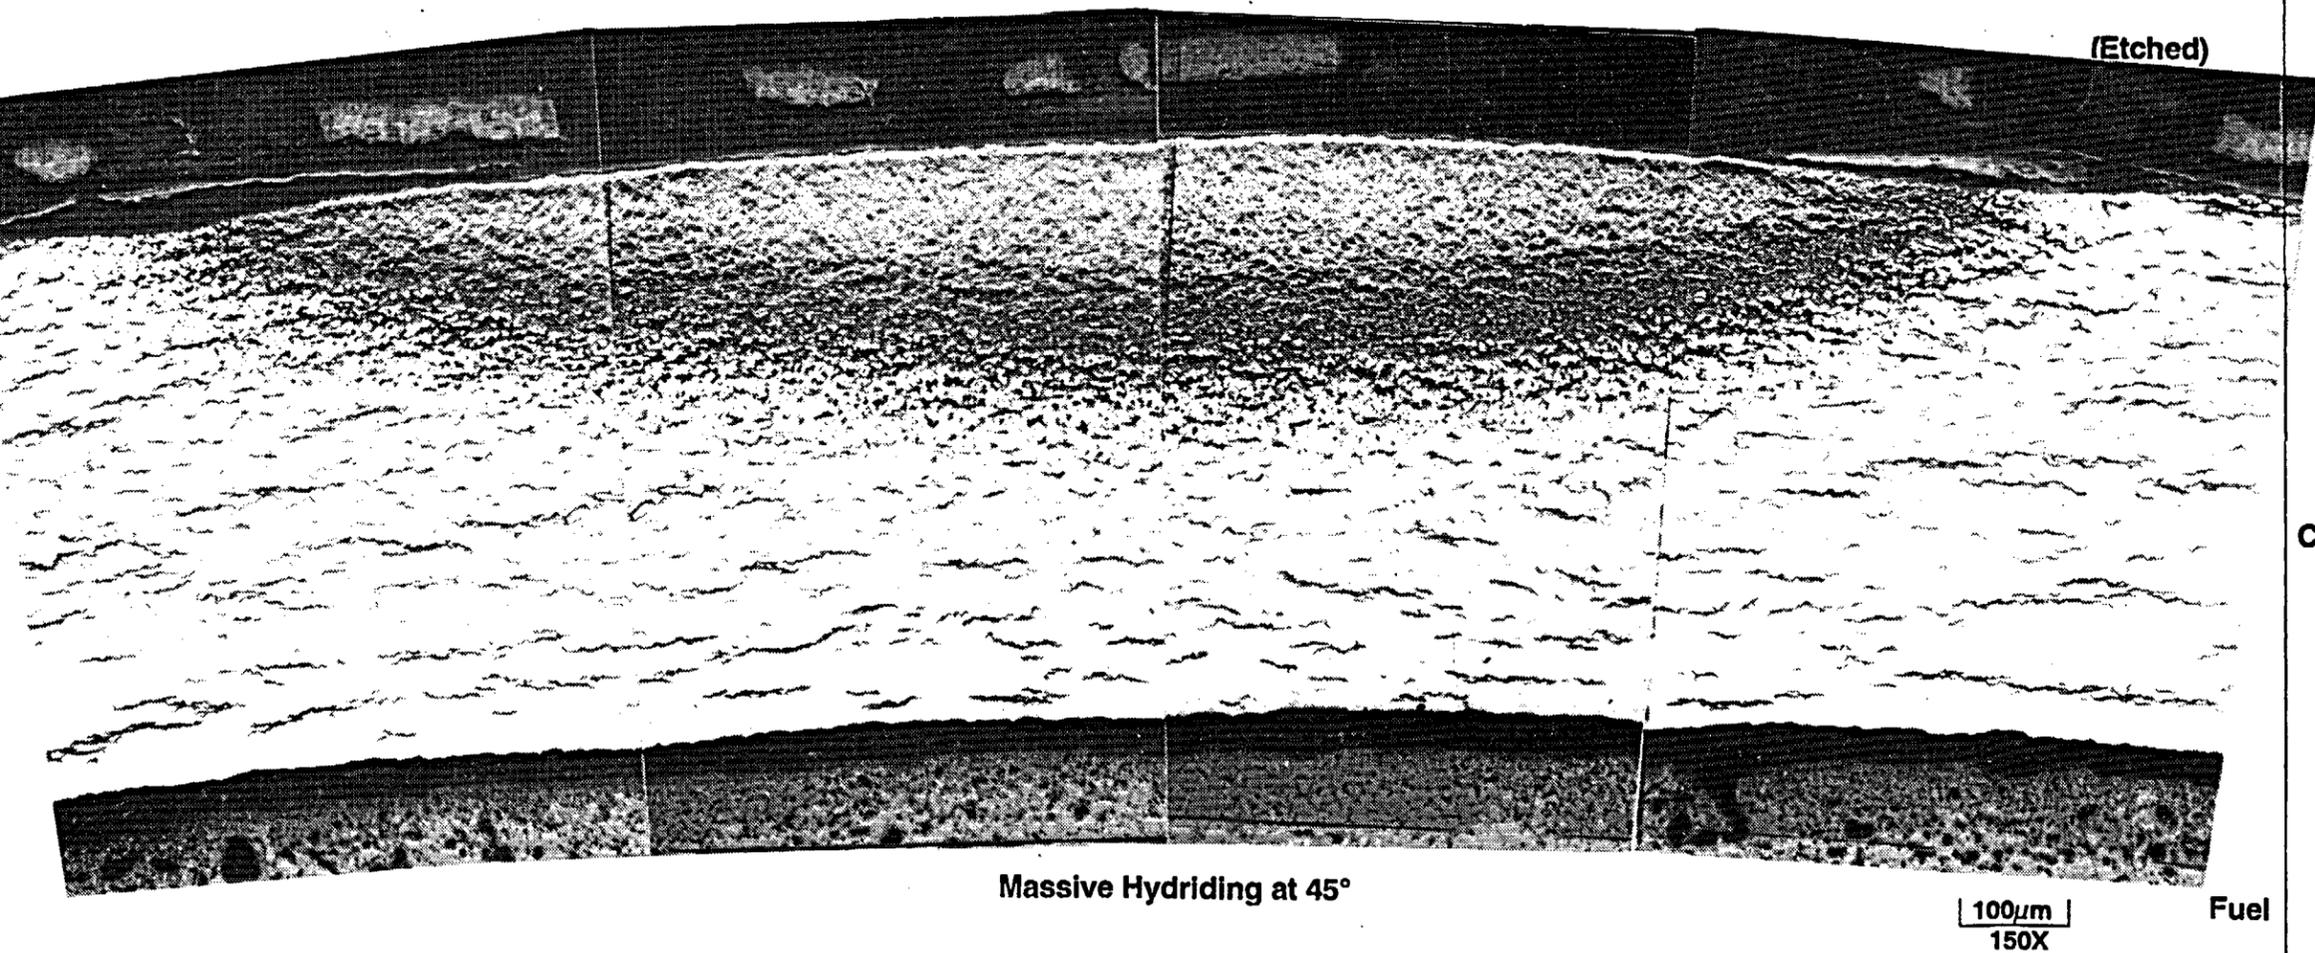
Figure 3.3-15. Localized Massive Hydriding at O.D. Oxide Spalled Area, Rod VV2/K14; 127 Inches from the Bottom
