~~CONFIDENTIAL~~  
EPRI TR-104721  
Project 2229-01  
ESEERCO Project EP89-31  
Final Report  
December 1994

# **Evaluation of Fuel Rod Leakage Mechanisms—Summary Report**

## **Joint EPRI/ESEERCO/Westinghouse Studies**

Prepared by  
Westinghouse Electric Corporation  
Pittsburgh, Pennsylvania

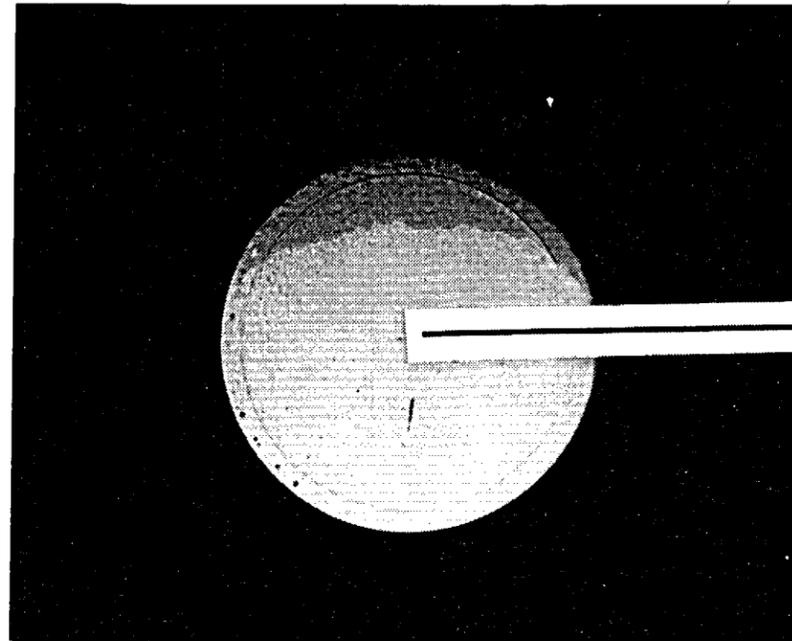
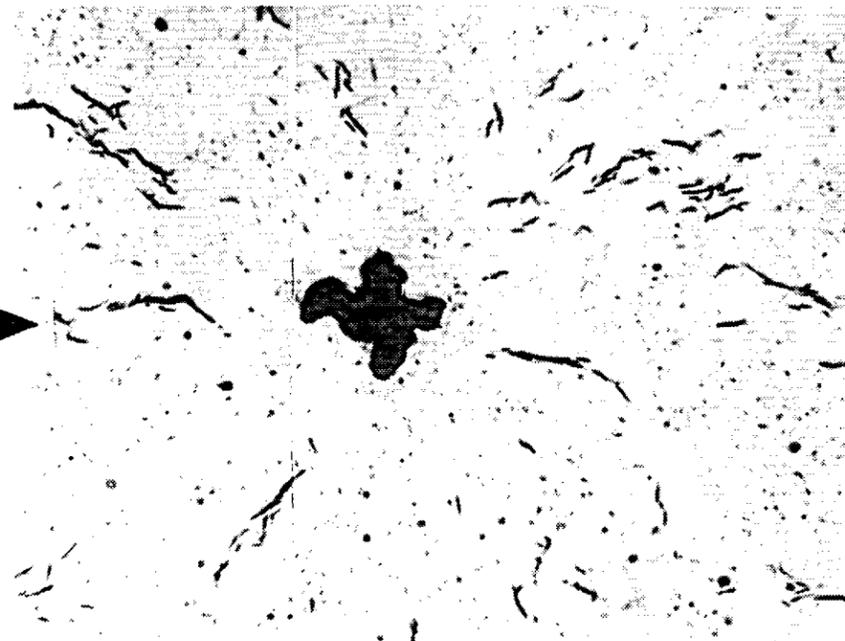
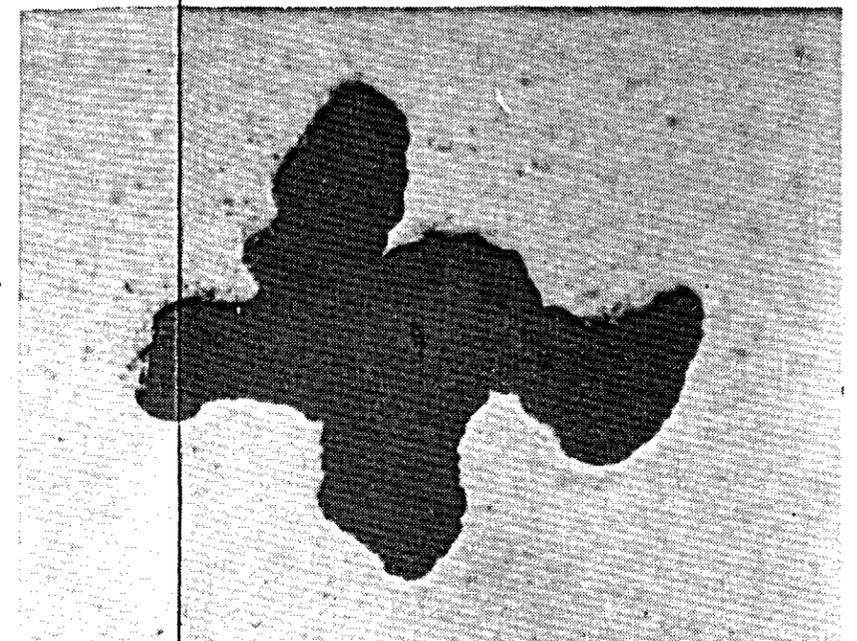
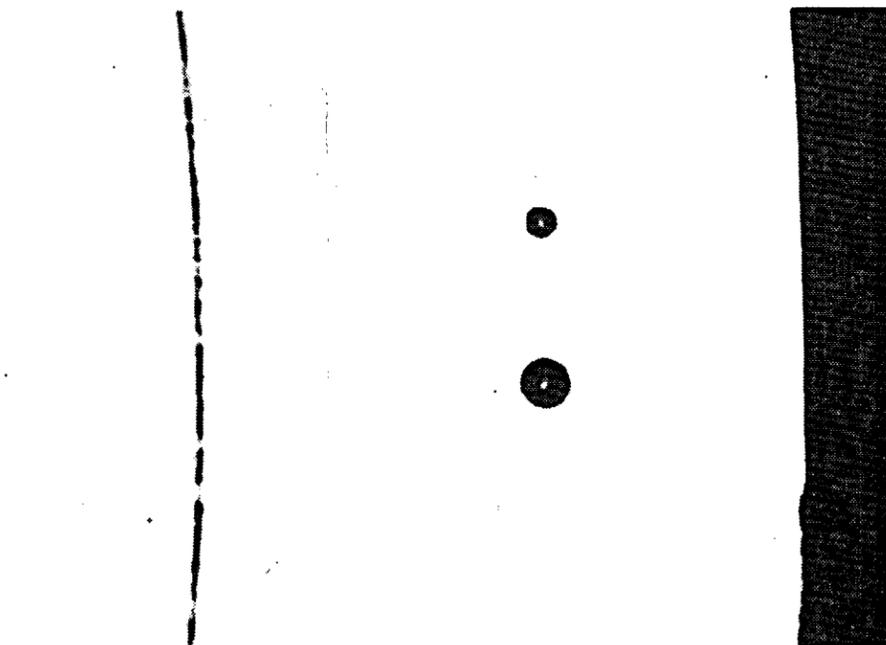
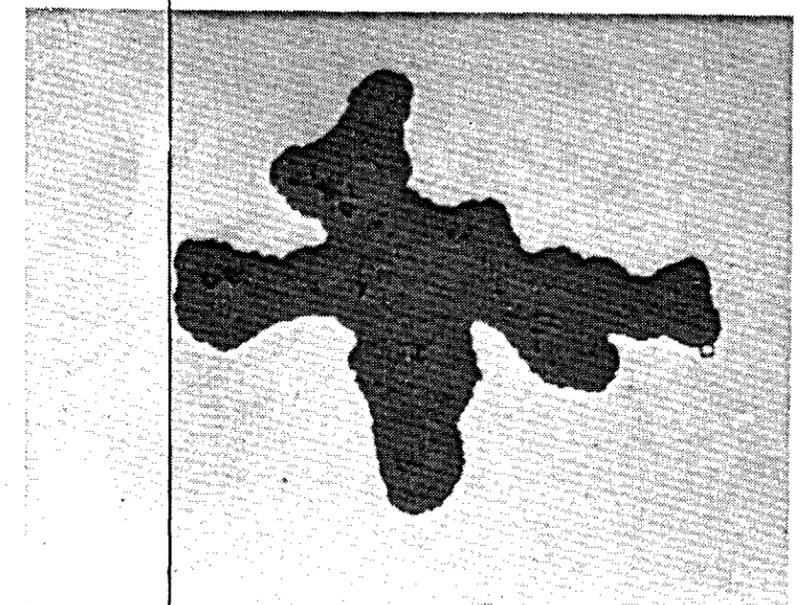
Figure 3.3-1. End Plug Piping in Two Byron-2 Rods (T74J/116 and T77K/D02)

End Plug Piping

Porositles in Cladding

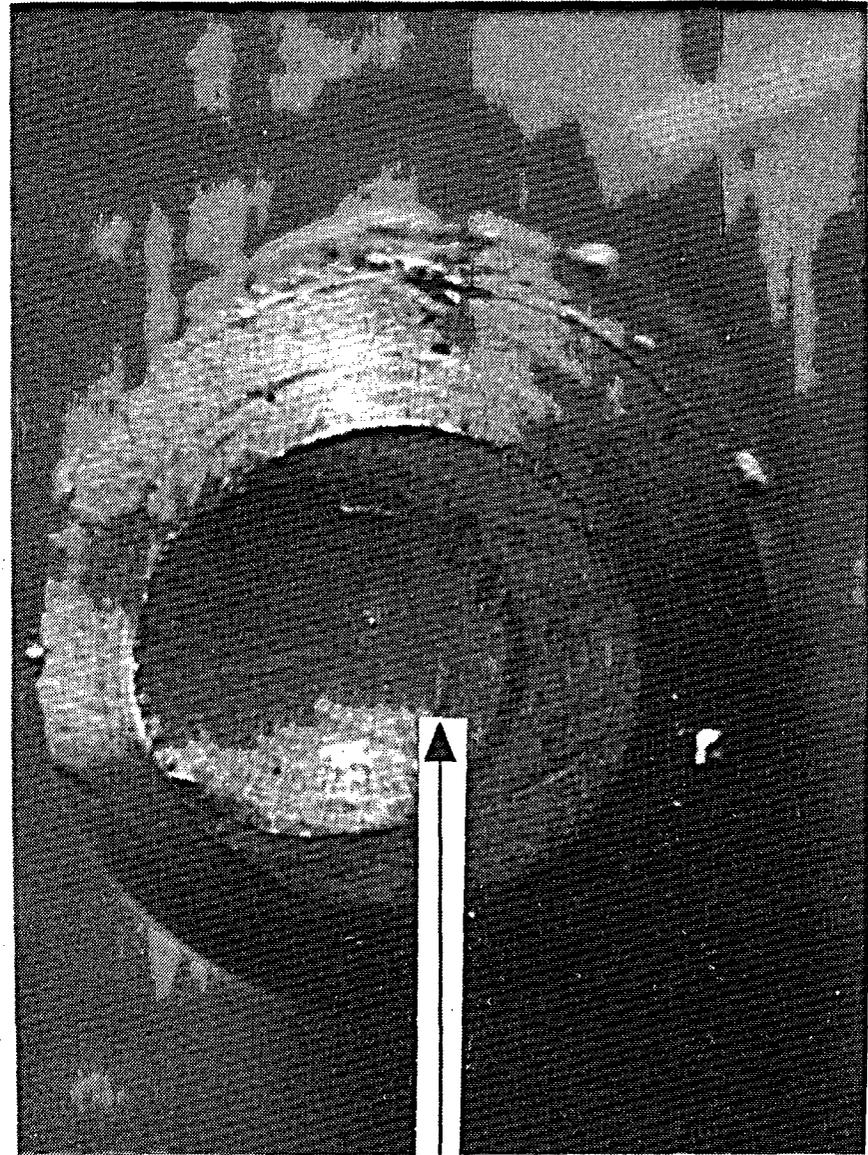
Suspicious discolored mark

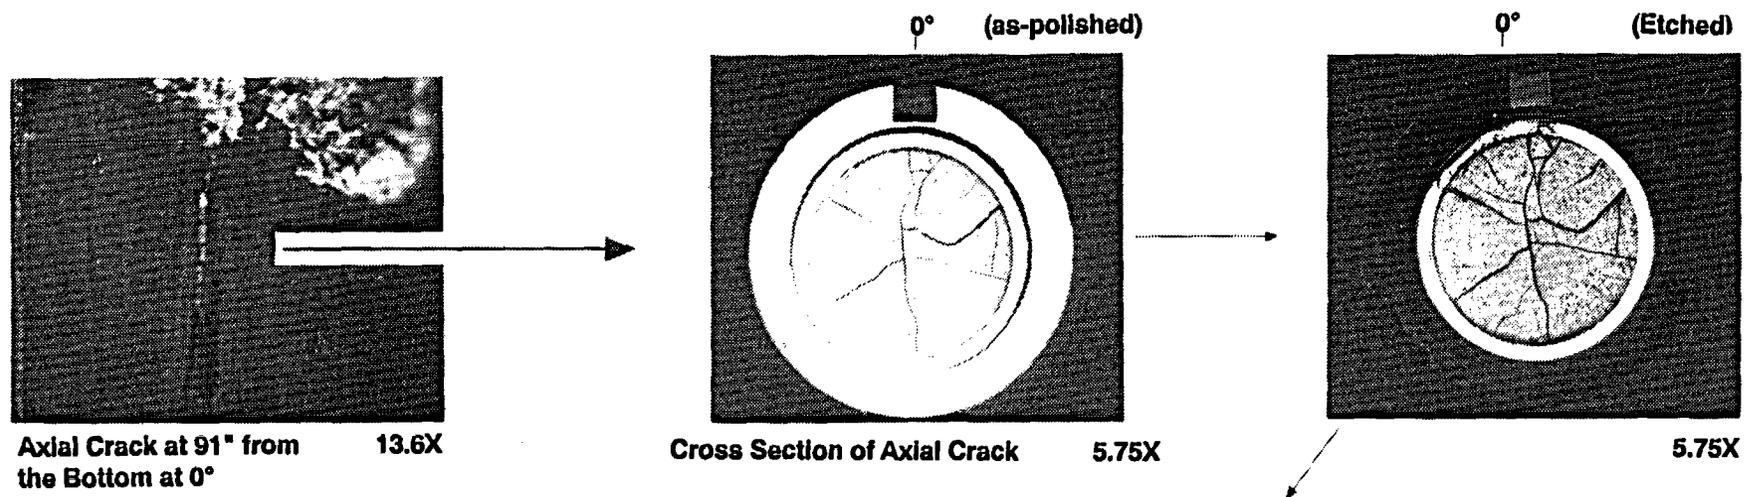
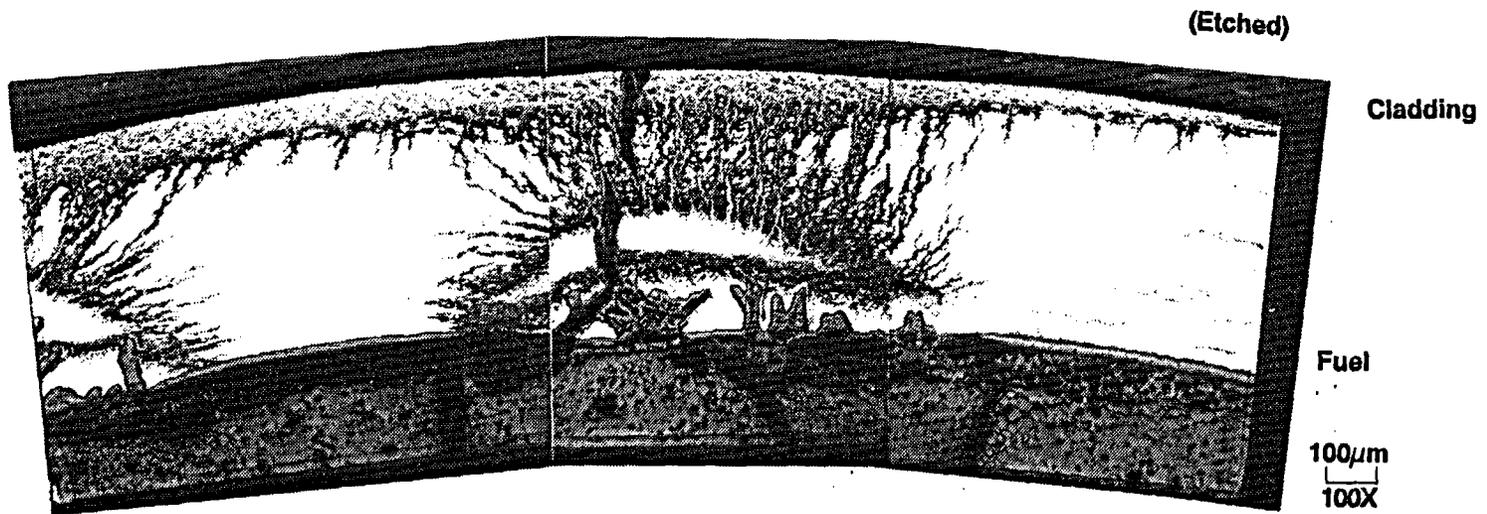
The metallographic measurements of waterside corrosion (up to 81 microns for the clad circumferential average of the area excluding oxide spalling and oxide pit regions) showed the expected trend of increasing corrosion with increasing distance from the bottom of the rods. The results reflect the increase in metal/oxide temperature resulting from the progressive increase in coolant temperature up the rods. The waterside corrosion data from metallography were compared to the corresponding onsite eddy current data, Figure 3.3-11. The comparison revealed that essentially no bias exists between the two types of data. Oxide spalling was observed at the upper elevations of the rods examined. The spalling was caused by delamination at the base of the corrosion films due to thick oxide.

Figure 3.3-4. Axial Crack Due to Massive Hydriding, Rod T77K/D02, at 93" from the Bottom

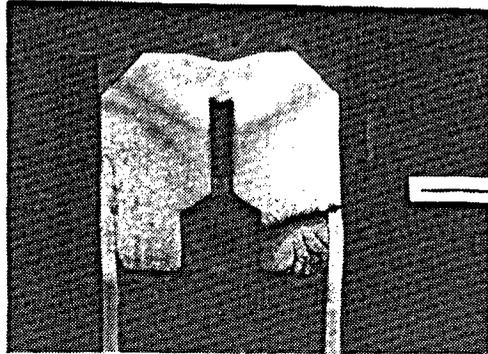
**Crack in Top End Plug Weld Region**

**Figure 3.3-5. Circumferential Cladding Crack in Top End Plug Weld Region Caused by End Plug Hydridding, T74J/I16**

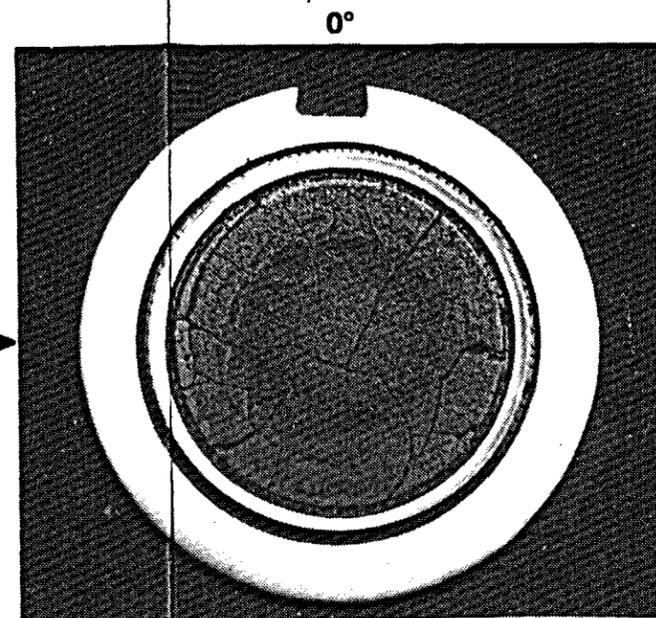
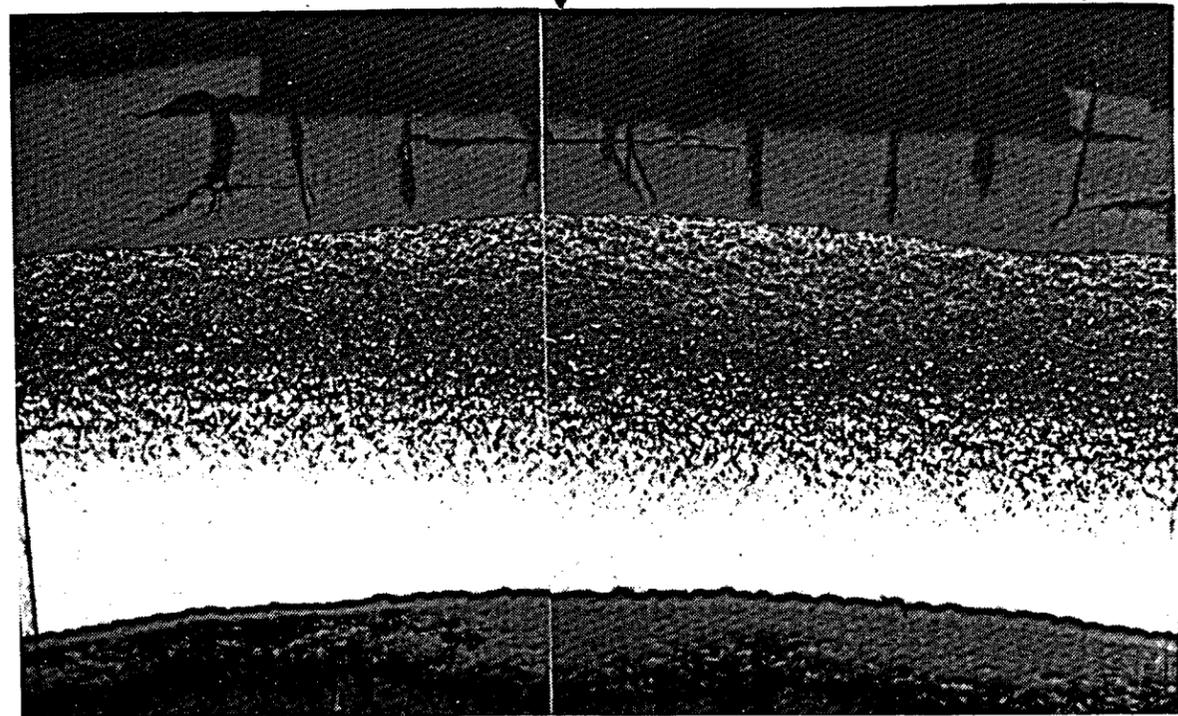
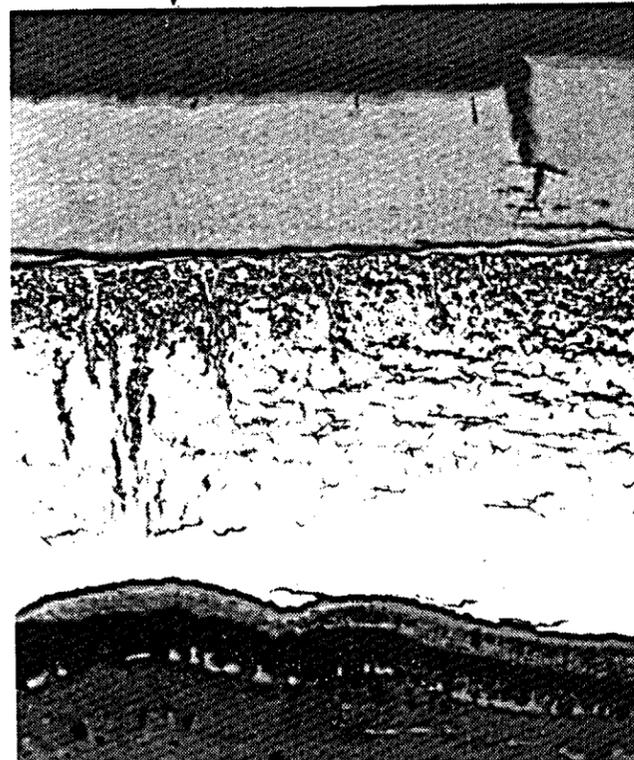
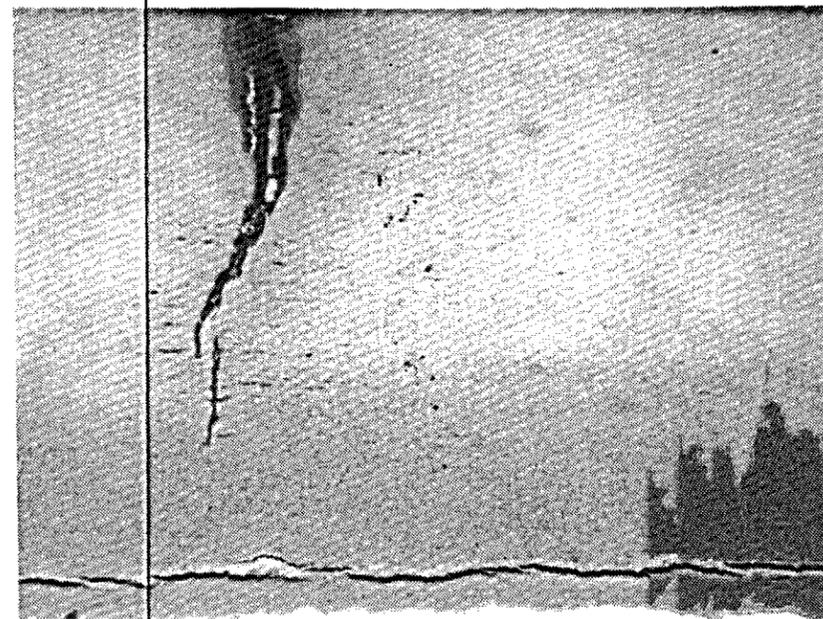
Pitted Oxide

Hydride Reorientation  
and Cladding Thinning

Maximum Oxide - 210µm (at 310°)

Figure 3.3-6. O.D. Oxide Pitting Near Rod Fracture, Rod D79F/H12

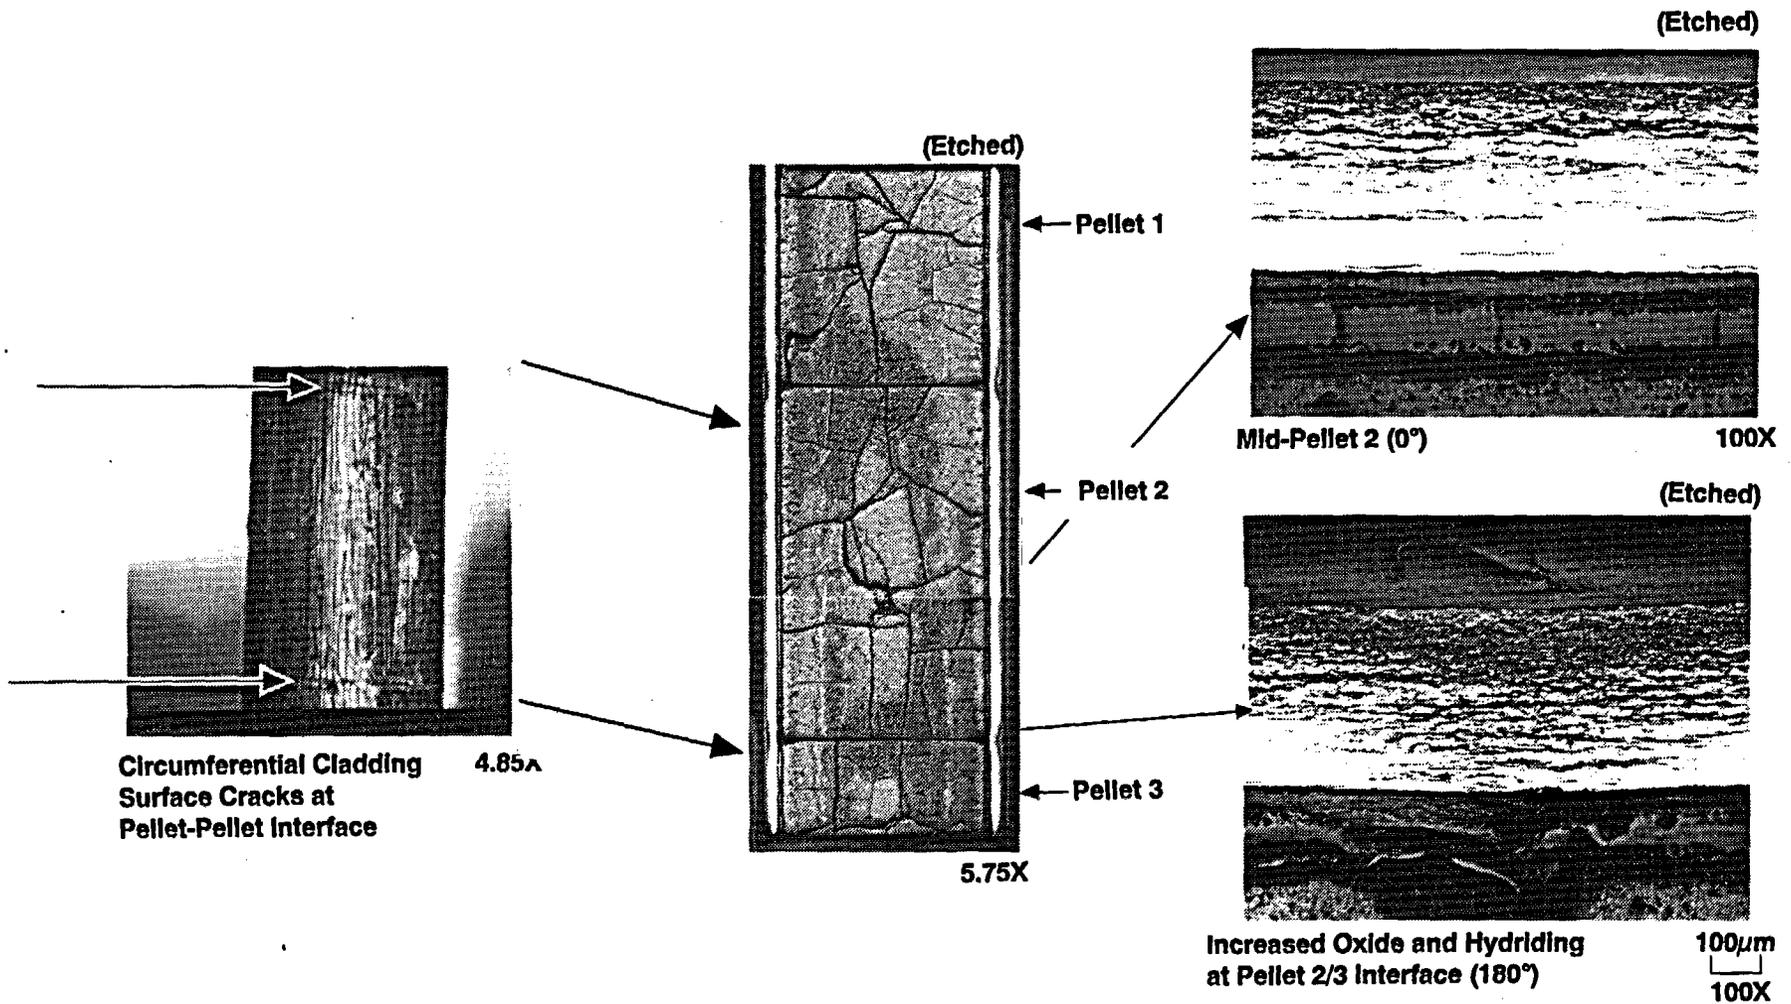
Figure 3.3-7. Increased O.D. Oxide and Hydride Precipitates at Pellet-Pellet Interfaces, Rod D79F/H12

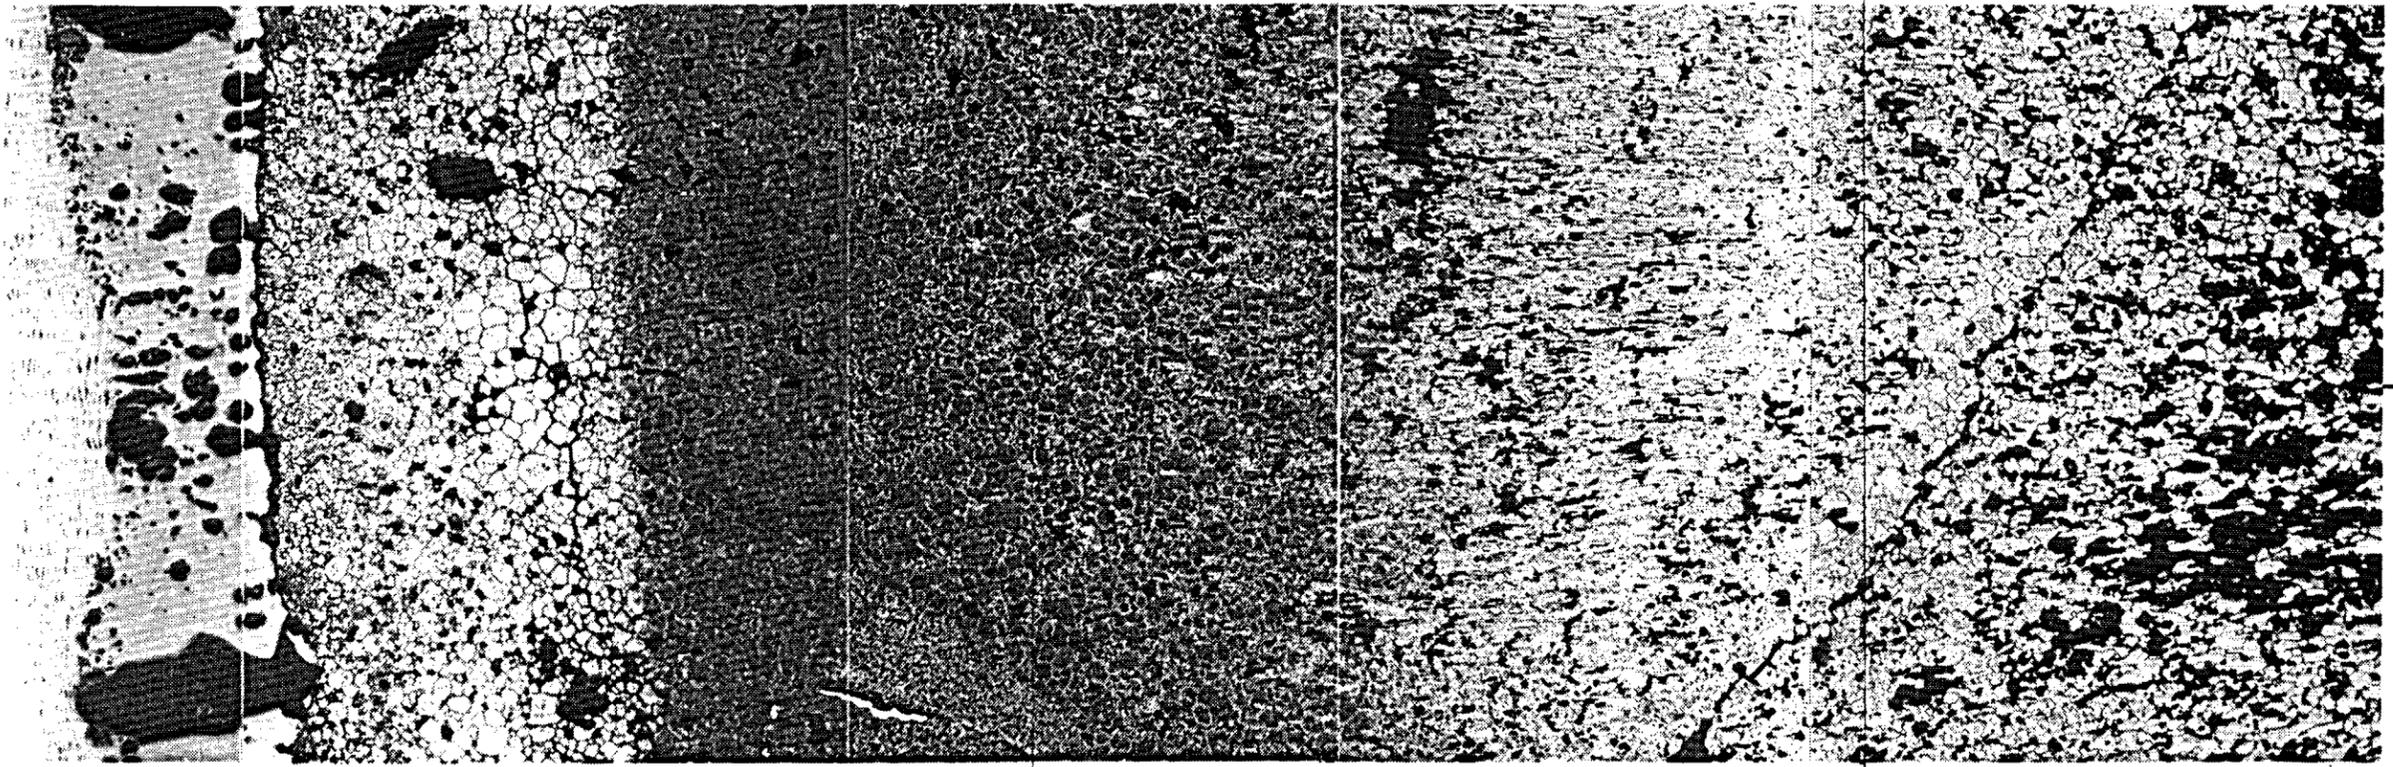
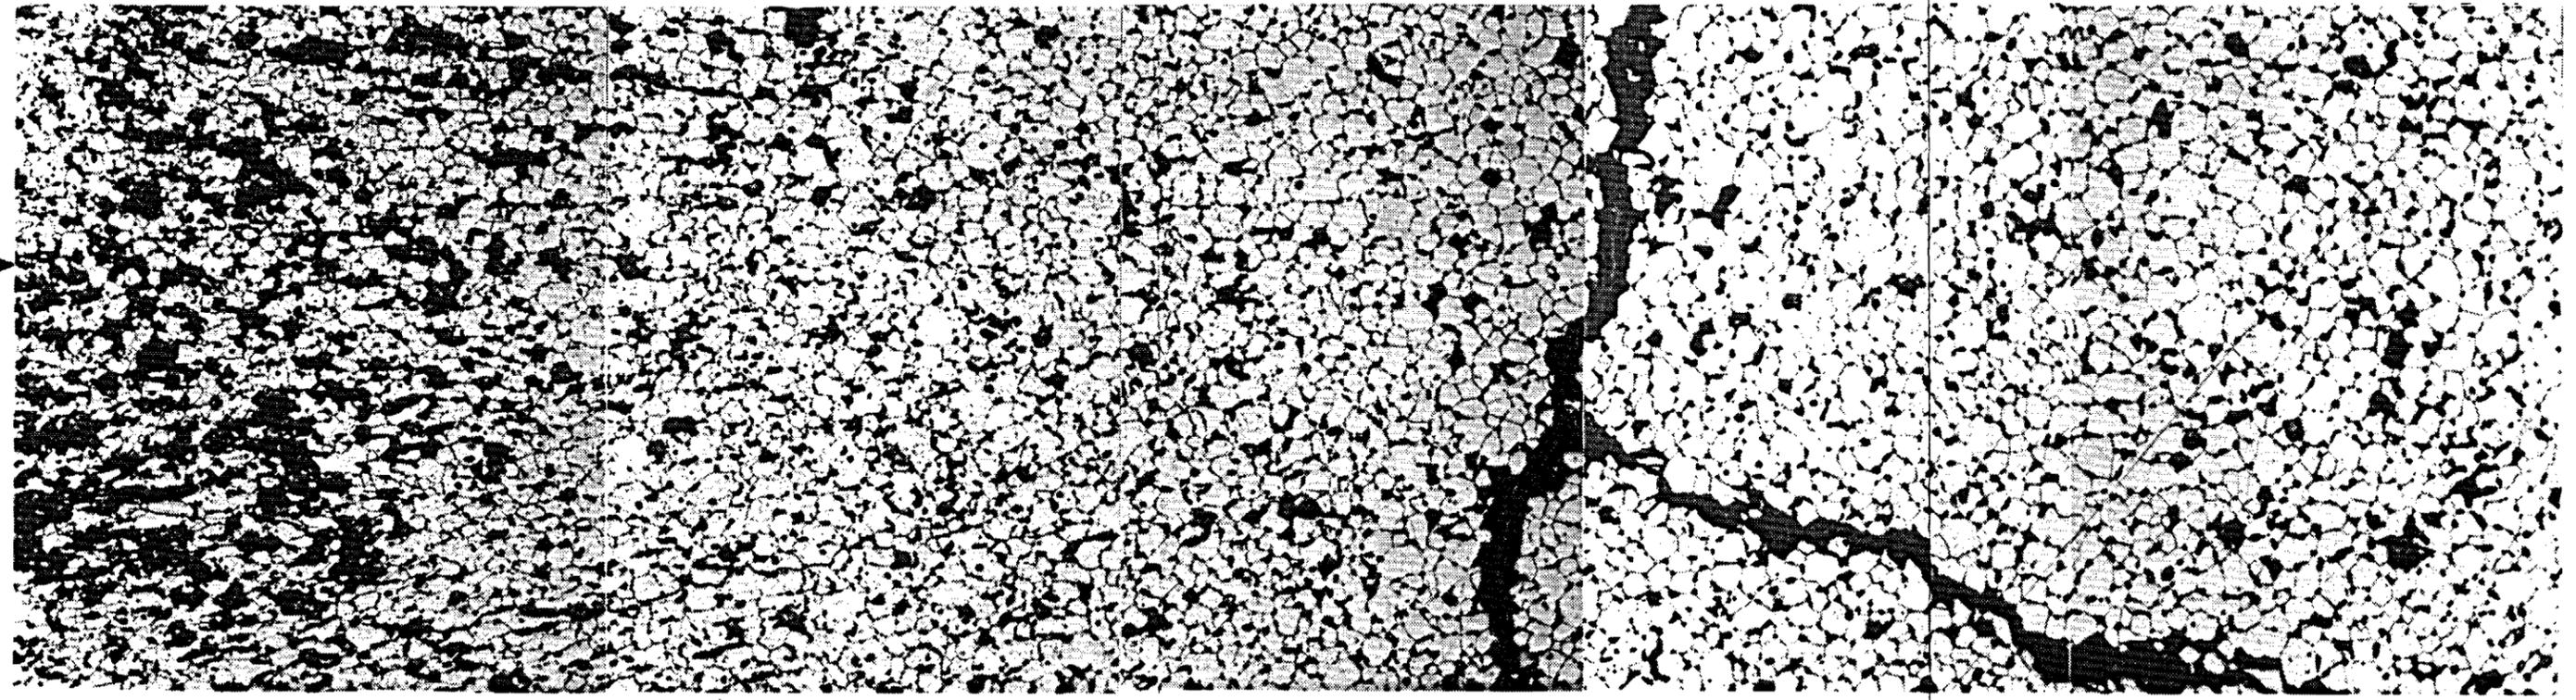
Figure 3.3-8. Fuel Structural Changes near Rod Fracture, Rod D79F/H12

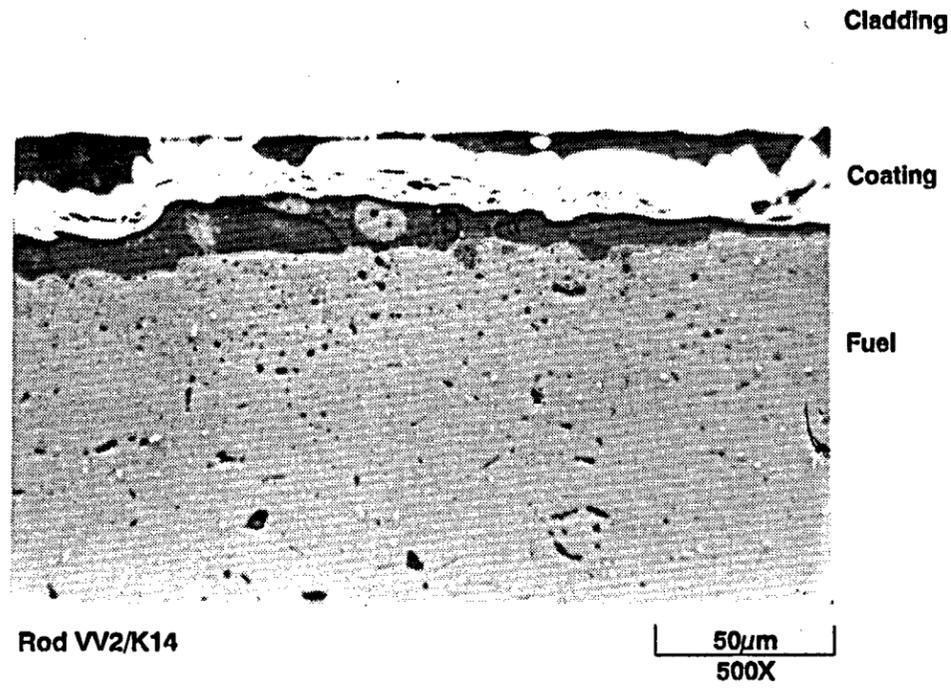
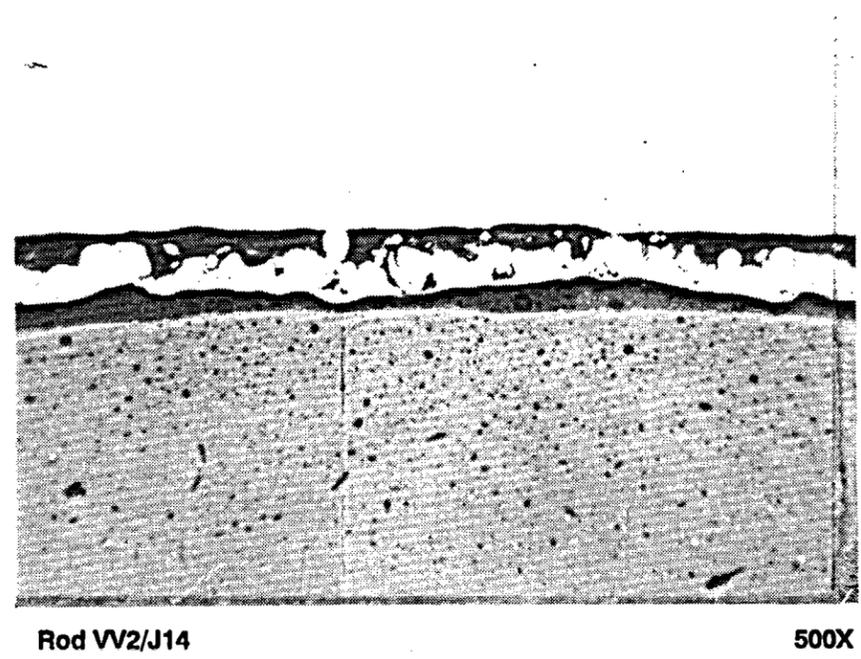
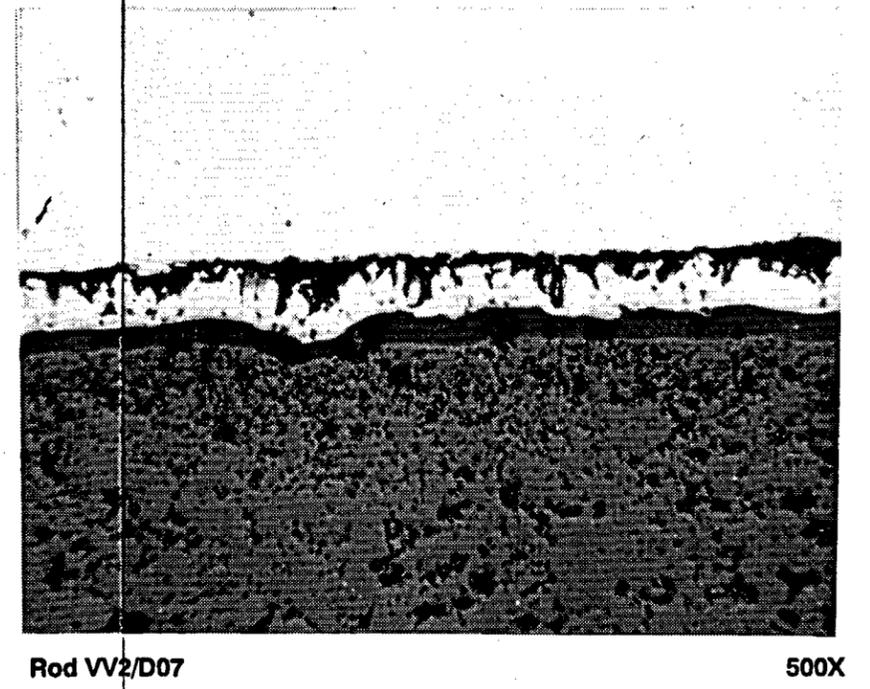
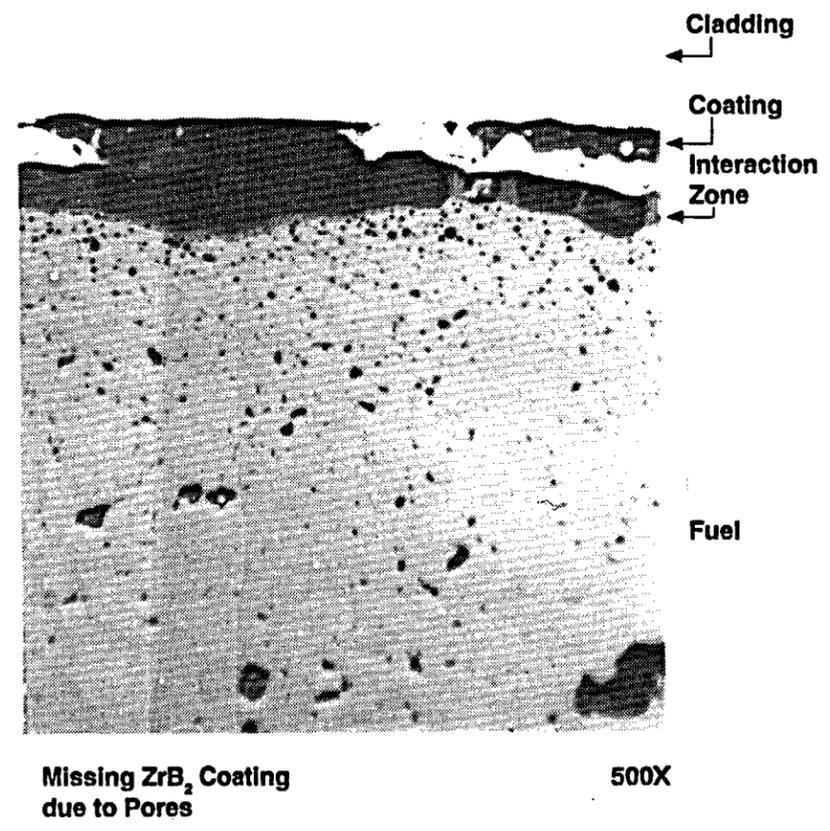
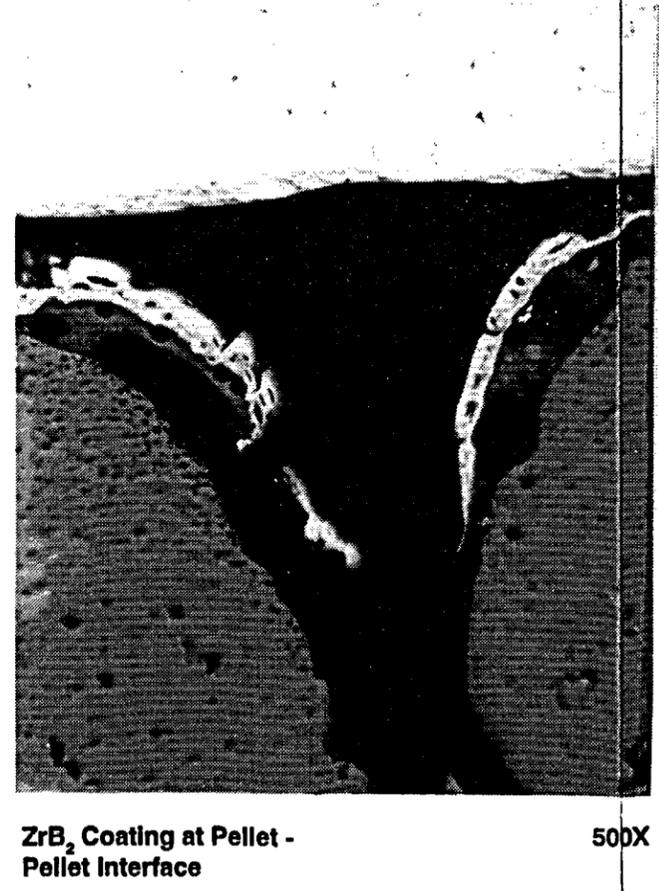
Fuel microstructure of both standard OFA rod and IFBA rods exhibited stable behavior. No structural difference was seen between the standard OFA and IFBA rods. Essentially, no restructuring phenomena were observed except the "rim effect" seen in the fuel peripheral region and the dark band seen in the fuel outer region. The rim region was characterized as a porous region (cauliflower microstructure) where the initial grain boundary structure has disappeared and seems to be replaced by a very small grain structure (1 micron size). The dark band was characterized as numerous pores in the grains. The fuel microstructures were generally consistent with the measured low fission gas release.

Figure 3.3-9. Appearance of ZrB<sub>2</sub> Coating, ZrB<sub>2</sub>-Fuel Interaction Zone, and Pores in the Interaction Zone

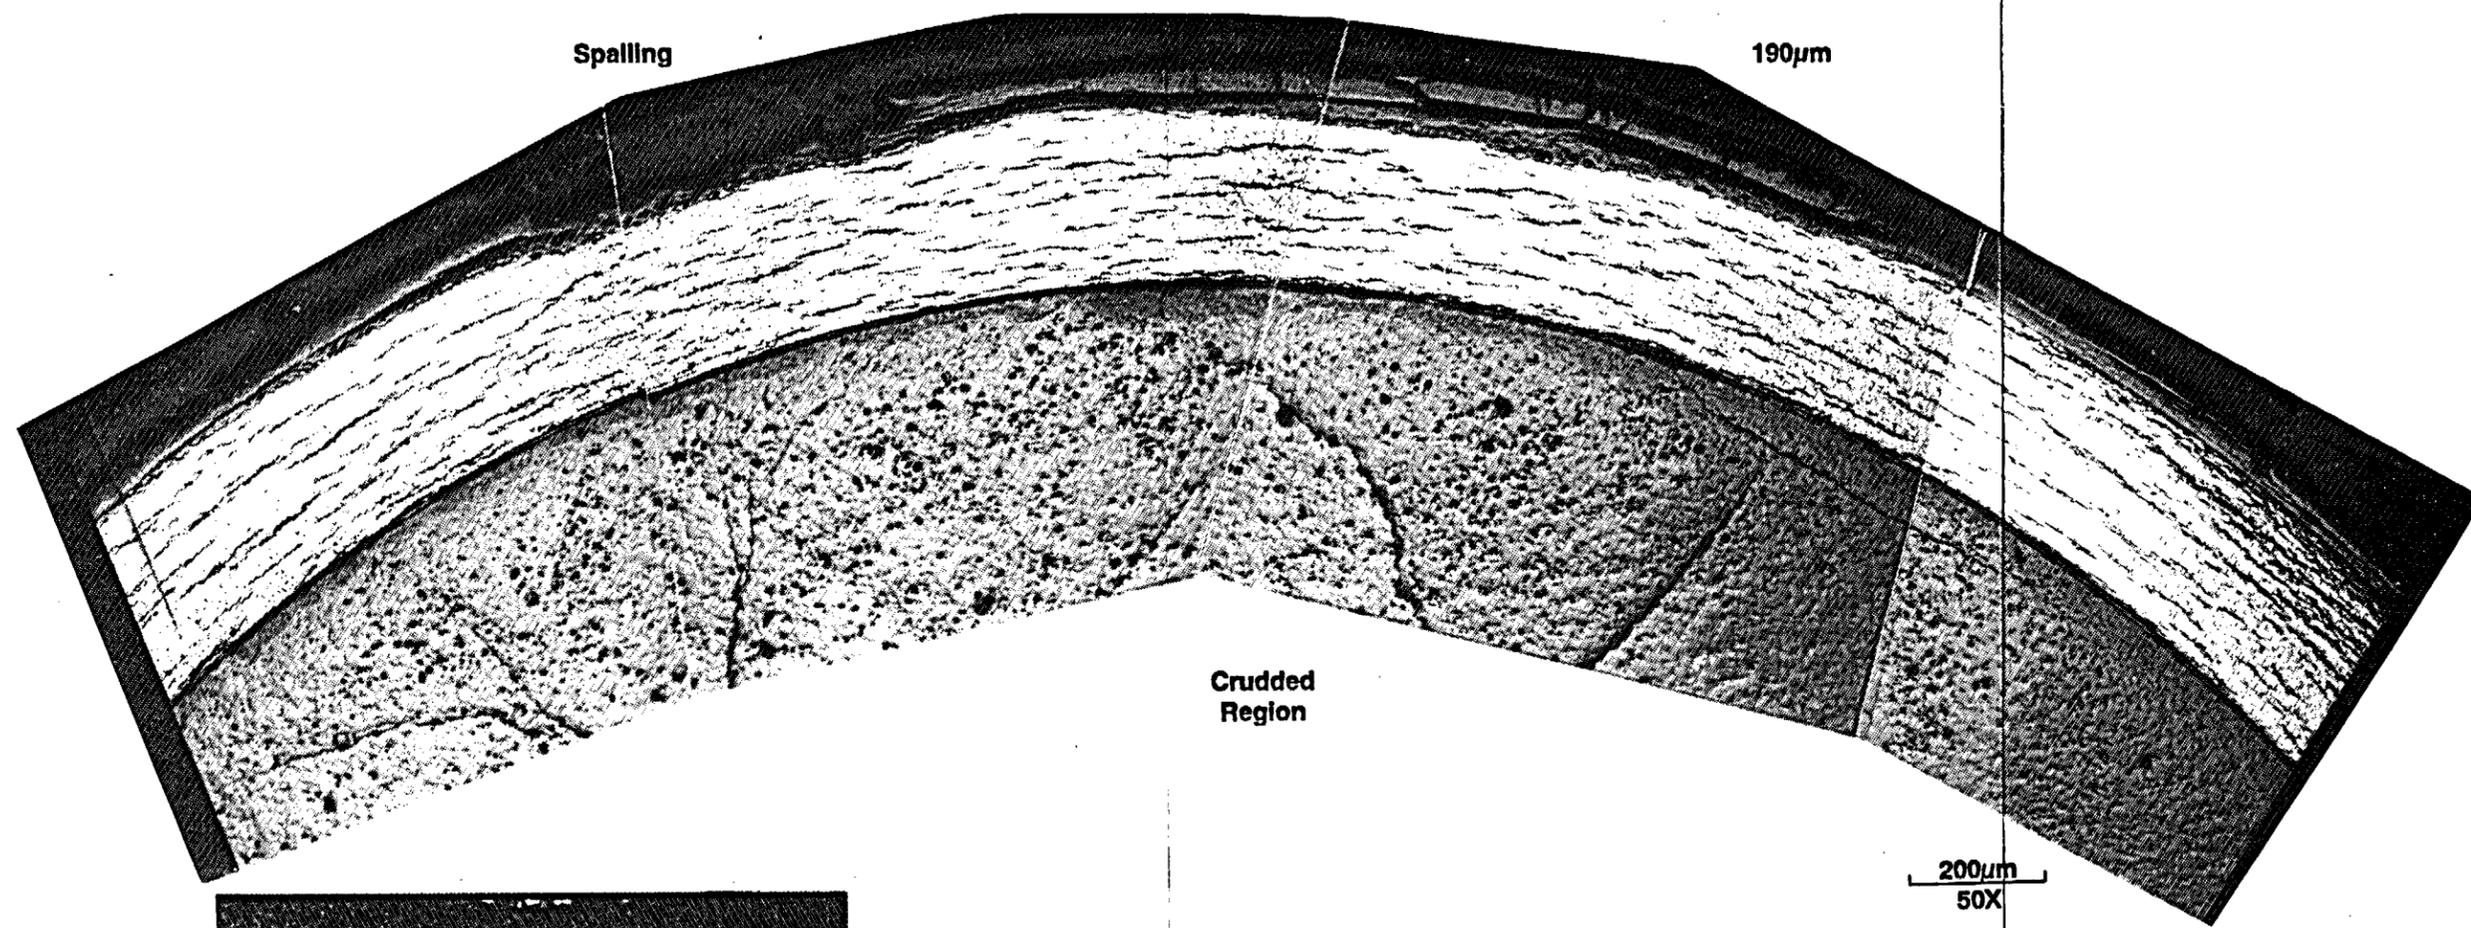
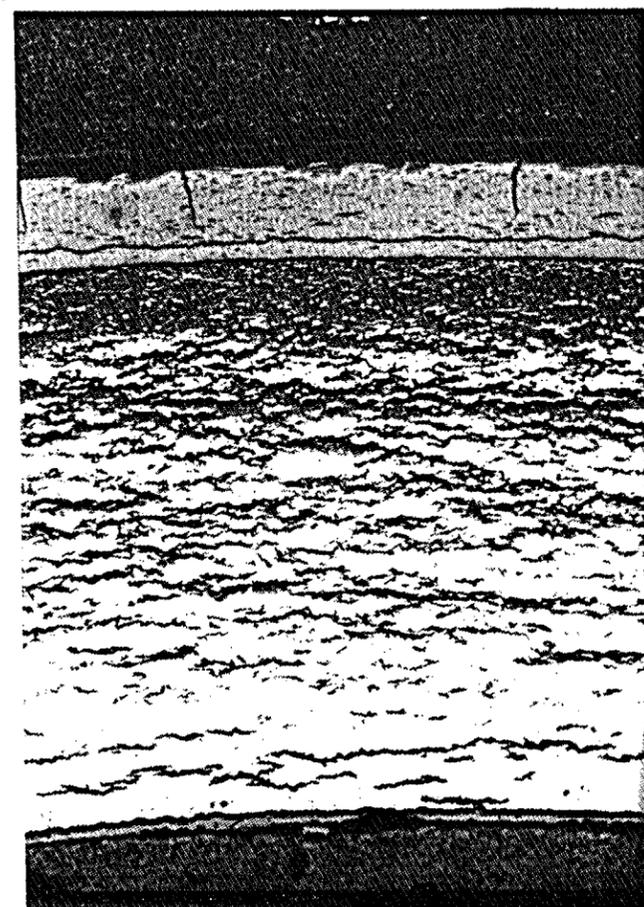
Figure 3.3-14. Increased Waterside Corrosion in the Crudded Region, V.C. Summer Vantage 5 Rod VV2/J05
